Labour Department
Concise Investigation Report for the
Fatal Accident in Hong Kong-Zhuhai-Macao Bridge Project
on 29 March 2017

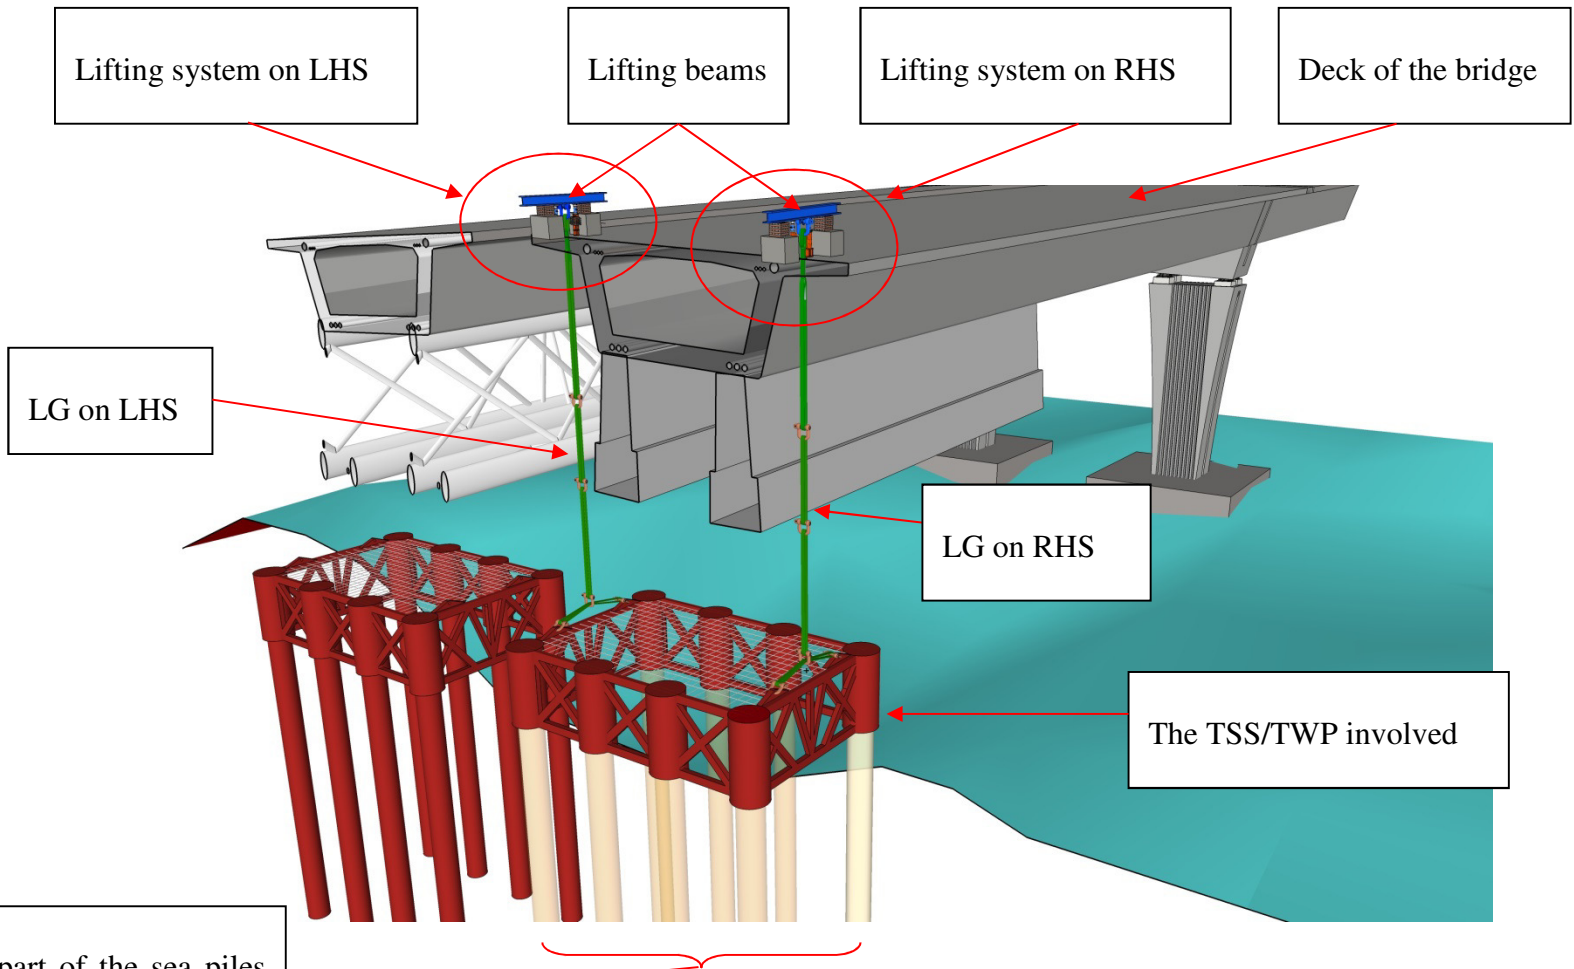
Figure 1 – Schematic diagram showing the TSS/TWP and the two lifting systems involved

2.3.3 One day before the accident (i.e. on 28 March 2017), the bottom parts of all eight sea piles of the TSS involved had been removed. Without support by these bottom parts, the TSS involved (including the upper parts of the sea piles, the TWP and the upper structures) had since been suspended by two sets of lifting systems, with one on the right hand side (“RHS”) and the other on the left hand side (“LHS”), which were set up on the deck of the bridge (Figure 1).

Bottom part of the sea piles (i.e. see light beige colour line) of the TSS/TWP involved had been removed, and the TSS had since been suspended by the lifting system

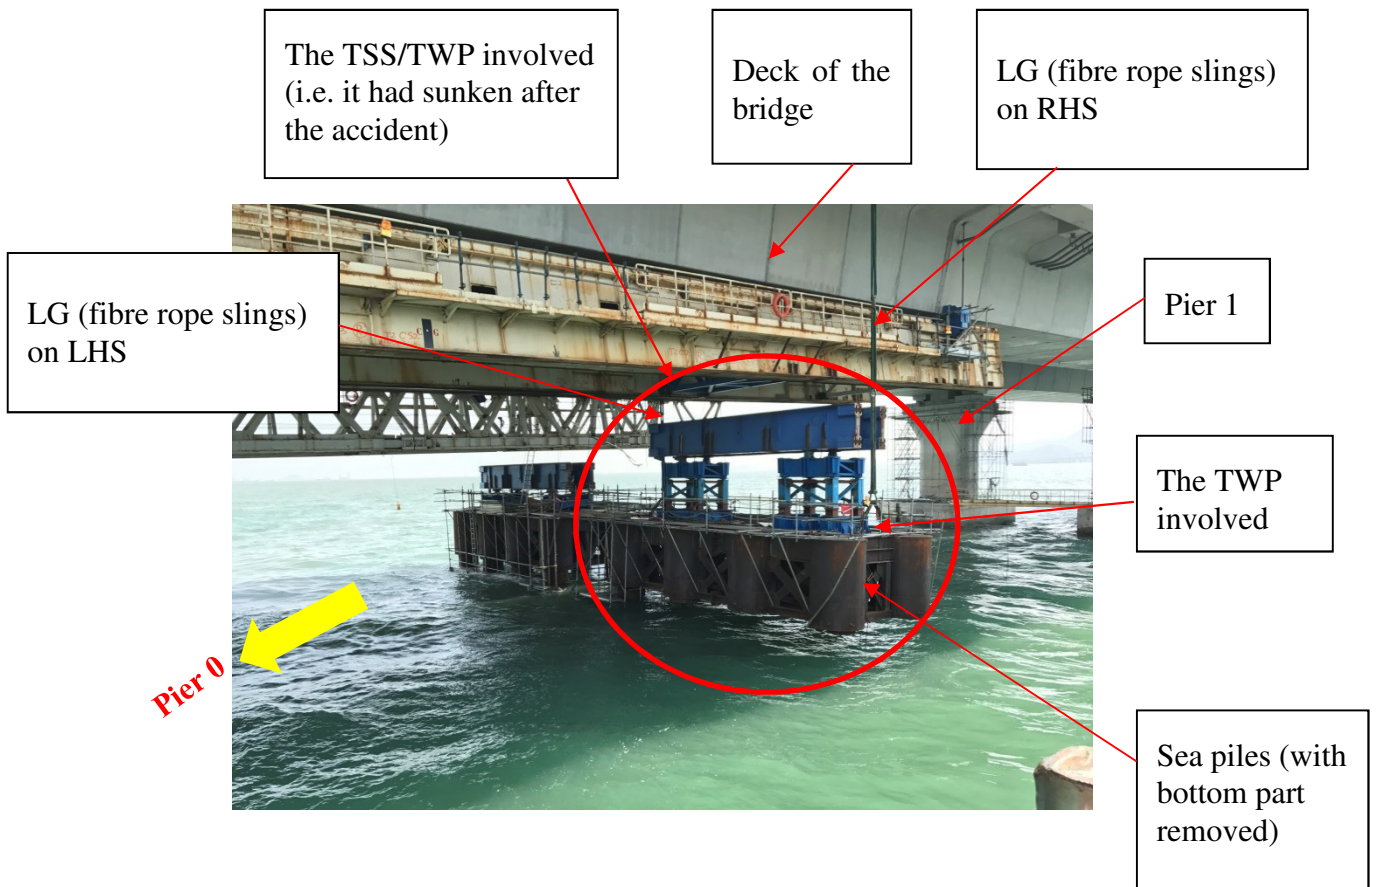
**Photo 1 – Overall view of the place of the accident
between Pier 0 and Pier 1
(Photo taken before the accident on 28 March 2017)**

2.3.1 Two TSSs were erected above the sea surface between Pier 0 to Pier 1 to provide support for the installation of pre-cast bridge segments to form the bridge surface (Photo 1 - taken by ARUP prior to the accident on 28 March 2017). Each TSS was supported by eight sea piles as footing.

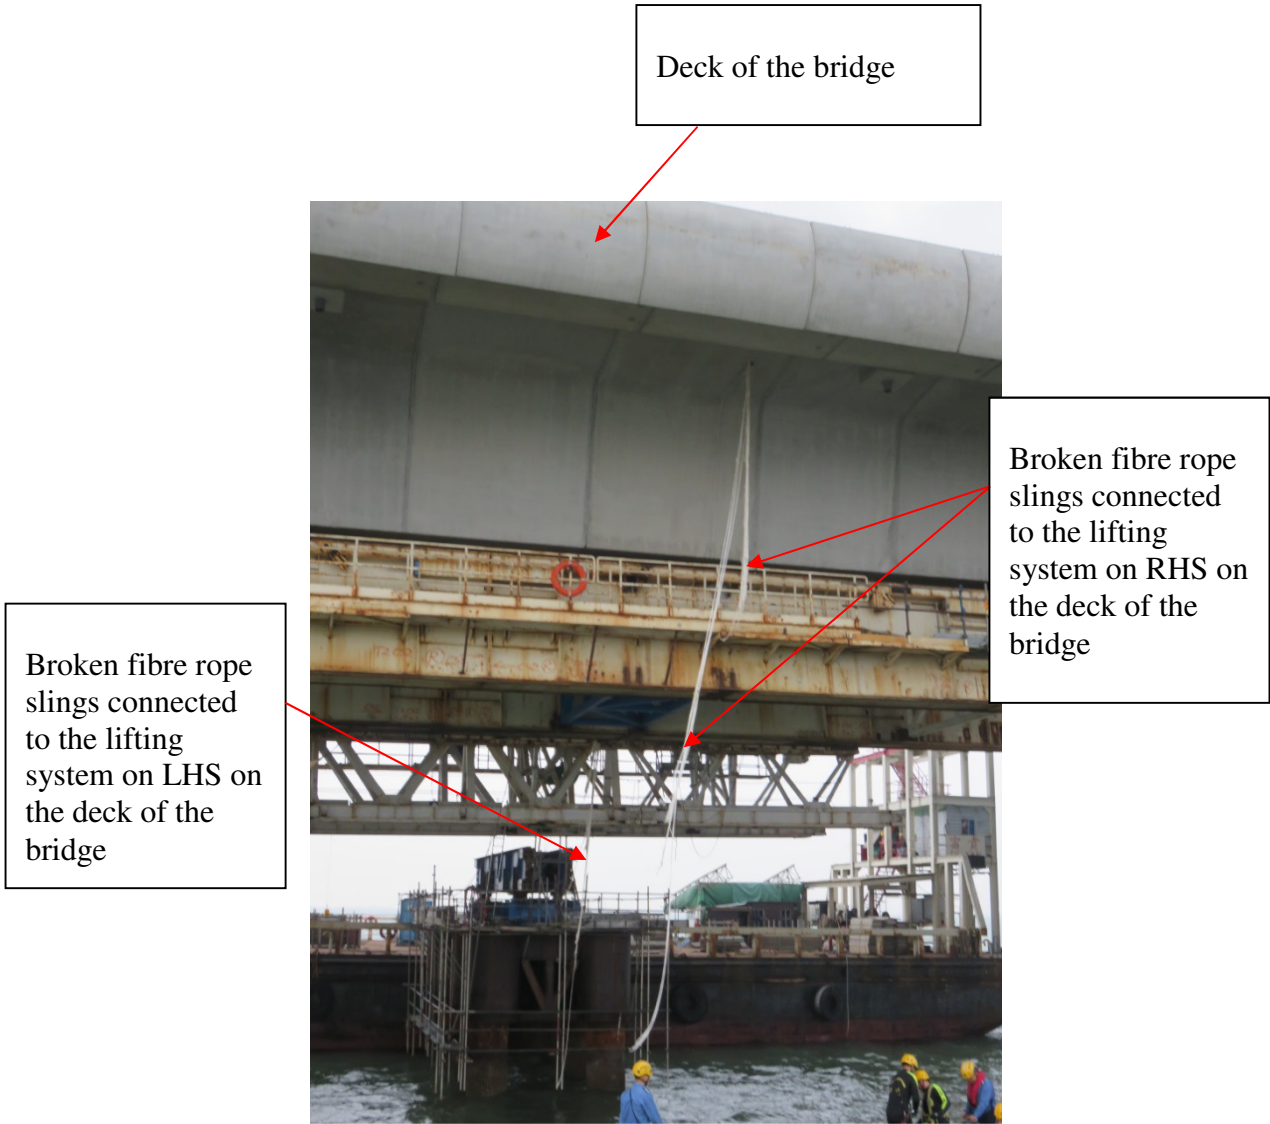
Photo 2 – Showing broken fibre rope slings beneath the deck of the bridge after the accident

- 3.3 During the lifting, the lifting beam on RHS on the bridge deck collapsed, causing breakage of two fibre rope slings which constituted the two sets of LG suspending the TWP on both sides (Photo 4). Given the failure of the LG, the TWP plunged into the water. D/P(1), D/P(2) and I/P(2) were dismantling a metal scaffold erected around the TWP concerned during the lifting. Whilst their safety harnesses were anchored to the guard-rail of the TWP, the three workers were dragged into the sea together with the collapsed TWP. At the same time, the collapsed lifting beam hit I/P(1) and I/P(3) who were working on the bridge deck. They were injured with bone fractures on their right legs.

- 5.2.1 Two broken fibre rope slings suspending in the mid-air were found underneath the bridge deck after the accident (Photo 2).
- 5.2.2 Two sets of the lifting systems for lifting up the TWP were found on the bridge deck. The lifting system on the RHS was found collapsed (Photo 4), with the lifting beam, hydraulic jacks and their supports scattered on the deck of the bridge, whilst the lifting system on the LHS was found remained intact (Photo 3).
- 5.2.3 The support for the jacks was made up of some makeshift metal blocks. LD's investigation revealed that their integrity as jack support had not been assessed. In particular, the strength of each block under various loading conditions was not known. Also, when stacked together, the overall stability was not assessed.
- 5.2.4 There was no temporary works design certificate issued for the lifting system.

- 5.3.5 The original design of the lifting systems and the LG arrangement proposed in the MS were not followed. Due to the unavailability of the required LG, LG having lower safe working load (“SWL”) was eventually used for the suspension of the TWP. The SWL of the LG being used was lower than the design lifting load stated in the MS.

- 5.3.6 The actual load of the TSS including the TWP being dismantled was higher than the SWL of the LG being used.
- 5.3.7 On the day of the accident, no safe working procedure on the dismantling works was made known to workers for them to follow. The MS for carrying out the dismantling work, though still pending approval, was not followed.

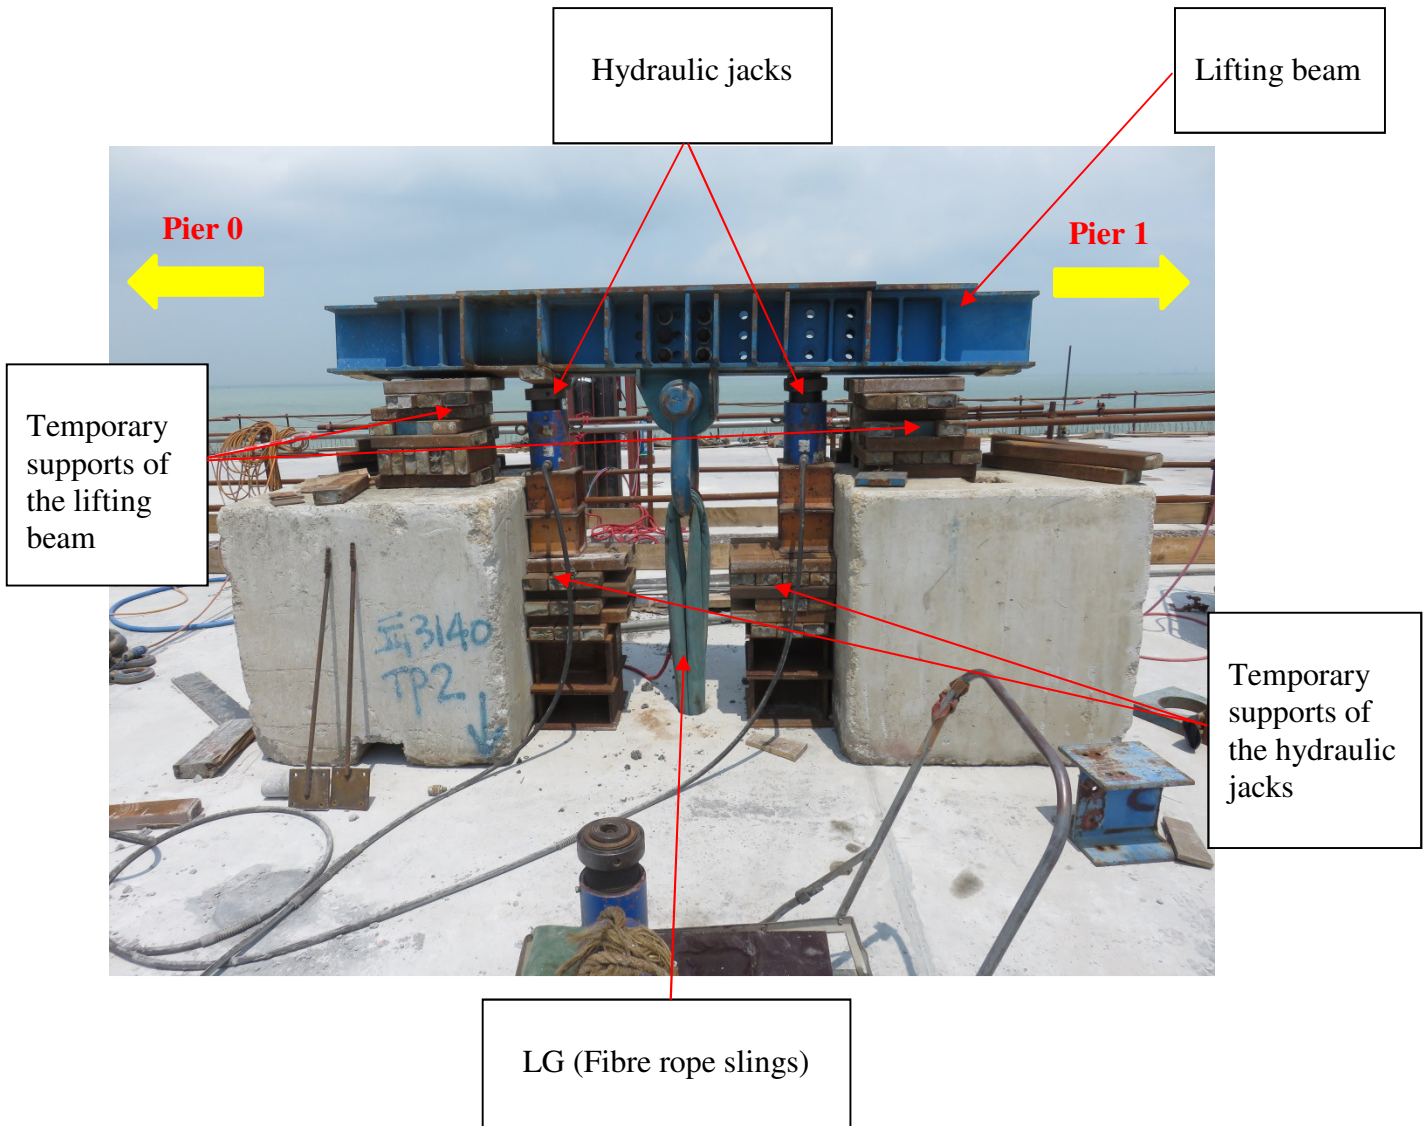
Photo 3 – No collapse of the lifting system on LHS on the deck of the bridge under construction

2.3.4 Each set of the lifting system consisted of a lifting beam, two hydraulic jacks, temporary supports for both the lifting beams and hydraulic jacks, and a set of LG (i.e. fibre rope slings connected by shackles)(Photo 2) connected to the centre of the lifting beam. The LG passed through the holes of the deck of the bridge to suspend the TSS/TWP underneath. Photo 3 showed the lifting system on LHS whilst Photo 4 showed the collapsed lifting system on RHS after the accident.

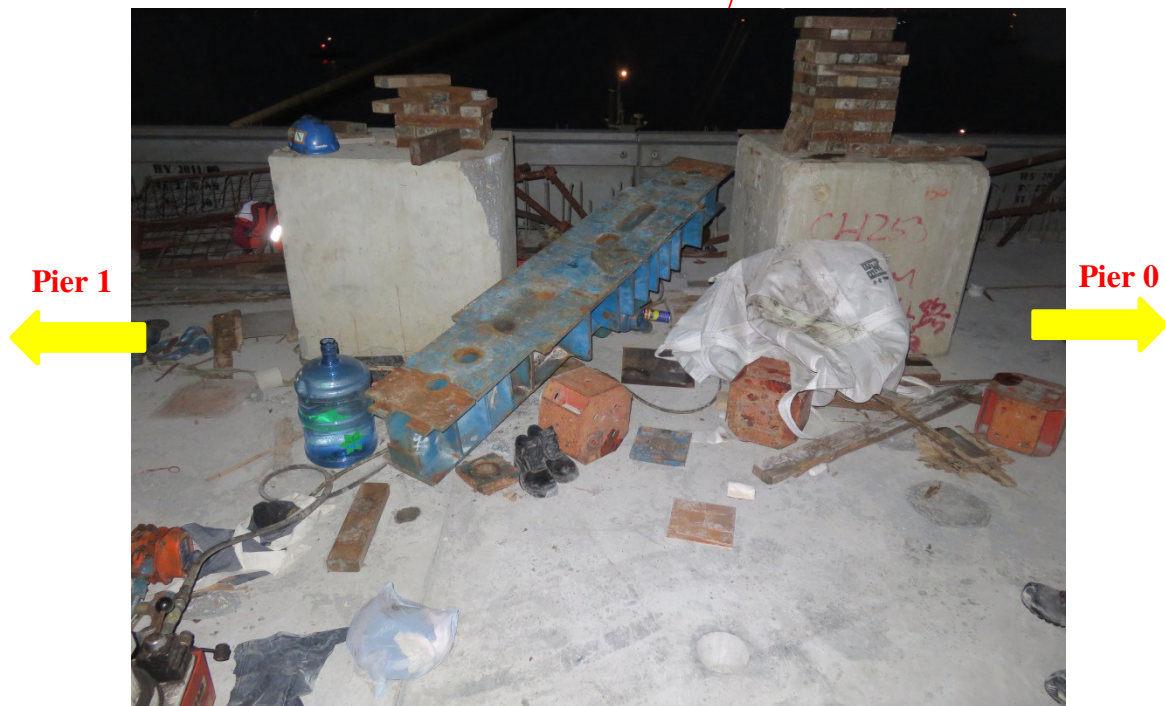
**Photo 4 – The collapsed lifting beam on RHS
on the deck of the bridge under construction**

- 5.4.1 It is suspected that the accident was mainly attributable to the unstable temporary supports of the hydraulic jacks at the RHS lifting system which fell, resulting in the collapse of the lifting beam.
- 5.4.2 The jerking force, that resulted from the collapse of the lifting beam and exerted to the LG, caused the breakage of two fibre rope slings. Eventually, the TWP suspended by the slings plunged into the sea.
- 5.4.3 At the material time of the accident, D/P(1), D/P(2) and I/P(2) were dismantling the metal scaffold erected around

Collapsed lifting
beam on RHS
