A Casebook of Occupational Fatalities related to Renovation and Maintenance Works

This Booklet is prepared by
the Occupational Safety and Health Branch, Labour Department

Second edition September 2018 (This edition has been amended mainly to add chin straps to the safety helmets worn by the workers in the illustrations.)

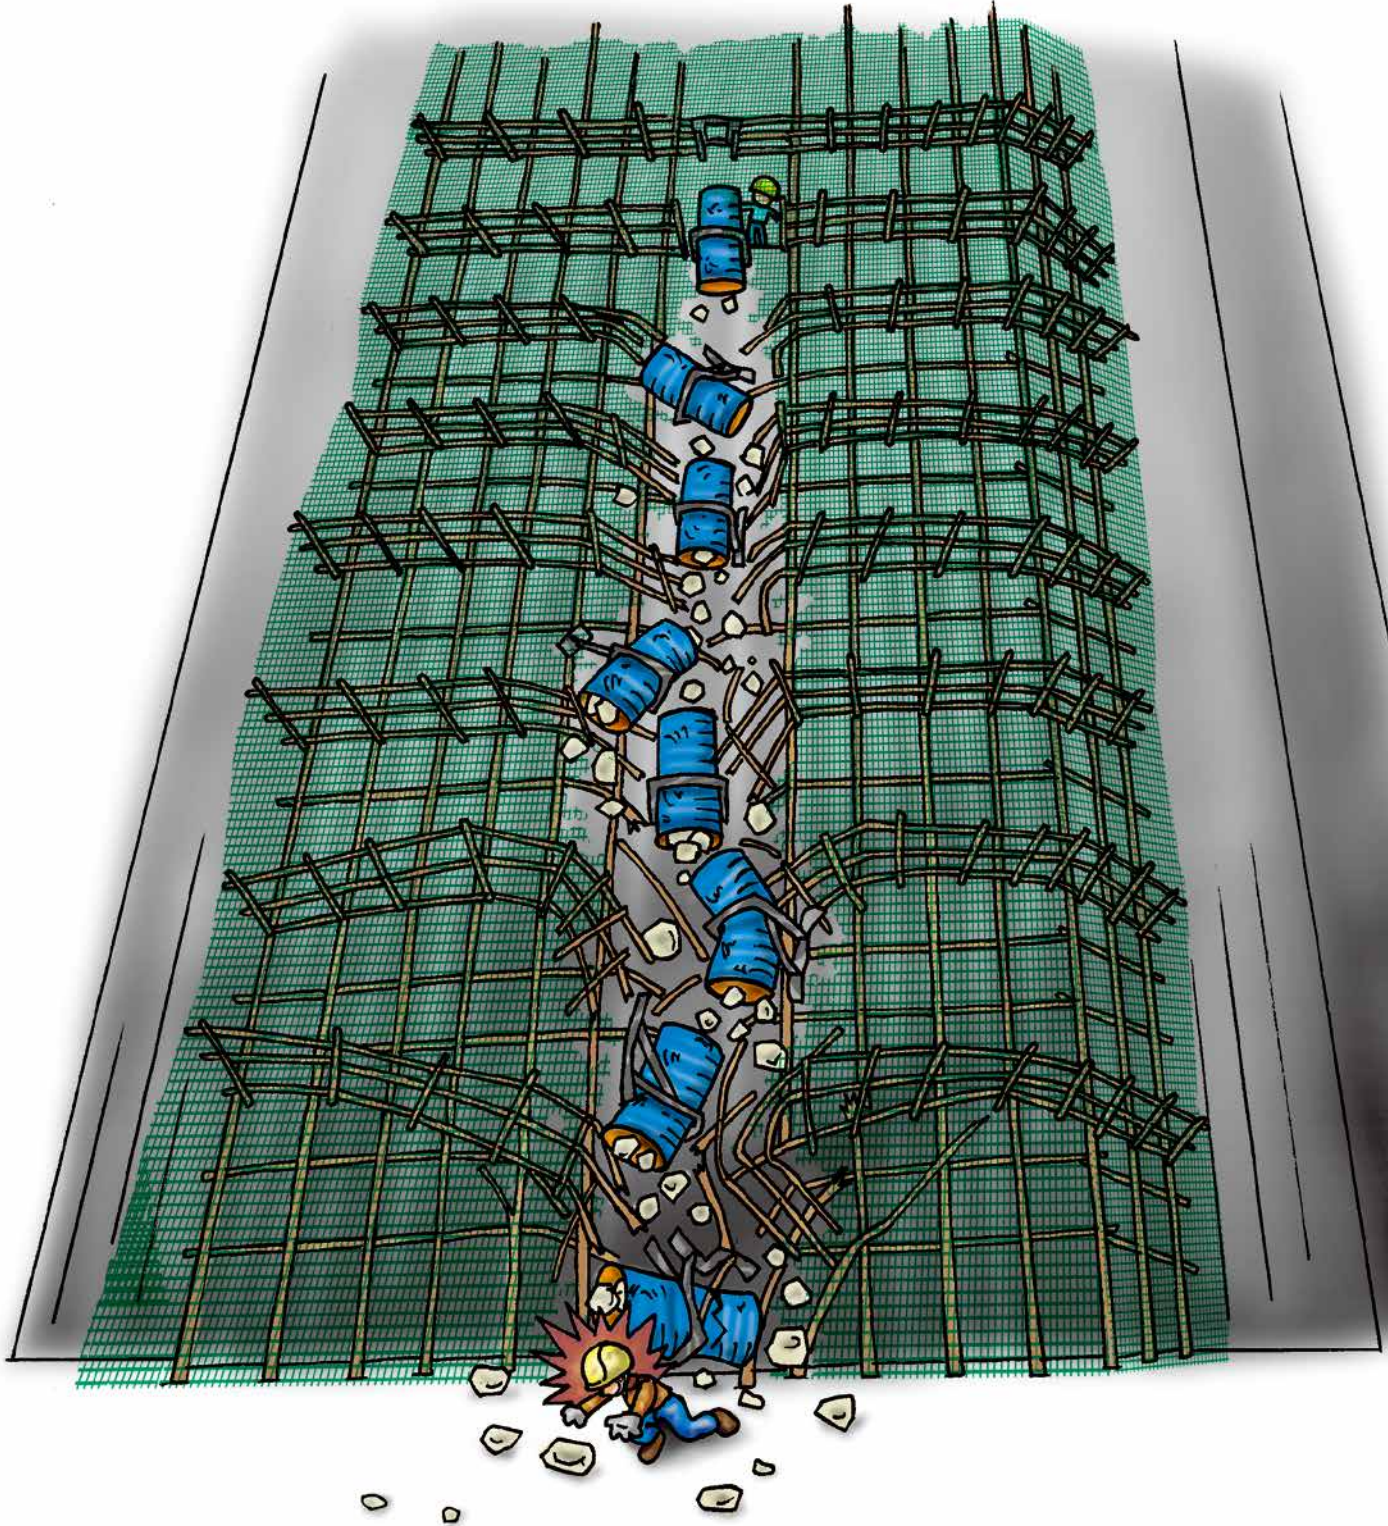
A foreman was fatally struck by a collapsed refuse chute

The refuse chute was built of sections of uPVC pipes (a kind of plastic polymer) and was mounted onto the building external wall by a number of steel brackets. However, the vertical load of the refuse chute was only supported by the lowest bracket. The other brackets only provided lateral restraint to the refuse chute.

The refuse chute was not constructed in accordance with any engineering design. The installation workers were not trained and had no previous experience of installing refuse chutes. After installation, the structural stability of the refuse chute was not examined by a competent person.

uPVC pipe was not a suitable material for use as refuse chutes. It was too brittle to resist impacts of waste mosaic tiles fallen from upper floors. Moreover, its diameter was too small and there was a risk of large pieces of debris blocking the pipe resulting in accumulation of waste materials inside the chute.

It was believed that some of the waste materials dumped into the refuse chute were too large. They blocked and accumulated inside the chute. As the lowest bracket could not support the additional load, the chute detached from the external wall and collapsed.

- a** Refuse chutes should be properly designed, constructed and examined by a professional engineer before putting into use. The chutes should also be properly maintained.
- b** Refuse chutes should be installed in a way that is safe and without risks to the workers.
- c** Suitable and sound material should be used for constructing refuse chutes.
- d** Necessary precautions should be taken to prevent workers from being struck by falling materials and objects.
- e** Sufficient information, instruction, training and supervision as may be necessary to ensure safety at work should be provided to the workers.

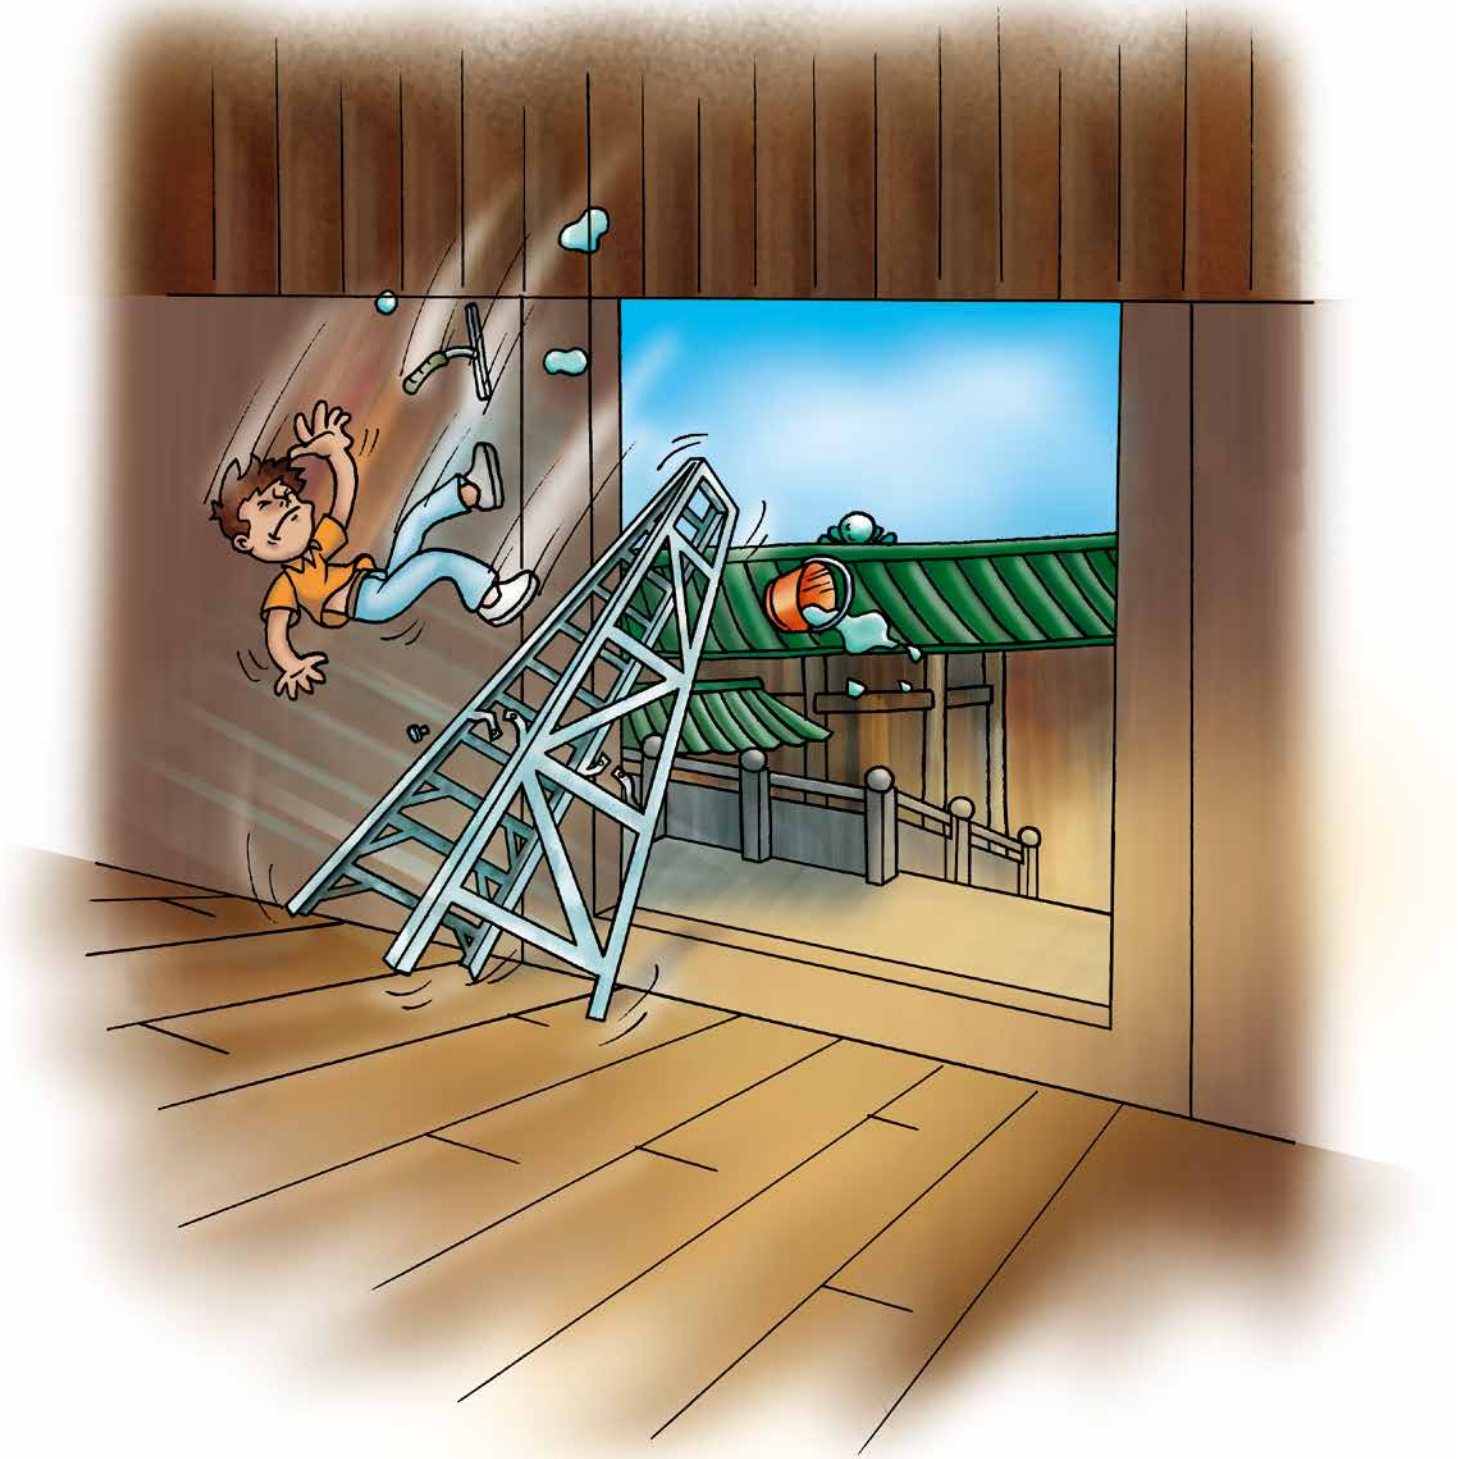
A cleaning worker fell to the ground while working on a stepladder

The aluminum folding stepladder used by the deceased person was fitted with steps on one side only (the front section). A pail was placed on top of the folding stepladder and there were 11 steps below. The top of the folding stepladder where the pail rested was 3.1 metres above ground. When the folding stepladder stood fully opened on the ground, the front and back sections were 1.56 metres apart at the base.

The folding stepladder had two restraining devices to limit the opening of the front and back sections. However, the rivets and washers fitted at the connecting points of the two restraining devices were missing. It was observed that the connecting point of one of the restraining devices was reconnected by tying up with a piece of metal wire. A strut was also tied by a length of electric cable to the front and back sections of the folding stepladder to restrict the opening distance.

Slip-resistant rubber pads fitted to the base of the ladder were all missing. As the floor of the temple hall was laid with ceramic tiles, a stepladder with no slip-resistant rubber pads would be insecure and unsafe when placed on the slippery floor for the cleaning work at a height.

- a** Suitable working platforms should be provided to workers for window cleaning work at heights.
- b** Stepladders should be of sound construction and properly maintained.
- c** Sufficient information, instruction, training and supervision as may be necessary to ensure safety at work should be provided to the workers. As far as practicable, the work carried out at heights should be closely supervised by a competent person.

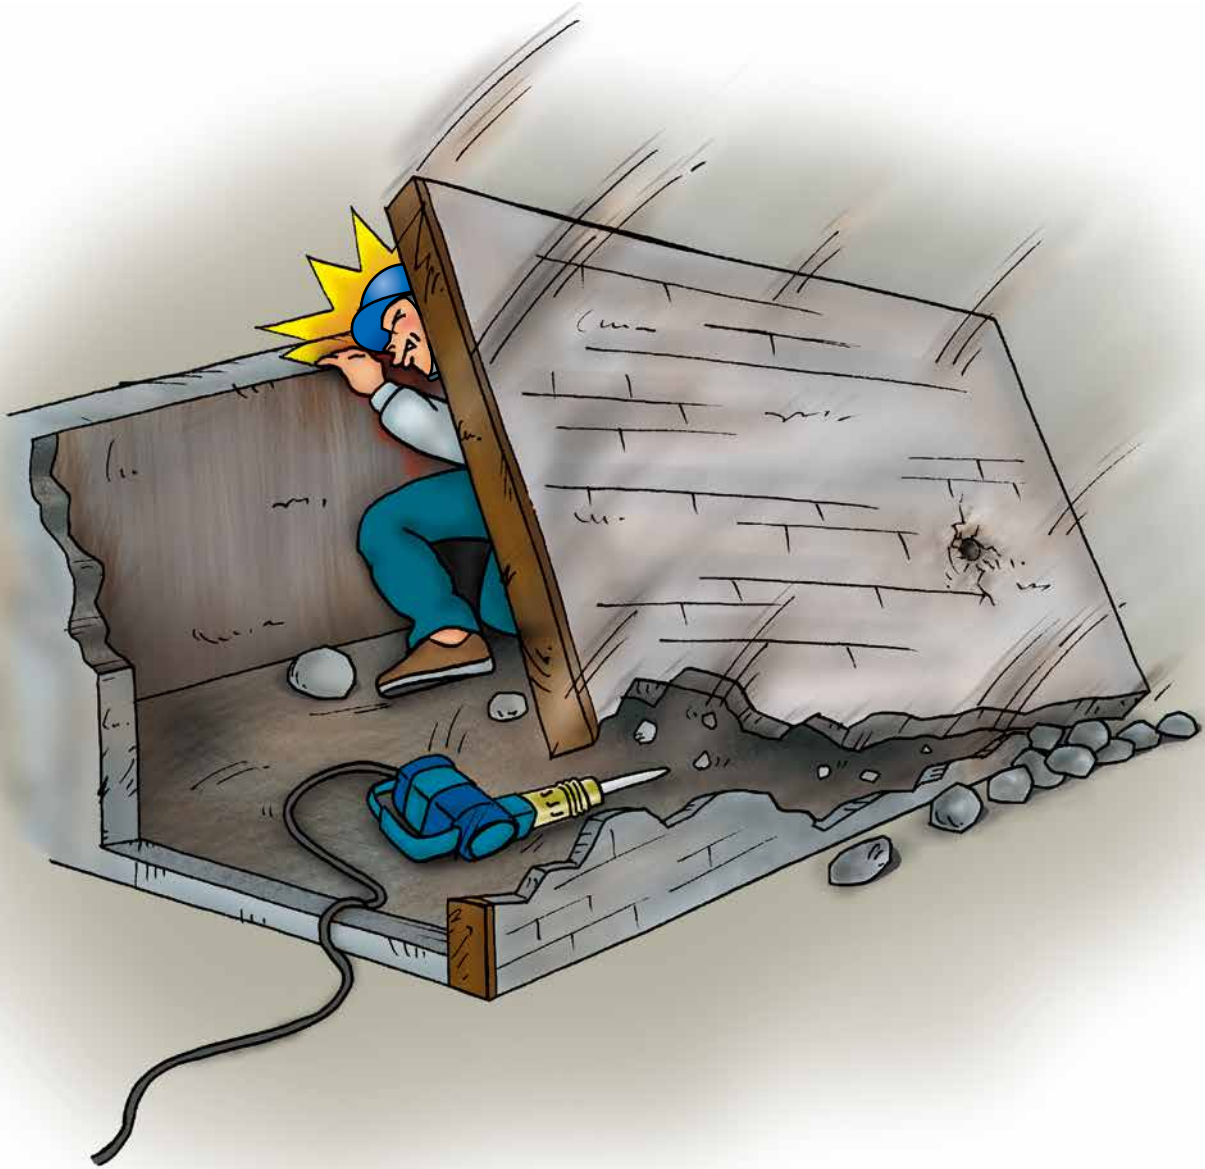
A worker was struck by a brick wall under demolition

The brick wall to be demolished was undermined before the accident in that more than half of its footing had been removed. The contractor planned to pull down the wall with a rope.

A hole was found on the collapsed wall. Its diameter matched with the diameter of the bit of the portable electric concrete breaker found on the site. It was believed that the deceased person was trying to break the wall with an electric concrete breaker. The stability of the undermined brick wall was thus overcome by the external force and collapsed as a result.

There was no risk assessment conducted before the demolition work. The undermined brick wall was left unattended and no temporary structure was erected to support it. The surrounding area was not fenced off and there was no warning notice posted.

- a** A safe system of work should be developed for the demolition of the brick wall. Top down demolition method should be adopted.
- b** Places liable to be dangerous should be clearly demarcated and fenced off. No person should enter the area without prior permission.
- c** Temporary support should be used to stabilize the brick wall being demolished. Warning notice should be conspicuously posted if it is left unattended.
- d** Sufficient information, instruction, training and supervision as may be necessary to ensure safety at work should be provided to the workers.

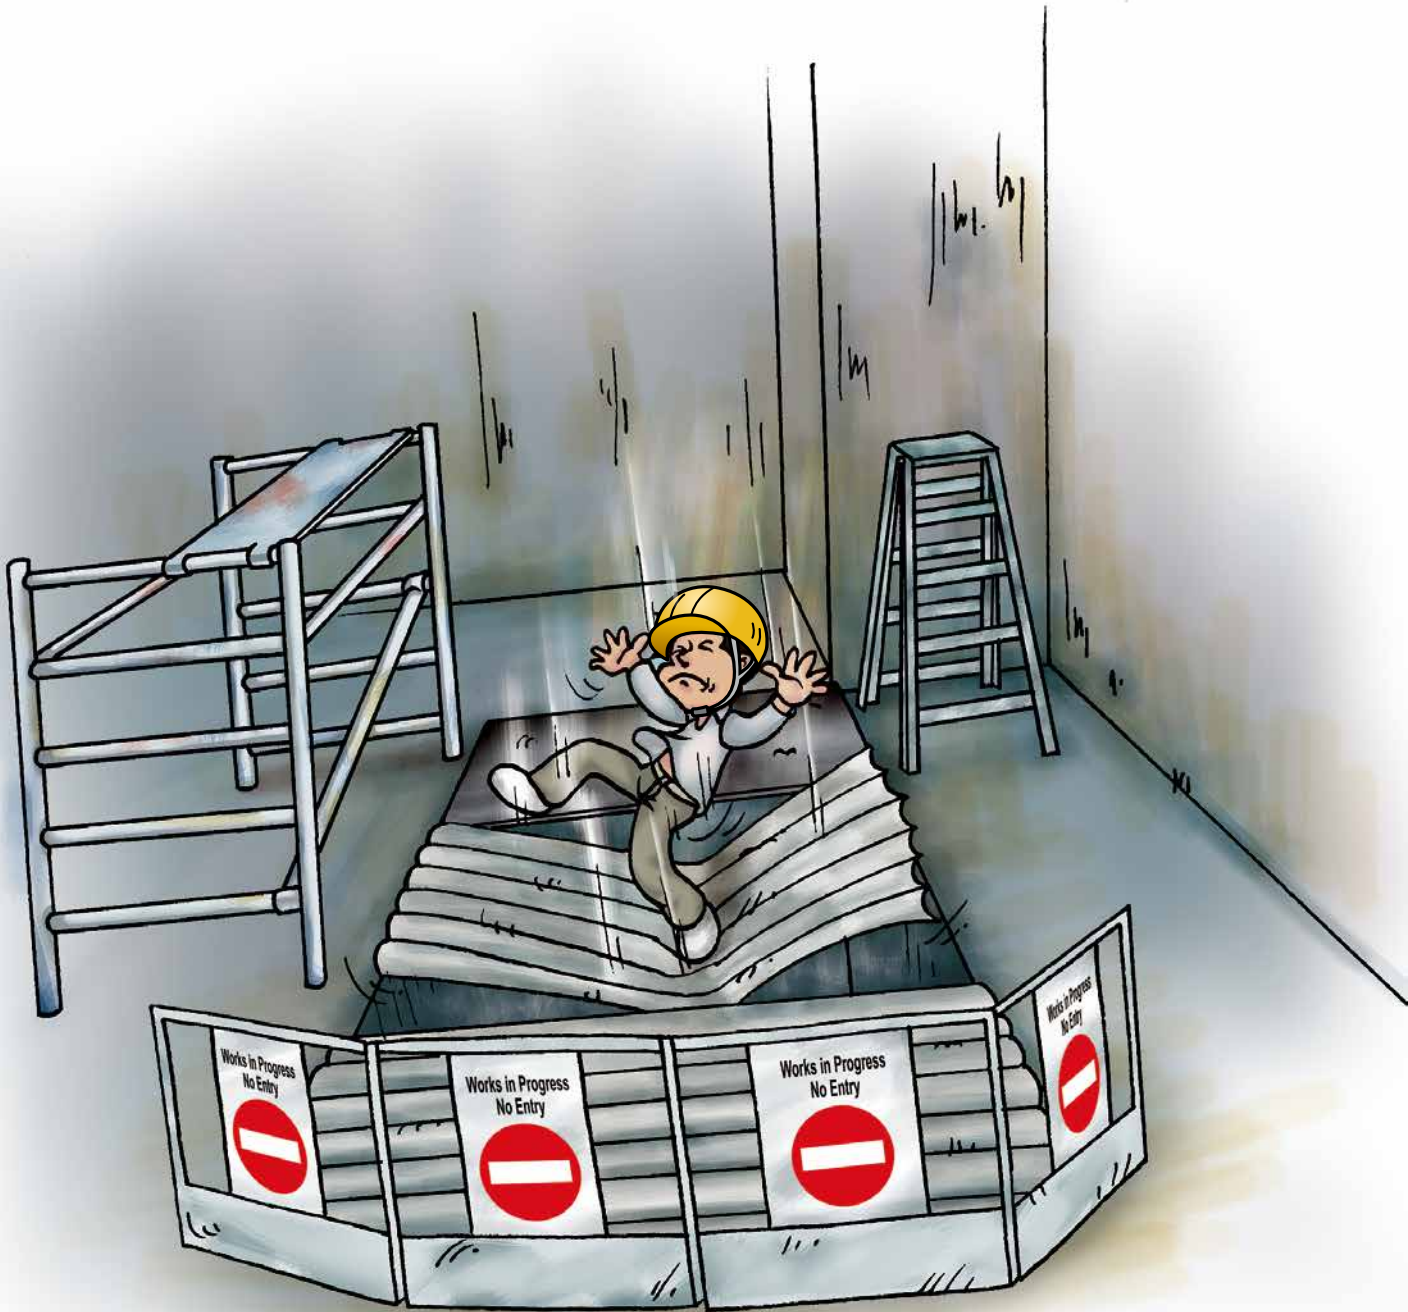
A worker fell through a floor opening to the floor below

The size of the metal sheet and corrugated sheets were smaller than the size of the floor opening. They were thus placed over the opening across the shorter side. All of them were not securely fixed and could be easily displaced.

Temporary barriers were erected at the front side of the floor opening. The remaining three sides were not suitably fenced.

There was no warning notice posted to indicate the presence of the floor opening.

- a** Floor openings should be properly fenced or covered to protect workers from falling.
- b** Materials used for covering the floor opening should be of adequate size, sound construction and securely fixed in position to prevent displacement.
- c** Warning notice to warn workers of the danger of falling through the floor opening should be prominently displayed in the upper floor plant room.

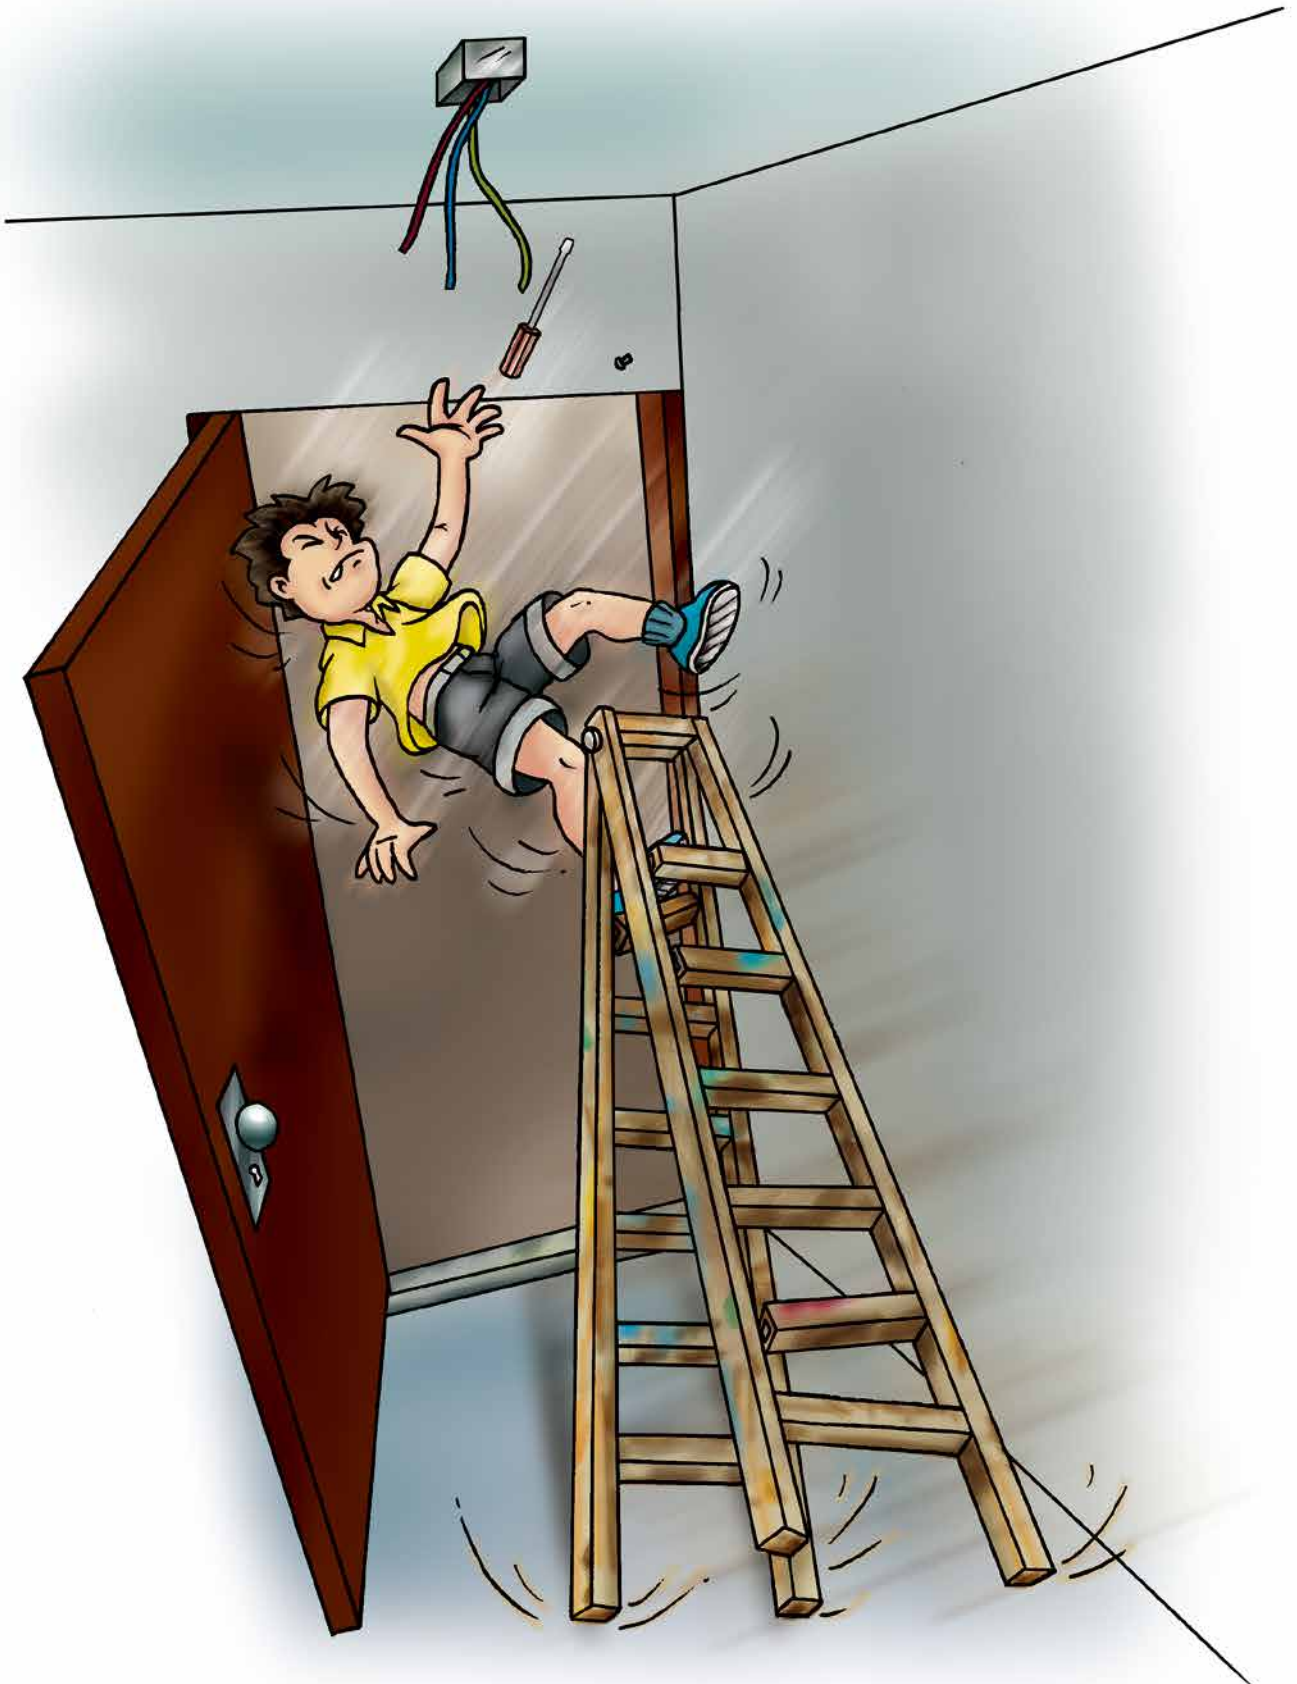
A worker fell from a wooden stepladder while performing electrical maintenance work

The ladder was not properly maintained. The two metal hinges connecting the front and back sections were deformed and loosely mounted. Restraining device limiting the opening of the front and back sections of the ladder was found only on one of its two sides. Moreover, one of its four side rails was observed to be 15 millimetres short of the ground when the ladder was fully extended. These unstable conditions would result in swaying of the ladder when being used.

The 6-rung stepladder involved in this accident was 1.78 metres high when fully extended. The deceased person had to ride on at least the second topmost rungs of the ladder and fully stretch his hands to perform the levelling work. In this manner, there was no handhold for him to maintain his balance on the ladder. A reaching-out body posture could cause the uneven stepladder to sway and topple.

There was no suitable working platform provided for carrying out the levelling work at heights. Fall arresting equipment, such as safety harness, independent lifeline or other suitable anchorage, was also unavailable.

- a** When work could not be safely done on the ground, suitable working platform with guardrails and toe boards should be provided.
- b** Stepladders should be regularly inspected and properly maintained to ensure that it is in a safe working condition.
- c** Risk assessment should be conducted and safe working method developed and implemented.
- d** Sufficient information, instruction, training and supervision as may be necessary to ensure safety at work should be provided to the workers. As far as practicable, the work carried out at heights should be closely supervised by a competent person.

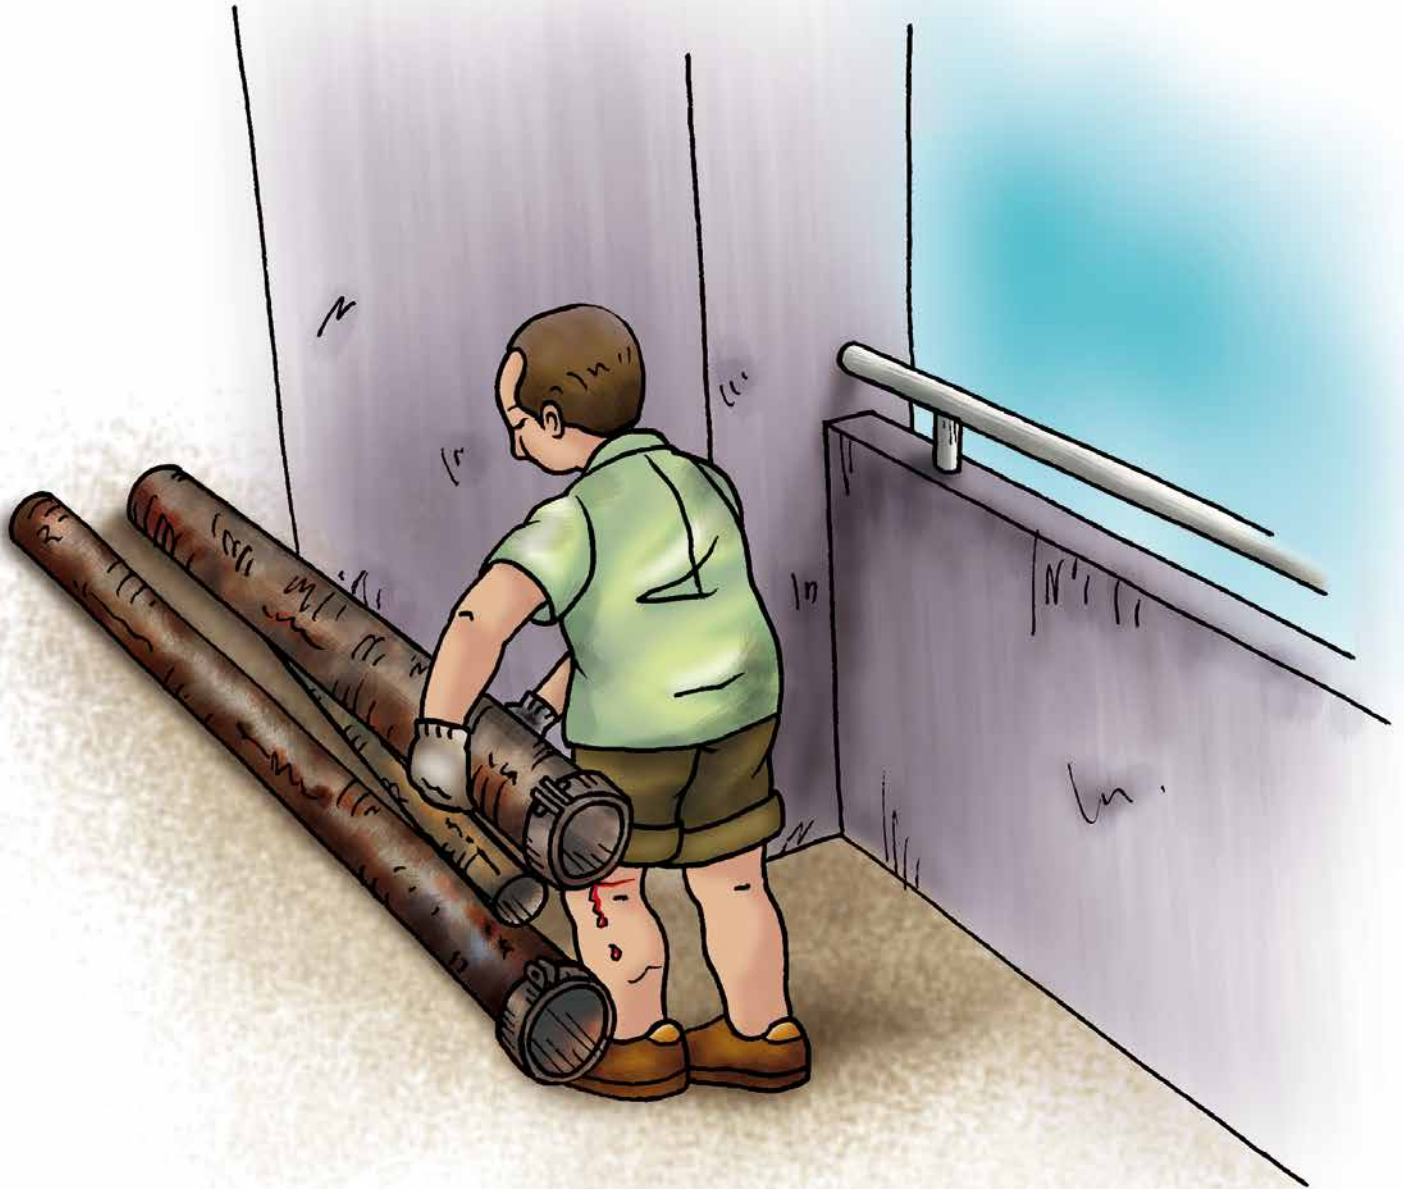
A worker sustained laceration injury and subsequently died of infection

There was no risk assessment conducted prior to the drainage pipe replacement work. Precautionary measures for handling sharp objects had not been devised and implemented.

Suitable clothing and personal protective equipment were not provided to the workers. The deceased person wore only a pair of short jeans while working.

The deceased person did not clean and dress the wound properly soon after his left leg was cut. He only wrapped the wound up with a piece of cloth and he did not seek any medical treatment afterwards. The wound was infected by bacteria consequently which later caused his death.

- a** Risk assessments should be conducted prior to the drainage pipe replacement work. Safe work procedures, including the precautionary measures to ensure sharp edges of dismantled pipes are safely handled, should be developed and implemented.
- b** Proper work clothing and personal protective equipment as were necessary should be provided to and used by the workers.
- c** Workers injured at work should have proper first aid treatment of the wound immediately and seek medical treatment as soon as possible.
- d** Sufficient information, instruction, training and supervision as may be necessary to ensure safety at work should be provided to the workers.

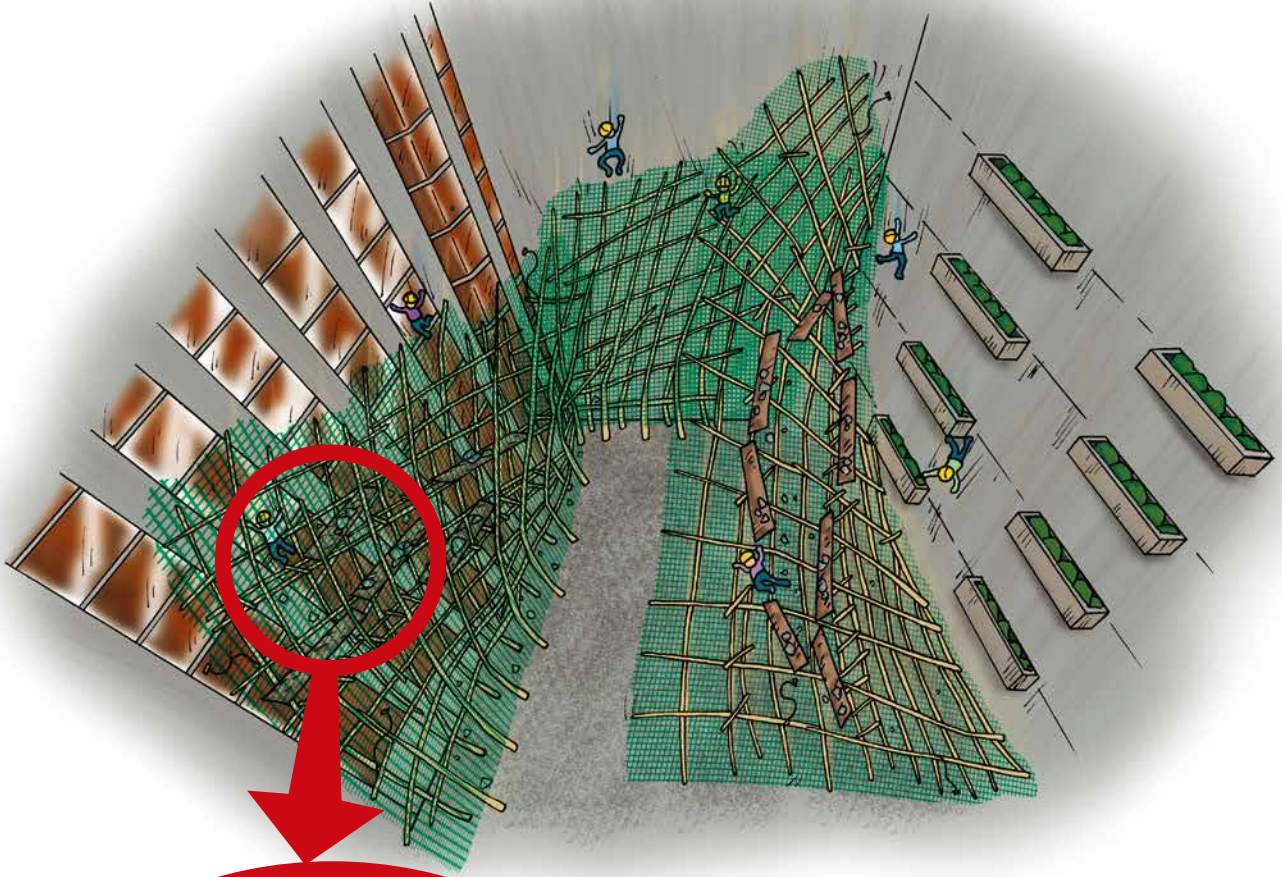
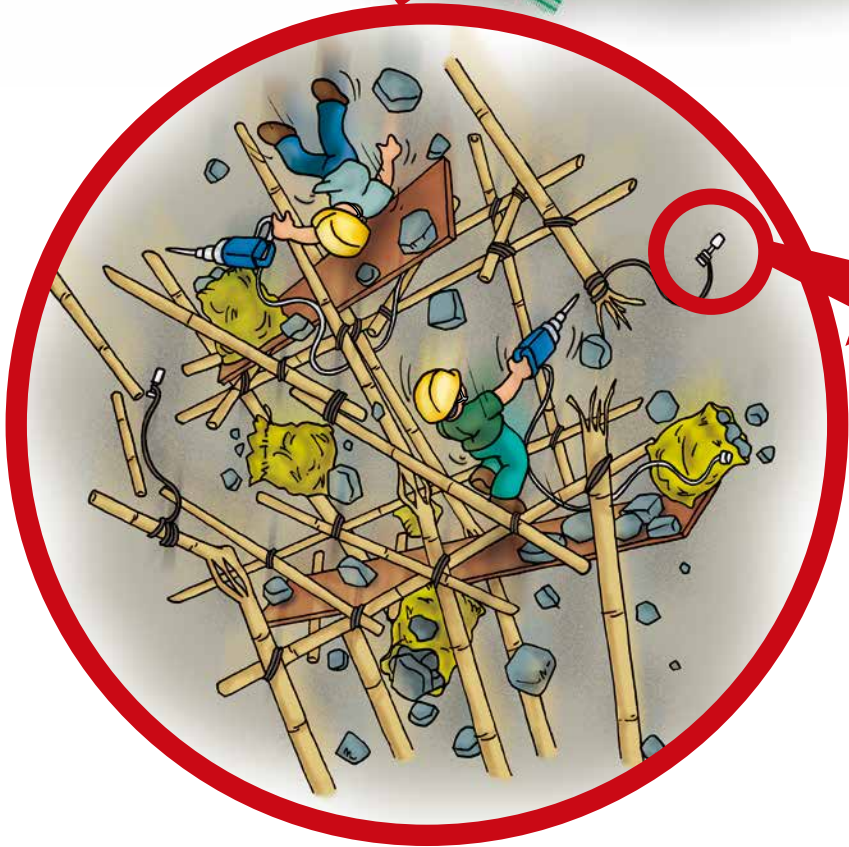
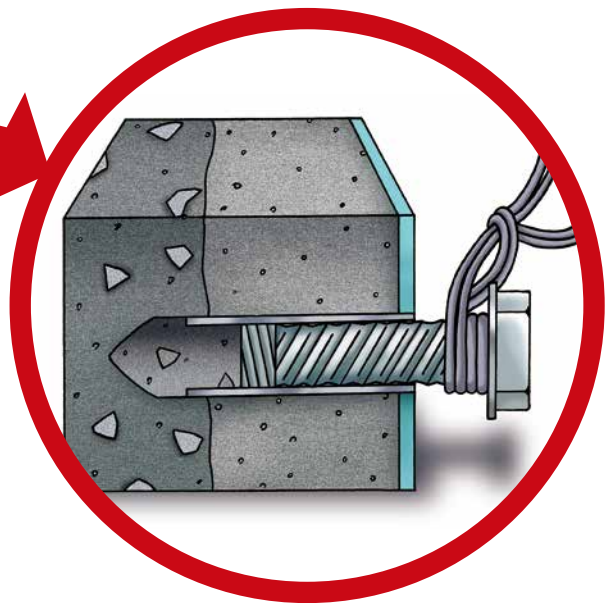
Case 7

A worker was killed and sixteen injured when the bamboo scaffolds they were working from collapsed

Two of the four scaffolds measured 35 metres wide and 37 metres high whereas the other two scaffolds were 16 metres wide and 37 metres high. Despite the large sizes of these scaffolds, they were not designed by a professional engineer. There were no proper construction details and design calculations. Working procedures in relation to the erection, inspection and maintenance of the bamboo scaffolds had not been developed and implemented.

Winches and metal buckets were used for transporting debris to the roof level. To facilitate the movement of buckets, some ledgers were removed. The overall rigidity of the scaffold was thus lowered.

Galvanized wires and expansion bolts were fixed on the walls to restrain transverse movement of the scaffolds. However, no metal bracket was installed onto the building wall to act as an intermediate support to the scaffolds. There were also no sills or other structural supporting points on the walls for the scaffolds to spread the load.

Diameters of the galvanized wires used varied between 1.06 millimetres to 2.34 millimetres and were far below the standard requirement of 6 millimetres as stipulated in the Code of Practice for Bamboo Scaffolding Safety (Fourth Edition September 2017). Moreover, during the mosaic tiles hacking process, some of the galvanized wires were broken.

Some of the anchor bolts were not properly fixed and secured onto the building walls. The tails of the sleeves were not expanded

sufficiently. The embedment depth of some studs in the wall was reduced after mosaic tiles and cement sand bedding were hacked off. The frictional grip of the expansion anchor bolts was greatly reduced.

As the scaffolds were insufficiently supported, some ties were unable to restrain the load. Some galvanized wires broke and anchor bolts were pulled out. The load was thus transferred to the other ties that also failed. The progressive failure of all ties led to the collapse of the four scaffold panels in succession.

- a The bamboo scaffolds should be designed and approved by a professional engineer who should be a corporate member under the constitution of the Hong Kong Institution of Engineers in the discipline of civil or structural engineering.
- b Effective communication between the bamboo scaffold designer and site workmen should be established and maintained. To ensure proper erection and subsequent maintenance of the bamboo scaffolds, complete and clear design drawings should also be provided to the site workmen concerned.
- c Sufficient information on the work activities and the relevant loading should be taken into account when designing and constructing the scaffolds.

- d A competent person with adequate experience and knowledge should be appointed to supervise the erection, maintenance and inspection of the scaffolds so as to ensure all modifications and changes to them are proper and without risk to the stability.
- e A safe system of work for coordinating the various work activities carried out from the bamboo scaffolds should be devised and implemented.

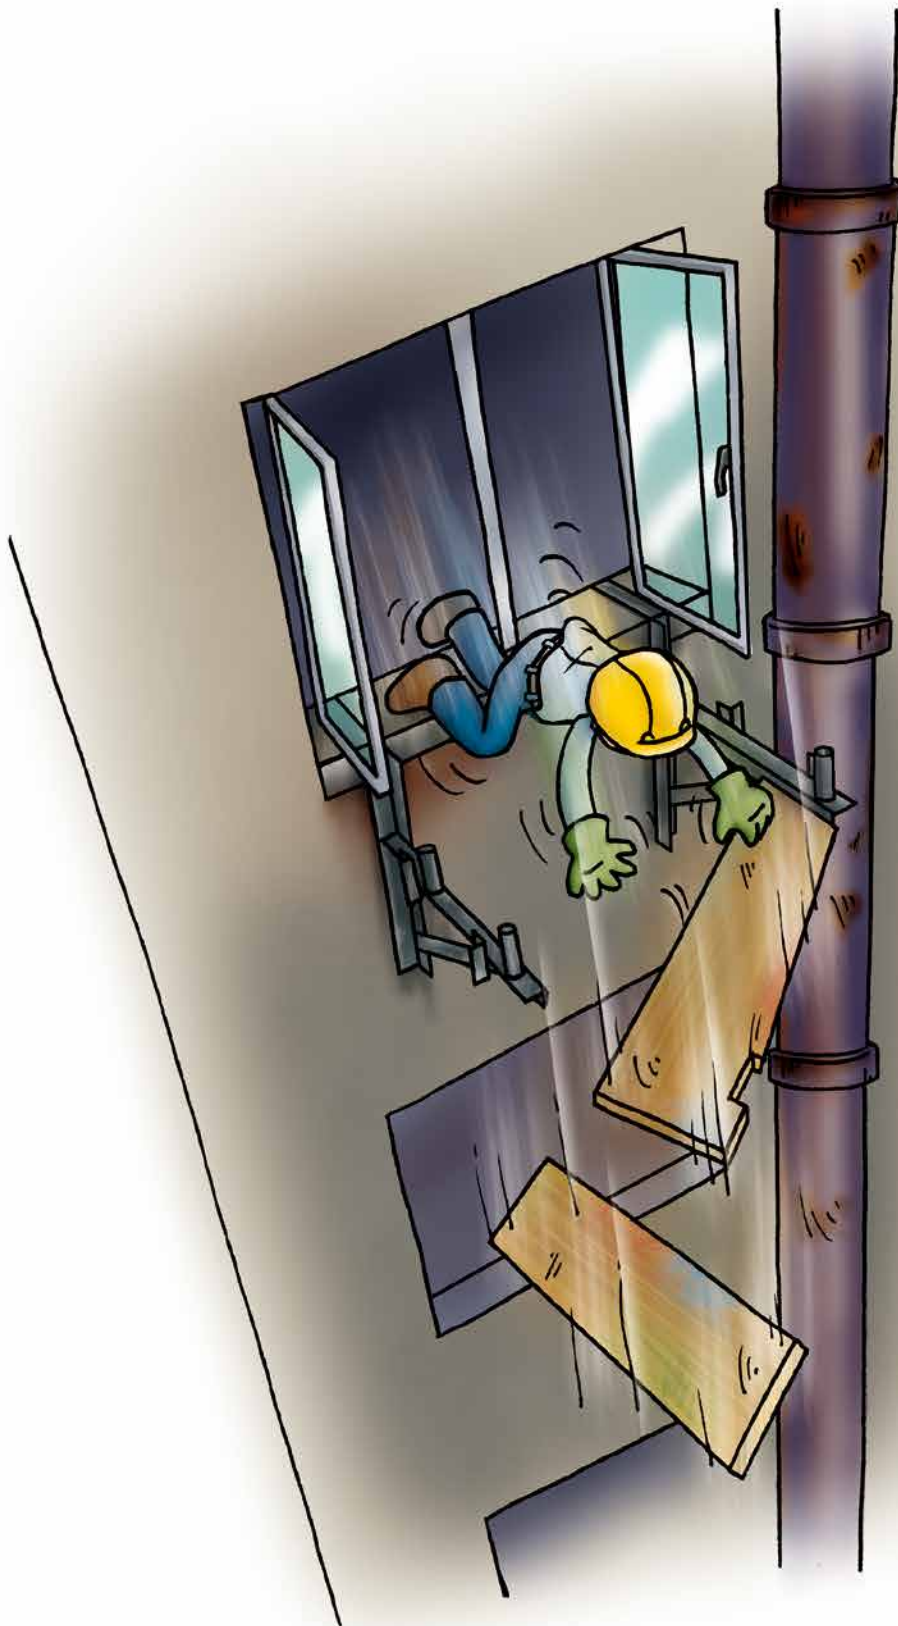
A worker fell from a height while erecting a truss-out working platform

To install the two metal bracket supports on the windowsill, the deceased person could simply stand on the floor in the lift lobby. But if he remained standing on the floor, he could not reach for a distance of 1260 millimetres to place the outer wooden board on the guides of the metal bracket supports. The deceased person therefore gained access on the windowsill to put the wooden board in place.

There was an independent lifeline installed. However, it was not tested, examined and certified safe for use by a registered professional engineer.

Fall protective equipment, including safety harness and independent lifeline, were not used by the deceased person when he was staying on the windowsill to perform his work.

- a** Adequate steps should be taken to prevent workers from falling from heights, including the provision, use and maintenance of a working platform that is suitable for the environment and the work to be carried out (e.g. a suspended working platform in this case).
- b** Erection of the working platform should be carried out by competent workmen with adequate training and experience.
- c** Suitable fall arresting equipment should be provided and used by workers exposed to risks of falling from heights. An effective monitoring system should be implemented to ensure that the workers make full and proper use of the safety equipment.
- d** Sufficient information, instruction, training and supervision as may be necessary to ensure safety at work should be provided to the workers.
