An Analysis on Occupational Fatalities Casebook

(Volume 4)

Occupational Safety and Health Branch
Labour Department

This edition March 2008

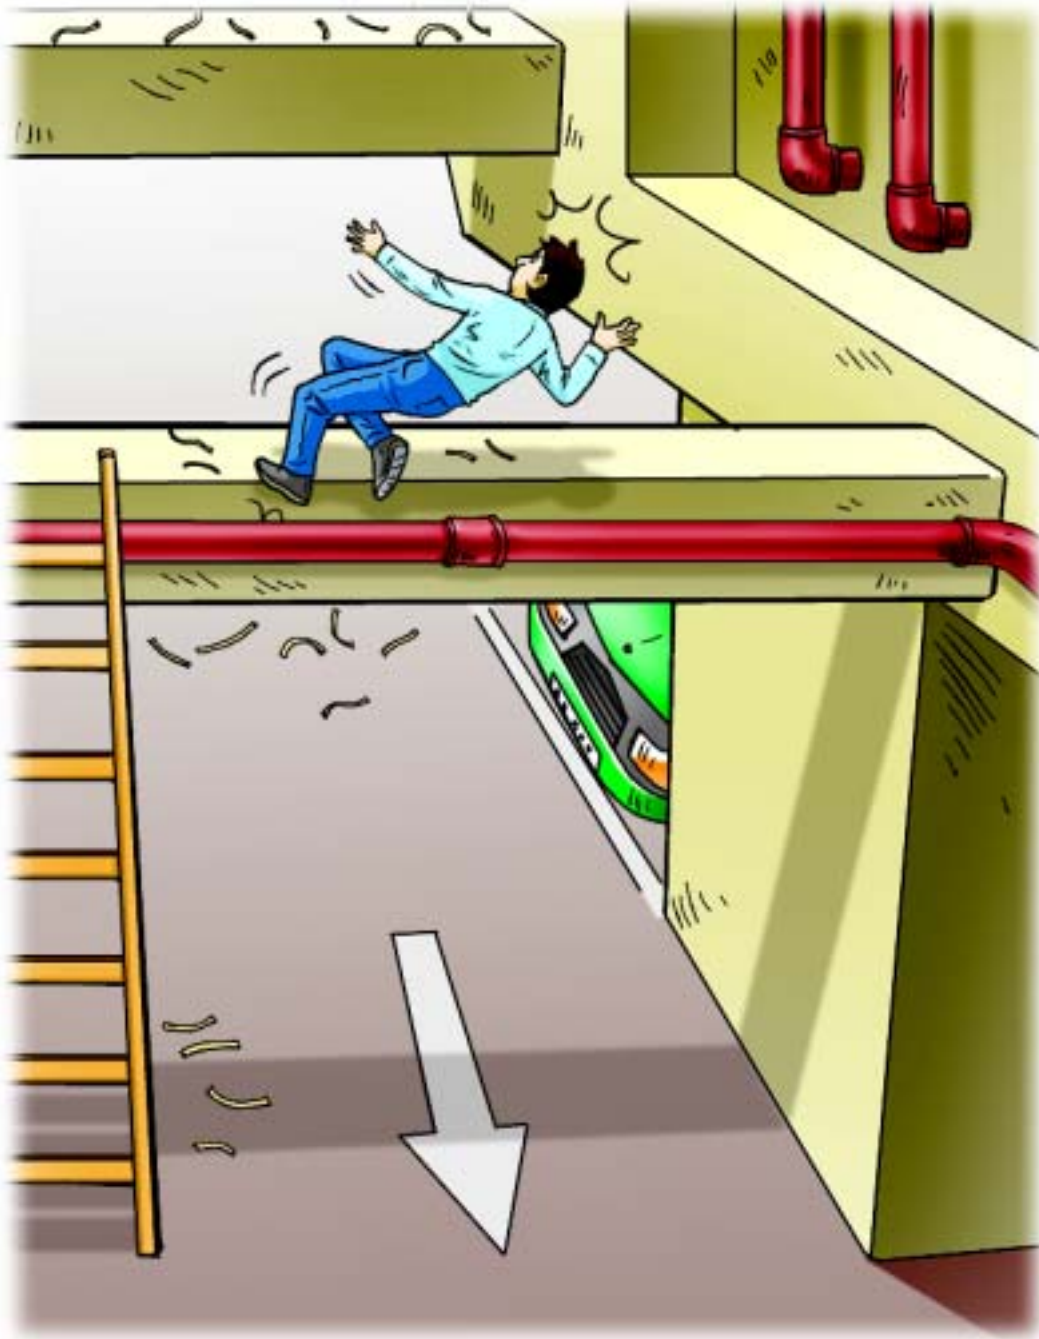
Case 1

A workman fell from a height to death

The deceased was appointed to replace part of the drainpipes at the carpark of a building. A bamboo scaffold was erected for the work. After the drainage works were completed, the bamboo scaffold was dismantled. The deceased intended to clean the workplace before handing over. He climbed up to a beam by a ladder for the cleaning work. During the work, he fell from the beam and sustained the fatal injuries.

- There were two beams at the carpark level of the building. One was 2.8 metres and the other 4 metres above the ground. The beams were 0.3 metres wide.
- The wooden ladder was 3.7 metres long. It was leaning, at an angle of about 70° to the ground, on a fire services pipe running by the side of the lower beam.
- Nylon ties were found on the top of the upper beam and the ground, but not on the lower beam. It was believed that the deceased had climbed up to the lower beam by the ladder, walked on the top of the beam and swept away the nylon ties. As the width of the beam was only 0.3 meters wide, he slipped and fell to the ground while working from it.
- There was no working platform and no anchorage for hooking lanyards of safety belts at the place of the accident.

The principal contractor responsible for the site and/or the employer of the workman should provide:

1. A properly maintained scaffold that is equipped with suitable working platforms and safe means of access and egress to and from the working platforms for the workman to carry out the cleaning work at a height.
2. Sufficient information, instruction, training and supervision to the workers to ensure their safety at work. As far as practicable, the work carried out at a height is closely supervised by a competent person.

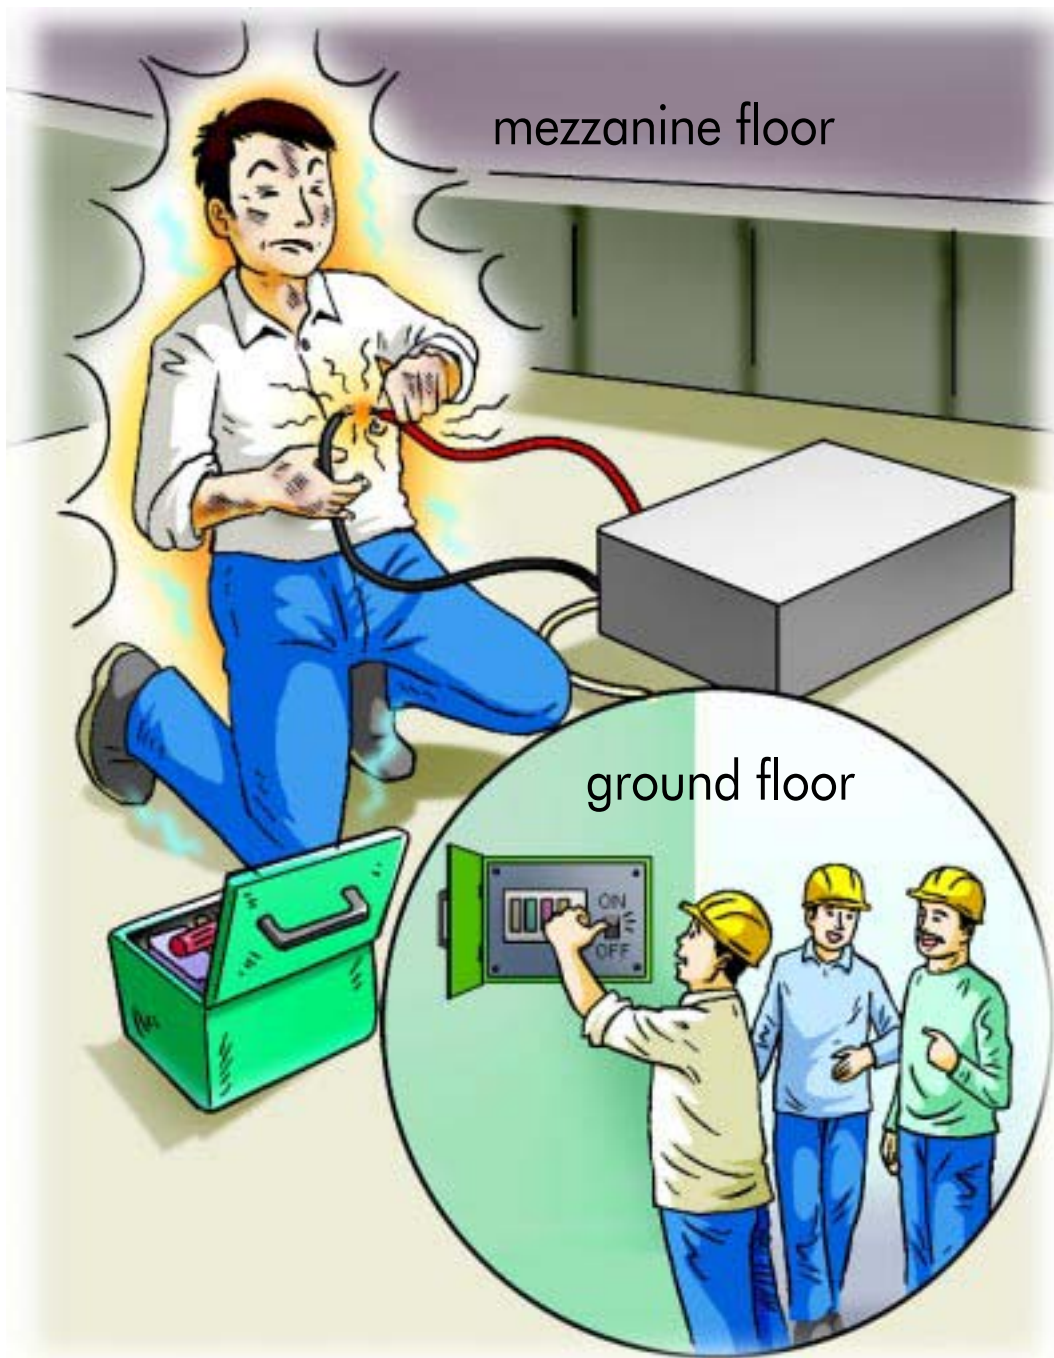
Case 2

An electrician electrocuted by live wire

The deceased was an electrician. He was employed by an electrical sub-contractor to work on the site. On the day of the accident, while other renovation workers were taking the afternoon tea break, the deceased continued with his work. He was connecting the power supply wires to the electric motor of the roller shutter being installed at the front entrance of the ground floor unit. Before the wiring work, the deceased went to the distribution panel installed at the rear of the unit beside the internal stairway leading to the mezzanine floor to switch off the electricity supply. He then proceeded with the wire connection work on his own on the mezzanine floor. After the other workers finished their tea break and resumed work on the ground floor for about 30 minutes, they found the deceased electrocuted on the mezzanine floor.

- The electricity supply from the power company was connected to a main distribution panel installed on the wall at the rear of the unit. All electric circuits on the premises were supplied by this distribution panel and the circuits were protected by circuit breakers. However, identification of respective electric circuits was not clearly marked on the distribution panel. There was a hinged type metal cover to shield off the circuit breakers. By design, the metal cover was kept closed by its own weight. However, there was no locking device to prevent the circuit breakers from being interfered by other workers.

- Power supplies to the artificial lighting both on the ground floor and mezzanine floor were shut down during the afternoon tea break. After the tea break, without checking why the power supply was switched off or whether someone was carrying out electrical work, one of the renovation workers switched on the power supply at the distribution panel to get electricity for the general lighting and the power driven machinery.

- The distribution panel was located on the ground floor and the deceased was working on the mezzanine floor. As the power supply of the artificial lighting on the mezzanine floor was shut down, the mezzanine floor was dark and the other workers who were working on the ground floor could not see the deceased easily. They thus had a mistaken belief that no one was working on the mezzanine floor. The deceased was electrocuted by the electric wire he was connecting when the electric supply suddenly energised.

- There was no arrangement to lock out the distribution panel to prevent interference by other workers. There was no warning notice informing others that electrical work was in progress. There was no defined work schedule and clear instructions to co-ordinate the work activities of the subcontractors of different trades carrying out work together on the same location. There was no monitoring system to supervise the workers and regulate their performance such that unsafe conditions could be effectively detected and rectified in a timely manner. The workers apparently had poor safety awareness and limited safety knowledge.

1. Electrical work is carried out by registered electricians under the supervision of a competent person who possesses the safety knowledge and awareness that enables the adoption of suitable safety precautions to prevent accidents.

2. In carrying out electrical work, all live parts of the electrical system are rendered dead by isolating the electricity supply at the distribution panel. The panel enclosure or the switchgear is capable of locking out. Appropriate warning signs and notices are posted to keep others well informed that electrical work is in progress.

3. Suitable insulated protective equipment are provided for the use of workers engaged in electrical work. Steps are taken, by supervision or otherwise, to ensure workers make full and proper use of the provided protective equipment.

4. A safety management system is devised and implemented. The system should include the following –
 - (a) a programme of evaluation of job related hazards is implemented. Safety procedures to prevent accidents is developed in line with the findings of the risk assessment. Particular attention is paid to the co-ordination of the multiple activities performed simultaneously on site by different subcontractors;

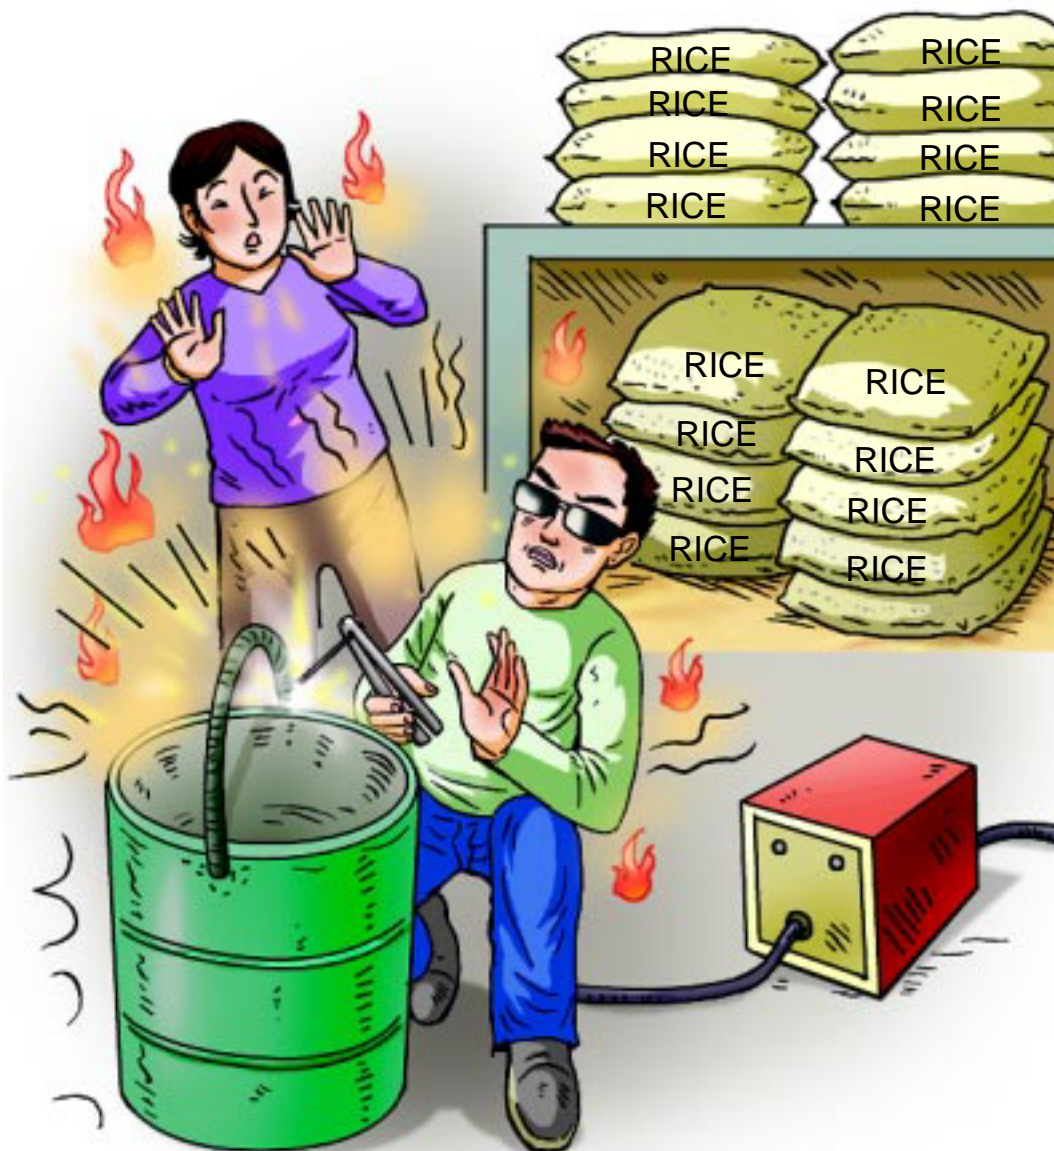
Case 3

The proprietor and a female worker of a food company seriously burnt in an explosion that occurred when a metal drum was being arc welded

The deceased was the sole proprietor of a food company which was engaged in the wholesale of rice. The accident took place in a temporary warehouse structure constructed of sheet metal. It was about 70 square metres in area and was used solely for storing rice. Except the electric arc welding set involved in the accident, no other mechanical or electrical equipment was found inside the warehouse.

At the time of the accident, the deceased was welding a metal handle onto the top rim of an empty metal drum using an electric arc welding equipment. A female worker was standing nearby to assist him. The metal drum in question was a 200-litre vessel previously used to hold gasoline or diesel. Before the welding took place, the metal drum was emptied by pumping out all the liquid. The deceased intended to modify the metal drum for other use. During welding, an explosion suddenly occurred and resulted in a small fire. The deceased, who was working close to the source of the explosion, suffered 90% burns. The female worker suffered 60% burns. The deceased passed away in hospital 9 days later.

- The welding leads, electrode holder and clamp of the arc welding set were all melted by the fire during the incident.
- It was not possible to ascertain whether the deceased possessed any relevant experience, knowledge or training in the arc welding work he performed. The female worker had no knowledge of arc welding at all.

- The metal drum involved in the accident had previously been used to contain highly flammable gasoline or diesel. Although the liquid had been pumped out and the drum was empty at the time of the accident, there were still traces of residual flammable liquid left in it.

- Intense heat was generated when the arc welding work was performed on the metal drum. The heat vaporised the flammable liquid residue in the drum, forming a flammable and explosive atmosphere. Once the flammable vapour came into contact with an ignition source, such as the sparks formed during the welding process, an explosion occurred causing a fire.

1. Before doing any arc welding operation, a risk assessment is carried out to identify all the hazards involved and implement appropriate safety precautions.
2. Any metal drum that has been used to hold flammable substances is thoroughly cleansed before carrying out any work likely to generate heat on it.
3. Any individual carrying out arc welding work possesses the relevant information, experience and training required to enable him to perform the work in a safe manner.

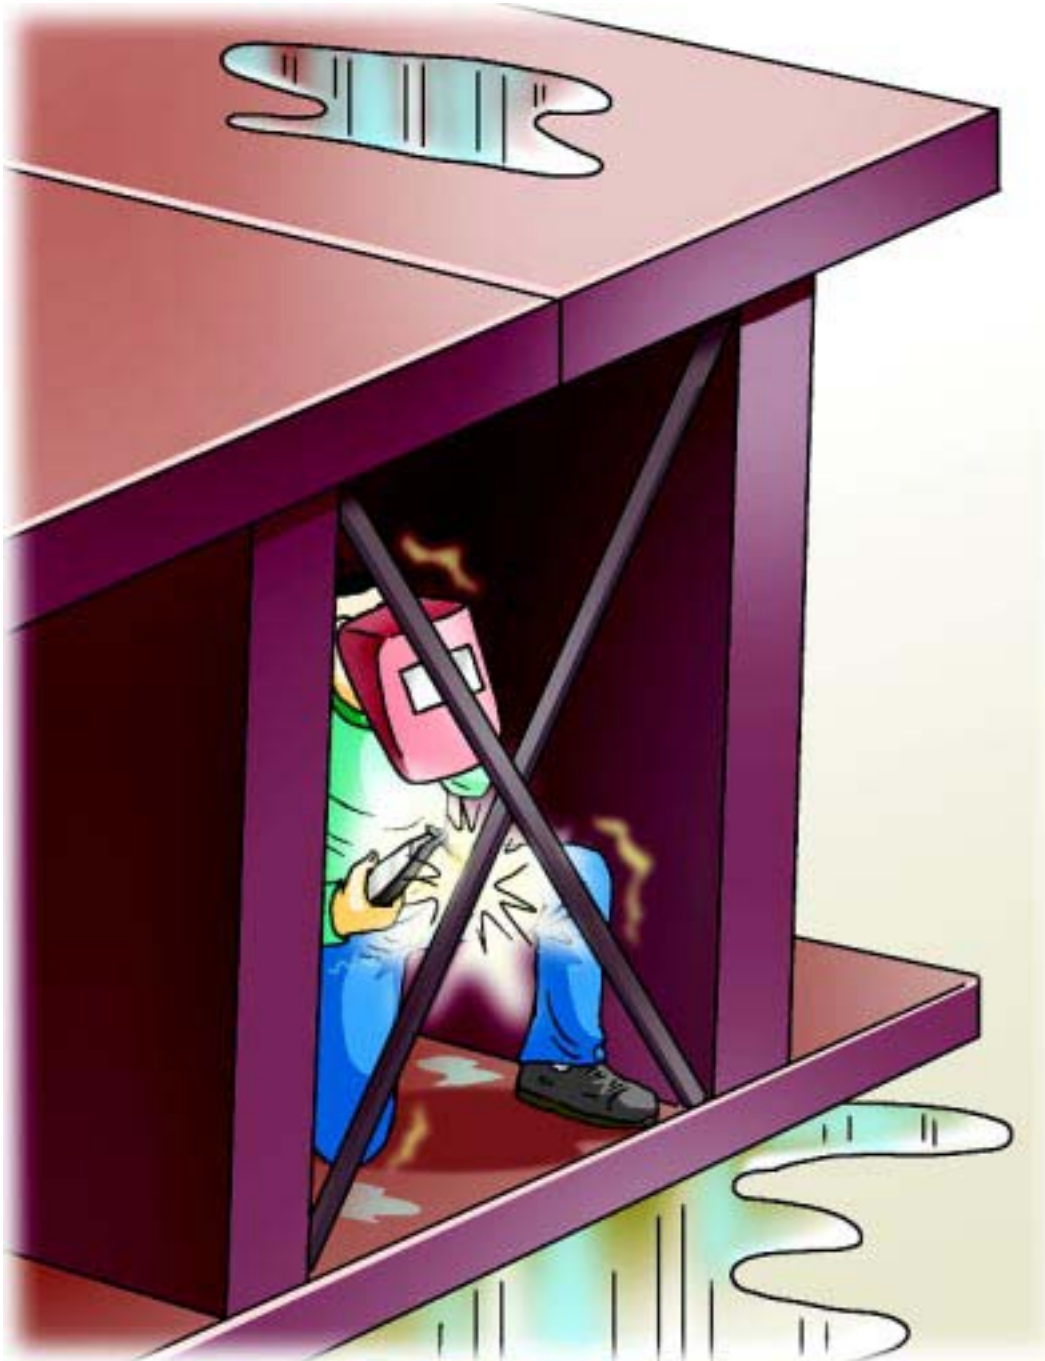
Case 4

A welder electrocuted when welding

Two welders were assigned on a rainy day to weld two I-beams together into a tubular structure at an open space and then to fix "X" shape bracings inside the structure with an electric arc welding transformer. One of the welders, the deceased, was electrocuted when he got into one end of the tubular structure to weld the "X" shape bracing.

- There was no shelter for the welding work. The workplace and the welders' bodies were wet because of the intermittent showers. But no one stopped the two welders from working further.

- The combined I-beam structure was placed on the ground. The cross section of the internal void space was 427mm x 580mm. To weld the "X" shape bracings, the welders had to squeeze into this congested space.

- The welders did not have any insulated welding gloves, footwear, stands, mats or other suitable device to prevent them from having direct contact with the workpiece and the electrode. The deceased, working close to the live welding electrode and the workpiece, was vulnerable to an electric shock.

- There was no clear and specific instruction for the proper procedures of fixing the "X" shape bracings.
- The supervisors and the workers had poor safety awareness and limited safety knowledge.

- There was not in place any monitoring system to detect unsafe conditions and enable these to be rectified in a timely manner. The workers were not suitably supervised and their performance safely regulated.

1. No welding work is carried out in a wet environment or at an open space when it is raining.
2. All live conductors, including those forming part of the apparatus, are effectively protected and insulated, or placed and safeguarded to prevent electrical hazard.

3. Suitable measures are taken to avoid contact with electrically conductive parts in the vicinity of the welding area, especially when the welding work is carried out at a congested space.

4. Suitable personal protective equipment are provided to the welders to prevent them from having direct contact with the workpiece.
5. An automatic voltage regulator is fixed in the welding transformer to reduce the open-circuit no-load voltage of the transformer output to less than 50V a.c.

6. A safe system of work is provided and maintained. The following safety precautions are taken to safeguard the welders working inside a metal structure with electrical equipment –

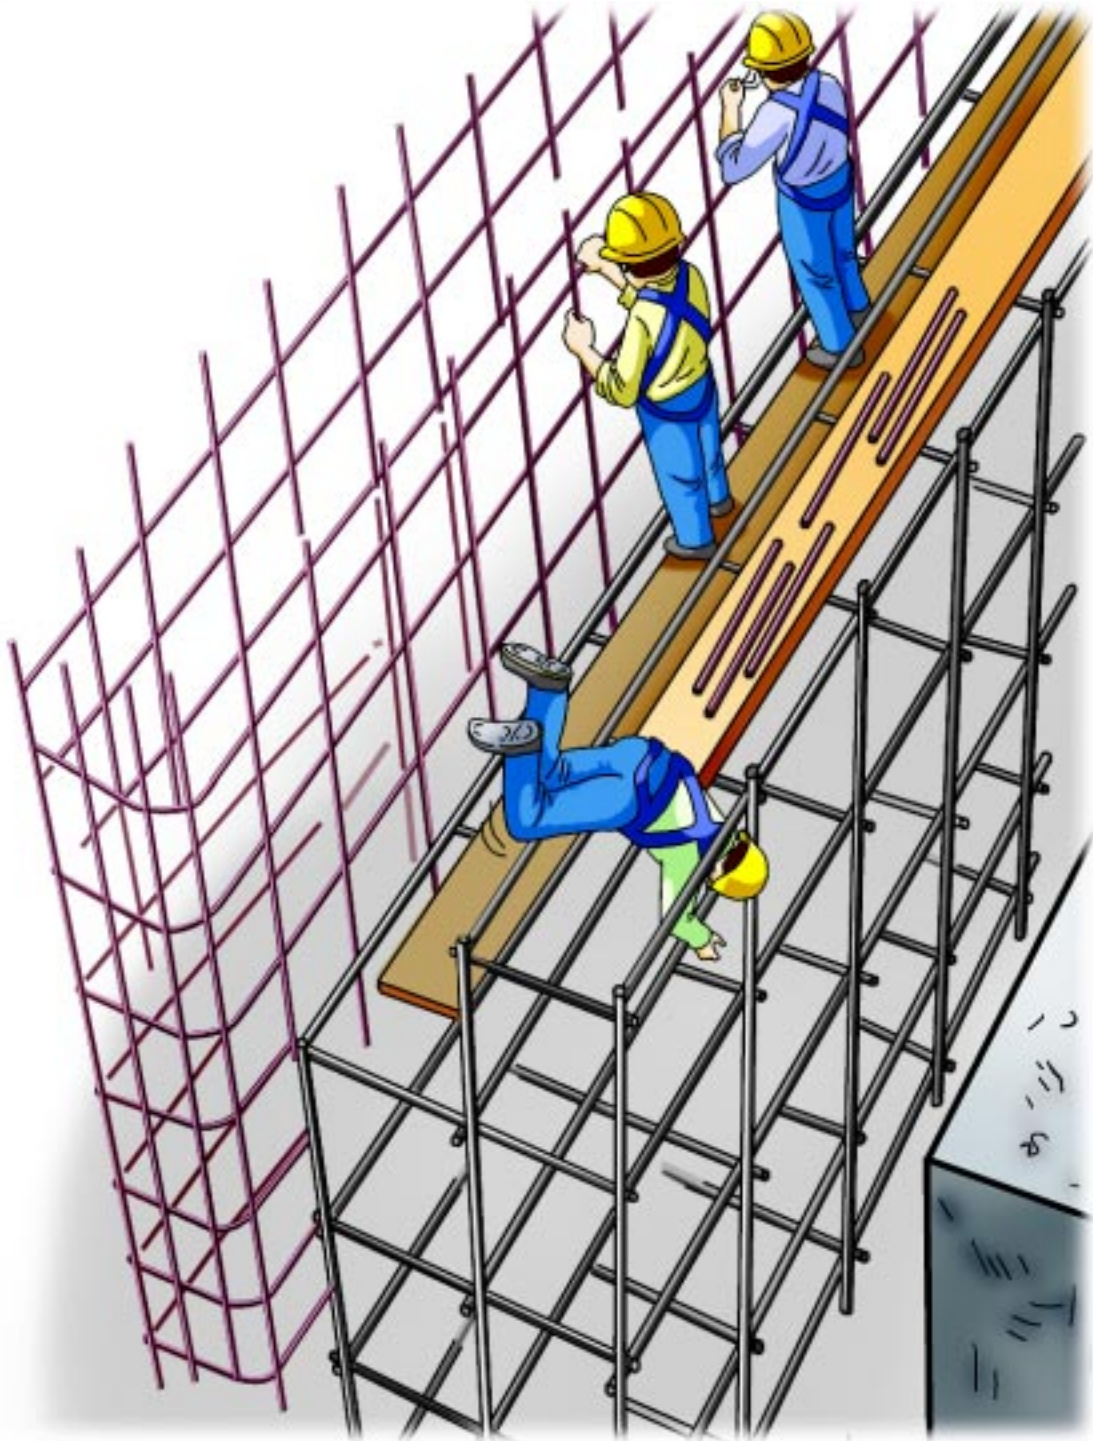
Case 5

A bar-fixing worker fell to death from a substandard working platform

On Level 5 of the building under construction, a tubular scaffold was erected to facilitate the fixing of a row of steel bars, 4 m high, 10.8 m long and 30 cm thick, for constructing the upper section of a wall. The scaffold consisted of 2 levels, a front lower level and a back upper level. The lower level of the scaffold, in five tiers, was facing the wall and was 5.3 m high, 10.8 m long and 1.9 m wide. The upper level of the scaffold, in six tiers, was further away from the wall right behind the lower level and was 6 m high. A working platform was erected on the top of the lower level of the scaffold to support the deceased and the three co-workers to fix the steel bars. Wooden boards and timber battens were also placed on top of the upper level of the scaffold where steel bars, timber material and tools were placed for use by the workers. To perform their duties, the deceased and his co-workers had to move about on the working platform and fetch material and tools from the upper level of the scaffold. At the time of the accident, while the deceased was taking a steel bar from the upper level of the scaffold, he lost his balance and fell 6 m to the ground through an opening on the working platform of the upper level. He sustained serious injuries and subsequently passed away in the hospital.

- The working platform on which the deceased and his co-workers worked was not closely boarded. There was a line of void of 20 cm to 40 cm wide between the rear edge of the working platform and the adjoining higher section of the scaffold. Neither toe-board nor guard-rail was erected on the working platform.

- The upper level of the scaffold was also not fully covered. There were two large openings on the working platform right behind the position where the deceased was working before the accident occurred. Each opening was 137cm long and 144 cm wide. The steel bars were stored close to these openings.

- The deceased and his co-workers had all worn a safety belt. However, there was no suitable anchorage or independent lifeline on the scaffold for them to anchor their safety belts. Furthermore, no safety net was erected underneath the working platform on the tubular scaffold.

- The working platform on the lower level of the scaffold was erected by the deceased and his co-workers. After erection, the site supervisory staff had not checked the working platform to see whether it was safe to use.

- No specific instruction, information and training were given to the bar-fixing workers that they needed to erect a closely boarded working platform with suitable guard-rails and toe-boards.

- The upper level of the scaffold was only 65 cm higher than the lower level. The top ledger of the scaffold on the upper level was therefore not a suitable guard-rail for the working platform erected on the lower level of the scaffold.

1. Working platforms of proper and safe construction are provided to prevent workers from falling from a height.
2. The working platform is closely boarded and fitted with suitable guard-rails and toe-boards.
3. Any openings on the working platform, through which a person is at risk of falling, are securely covered.
4. A safe system of work for the bar-fixing work is provided. The safe system has included the following elements –
 - (a) safe working procedures regarding the erection, inspection and use of the working platform;
 - (b) a competent person appointed to inspect the working platform before use;
 - (c) all relevant supervisors and workers adequately trained in the safe procedures and subject to regular surveillance; and
 - (d) the provision of adequate information, training and instruction in respect of the system of work to the workers.

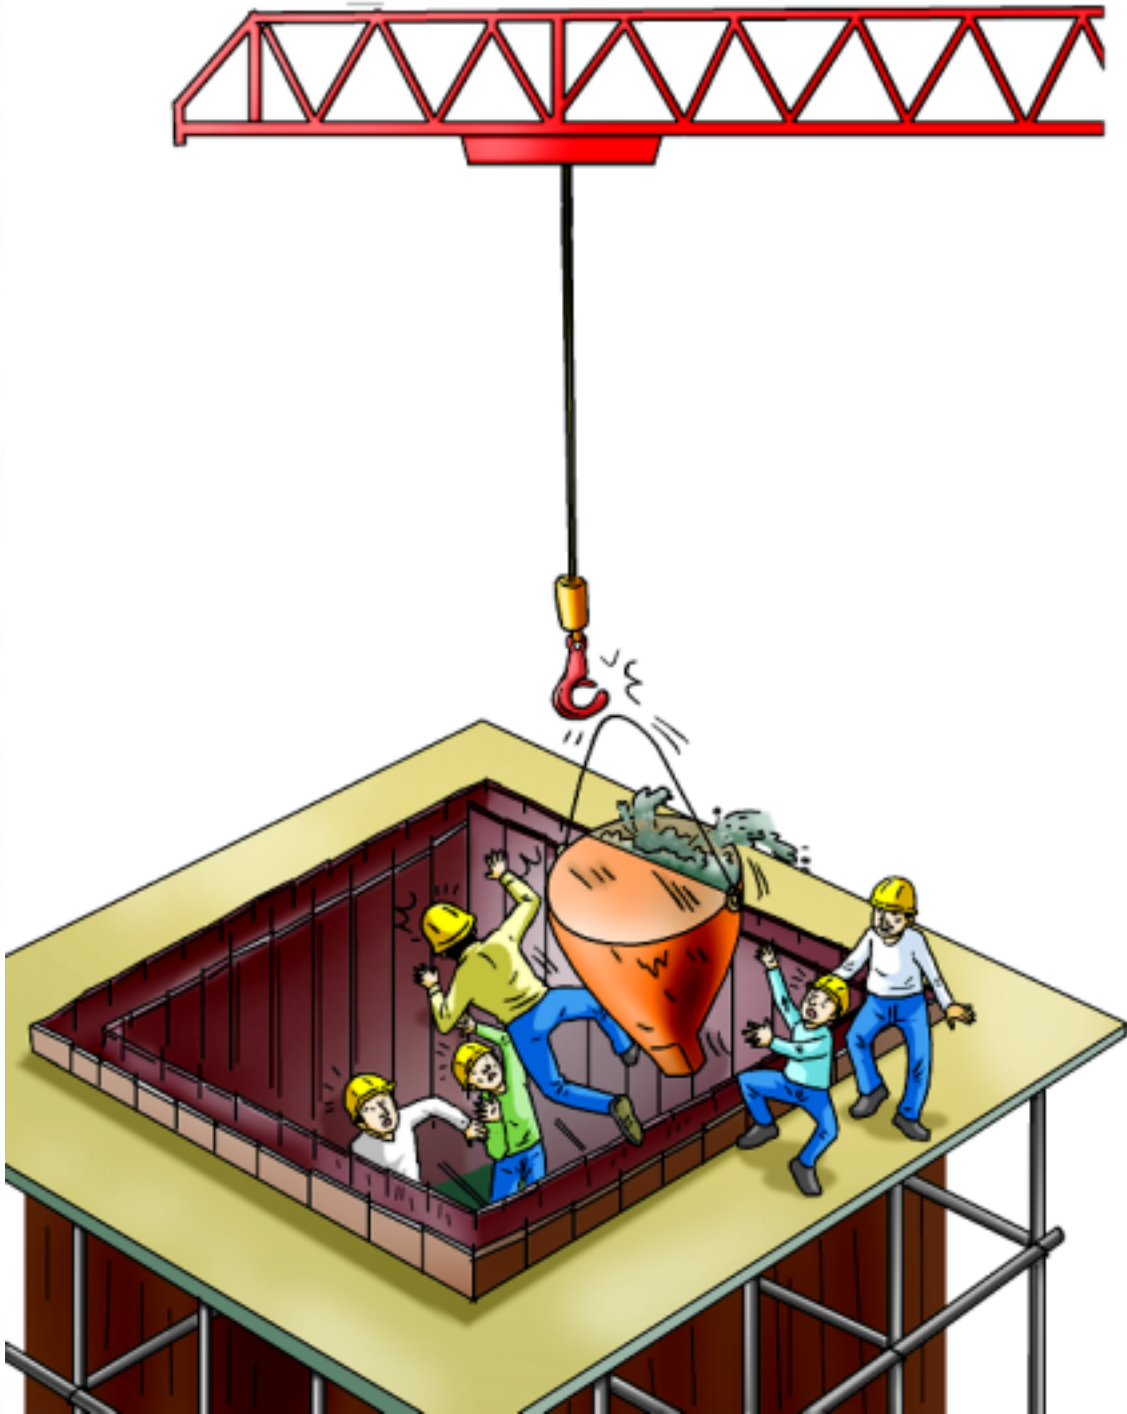
Case 6

One worker killed and three injured by a falling concrete skip

A water tank was under construction on the ground level of a building construction site. When erection of the formwork had been completed, three workers were assigned to carry out the concrete pouring work. A tower crane was used to convey concrete, by means of a skip, to the workers staying on a working platform provided on the formwork about 3.3 metres above the ground. While concrete pouring was in progress, another two workers were also performing levelling work at the bottom of the water tank.

When the accident happened, the skip loaded with concrete was conveyed by the tower crane to the workers on the platform. While a worker was attempting to release concrete from the skip, the skip suspended by a wire sling suddenly detached from the crane hook and fell onto the platform, causing the working platform to collapse. The three concrete pouring workers fell into the tank and were injured. The half-loaded concrete skip further fell to the bottom of the tank and struck a levelling worker to his death.

- The tower crane, wire sling and the skip had been tested, examined and inspected, and were certified safe to be used. No mechanical defect was noted on the lifting gears and they were not overloaded.

- The tower crane operator in the driving cabin could clearly see the whole water tank formwork structure.
- Since some reinforcement bars of the formwork were found buckled and some of the wooden battens supporting the formwork were broken, it was likely that there had been a strong impact of the skip against the formwork.

- The hook of the tower crane was fitted with a safety catch but it was found deformed and bent to one side.
- The detachment of the wire sling from the crane hook was probably caused by the concrete skip having struck against the reinforcement bars of the formwork. When the movement of the skip was abruptly stopped by the impact, the sling was forced out of the hook. The forceful departure of the sling might have caused the deformation of the safety catch. It was also possible that the safety catch had already been damaged during the operation before the accident.

- It was not necessary to undertake both the water tank concrete pouring and levelling work at the same time. The levelling work could be carried out after concrete pouring had been completed.

1. No workers stay at the bottom of the water tank when lifting operation is carried out overhead.
2. The concrete skip is kept clear from other objects while it is being lifted and conveyed.
3. Use other concrete conveying equipment, such as a concrete pump, to eliminate the hazards associated with the lifting operation.
4. Adequate information, instruction and training related to the hazards and safety precautions of the lifting operations are provided to workers.

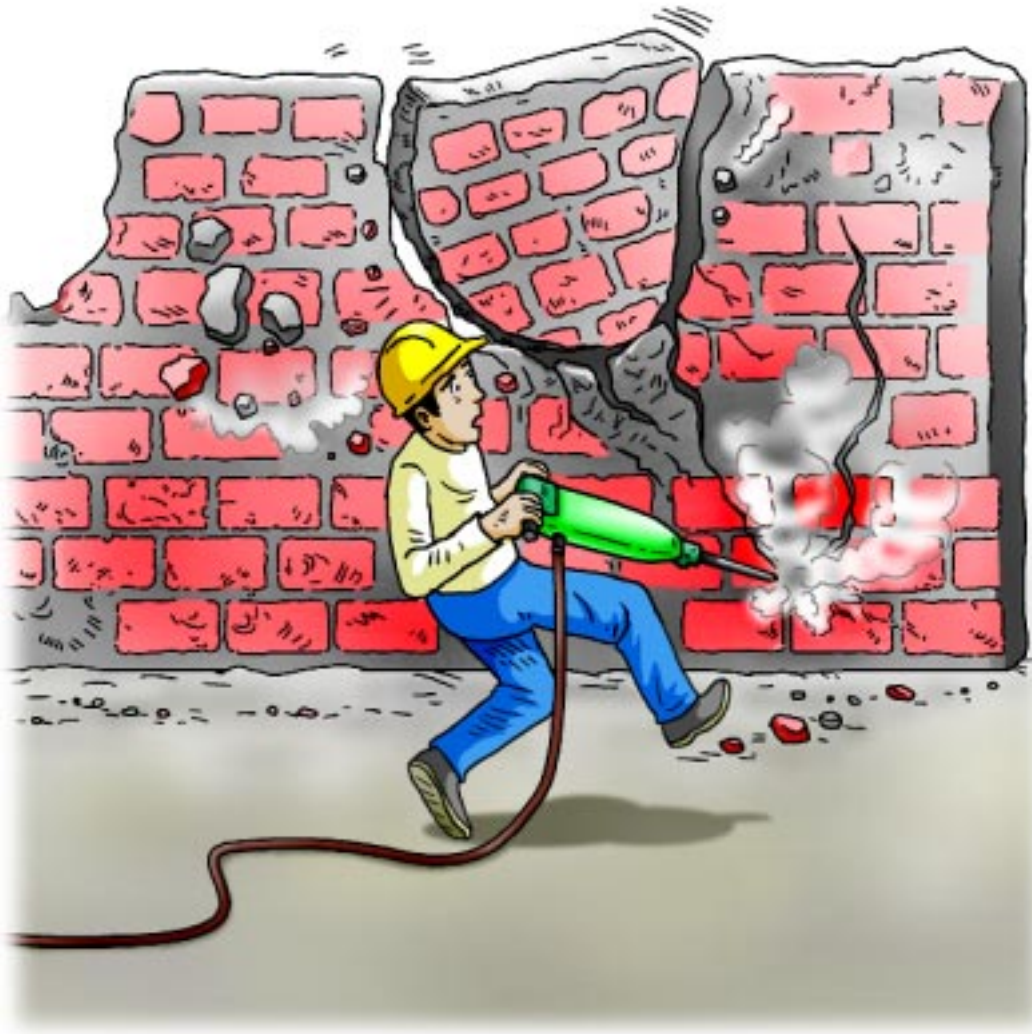
Case 7

A worker fatally injured when the brick wall he was demolishing collapsed

Three free-standing brick walls for displaying mock-up wall tiles were erected in the open area outside the site office of a building construction site. A subcontractor was awarded the contract to demolish these three walls. The deceased was employed to carry out the demolition work. Before the work commenced on the day of the accident, the principal contractor's site agent told the deceased to erect a tubular scaffold to use as a working platform and to demolish the walls from top down using an electric hammer. After that, the deceased was left alone to demolish the walls. Just before the accident occurred, a worker employed by another subcontractor happened to walk past the scene. He saw the deceased undermining the foot of one of the walls with an electric concrete breaker. A few seconds later, he heard a loud 'bang'. He turned around and found the brick wall collapsed and the deceased trapped by two large shattered pieces of the wall. The deceased was sent to hospital for treatment but passed away on the same day.

- The brick wall involved in the accident was built by laying bricks layer by layer with plaster, without reinforcement bars inside. There were two flanges at the two ends of the wall and the wall was in the form of a 'U' shape. Wall tiles were laid on the plaster surface on the outer side of the 'U'.

- The brick wall measured 3 m high, 3 m wide and 200 mm thick. The two flanges at the two ends measured 550 mm wide each.
- The brick walls sat on a cement base ground that was even and firm. After the accident, no sign of ground subsidence was noted at the location of the collapsed wall.

- No tiebacks or guides such as rope was provided to stabilise the wall during the demolition. No tubular scaffold or working platform was found in the vicinity of the collapsed wall.

- Hammer marks were observed on the bottom edge of a large piece of shattered brick wall. These marks were approximately 200 mm to 400 mm above the ground.

- From the two large shattered pieces of the collapsed wall, it could be seen that approximately 2 m of the foot of the brick wall had been hammered off. This indicated that prior to the collapse, the deceased had hammered off about two-thirds of the length of the foot of the wall.

- The collapse was caused by the excess removal of the foot of the brick wall. When over half of the width of the foot was removed, the wall could no longer stand by itself and consequently collapsed.

- The deceased was not competent to erect a tubular scaffold. He was left to work alone. There were no supervisory measures in place to ensure that the instructions given to him were properly followed.

- The deceased did not wear suitable eye protectors while performing the demolition work.

1. Demolition of walls is carried out in accordance with the “Code of Practice for Demolition of Buildings (2004)”, which includes the following –
 - (a) brick removal begins from the top layer downwards; and
 - (b) the work is carried out layer by layer with each layer not larger than 300 mm.
2. Suitable working platforms with guard-rails and toe-boards are provided for workers engaged in brick wall demolition. Erection of the working platform is done under the supervision of a competent person.
3. Adequate supervision is exercised to ensure the safety and health of workers at work.
4. Reasonable steps are taken to ensure that workers engaged in brick wall demolition make full and proper use of suitable eye protectors.

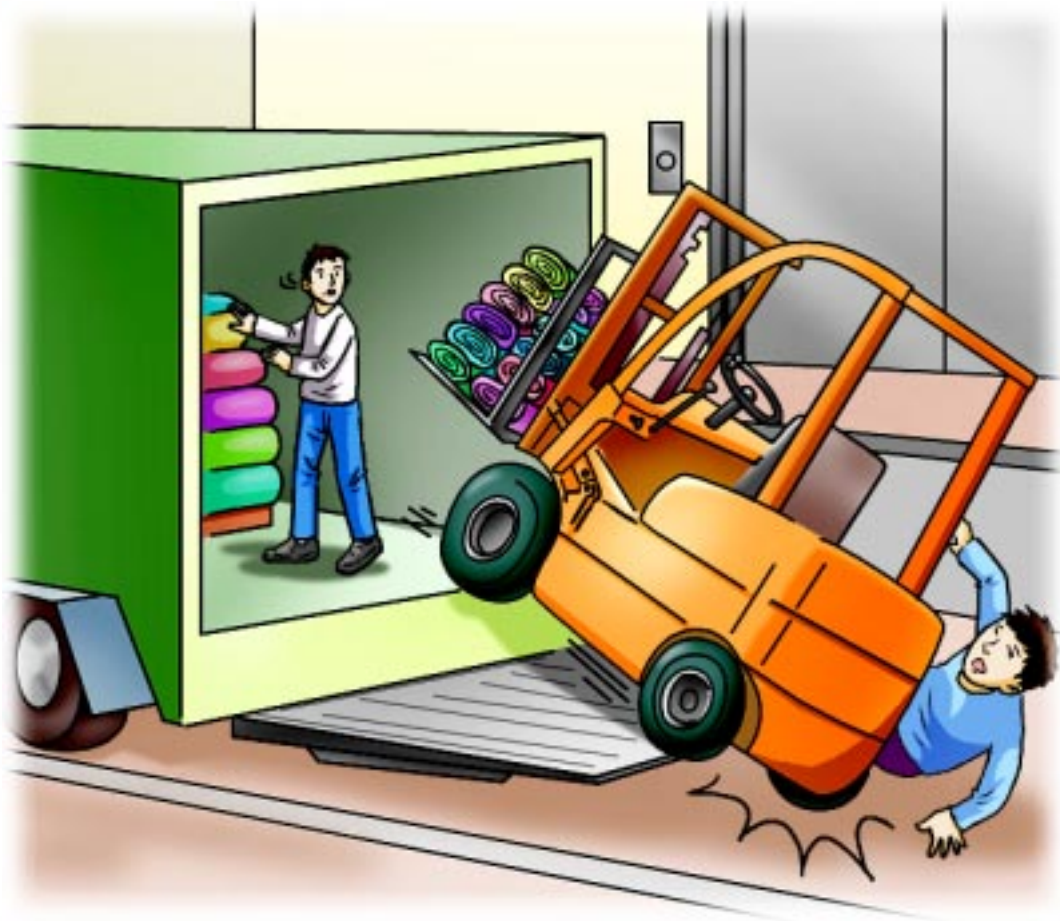
Case 8

A truck driver pinned under an overturned battery-operated pallet stacker

Bales and rolls of fabric were transported from a warehouse to a truck in the loading bay of an industrial building. The deceased was responsible for driving the truck to the loading bay of the warehouse. The other two workers, worker A and worker B, were responsible for moving the fabric from the warehouse to the loading bay and stowing it into the truck with a battery-operated stacker. During the operation, the tailgate platform of the truck was lowered and the stacker was positioned on it. Bales of fabric were raised to the necessary height by the stacker and then stowed manually into the storage compartment of the truck. Before the accident occurred, worker A had left the scene to fetch some documents from the office, leaving worker B to handle the rolls of fabric alone. The deceased was by then standing at the loading bay at the rear end of the truck. Before the accident occurred, worker B was using the stacker to lift a roll of fabric to a height of about 160 cm. Not having disengaged the starter key of the stacker, he proceeded to stow the fabric manually into the truck. Suddenly, he heard a loud crash and found the stacker toppled. The deceased was pinned underneath the stacker. He died in hospital later that evening.

- The tailgate of the truck was operated by a hydraulic system powered by the battery of the truck. It could still work even with the engine switched off. Its up and down operation was initiated by two separate control devices. One of these was located below the deck at the right rear end of the truck. The other was a remote device which could be controlled from within or outside the truck. The tailgate was in good working order at the time of the accident. Nothing abnormal was noted.

- The starter key of the stacker must be inserted before the stacker could be operated. Steering was done by a control lever which turned it left or right. Its driving mode was operated by a travelling switch that was also on the handle of the control lever. The stacker was in good working order before the accident occurred.

- Simulation tests performed on the stacker revealed a low centre of gravity remaining inside the machine body even when the lifting forks were raised. Under normal circumstances, the stacker would not topple.

- At the time of the accident, the lowered tailgate platform of the truck was not at ground level. It was reported to be approximately 5 to 7.5 cm above ground.

- Three fresh collision markings were found on the concrete surface of the loading bay. It is believed that one of the marks was caused by the deformed edge of the tailgate platform when it was lowered onto the loading bay. The other two were possibly caused by the impact of the folding platform hinging on the ground.

- At the time of the accident, the starter key had not been removed from the stacker. This meant that it could easily have been operated or caused to move by anyone other than its operator.

- With the starter key on, it is believed that the deceased, for some unknown reasons, might have operated the stacker or caused it to move away from the tailgate platform. Since the tailgate was a few centimetres above ground level, once the stacker slid off, it toppled. The folding hinge at its base hit the ground first, followed by the crashing of the whole stacker.

1. A safe system of work for operating the electric stacker is provided and maintained for all operators. This includes (but not be limited to) the following –
 - (a) the electric stacker is operated only by a person who has attended the relevant training courses and holds a valid certificate;
 - (b) there is supervision at all times to ensure that the stacker is operated only by the above authorised person;
 - (c) the operator has not left the stacker unattended unless he has ensured that –
 - (i) the hand brake is applied;
 - (ii) the starter key is removed to prevent any unauthorised person from operating the stacker; and
 - (iii) should it be parked on a slope, the stacker is securely wedged in by stop blocks.
2. Before operating the stacker, the tailgate platform of the truck is lowered until it rests squarely on ground level.

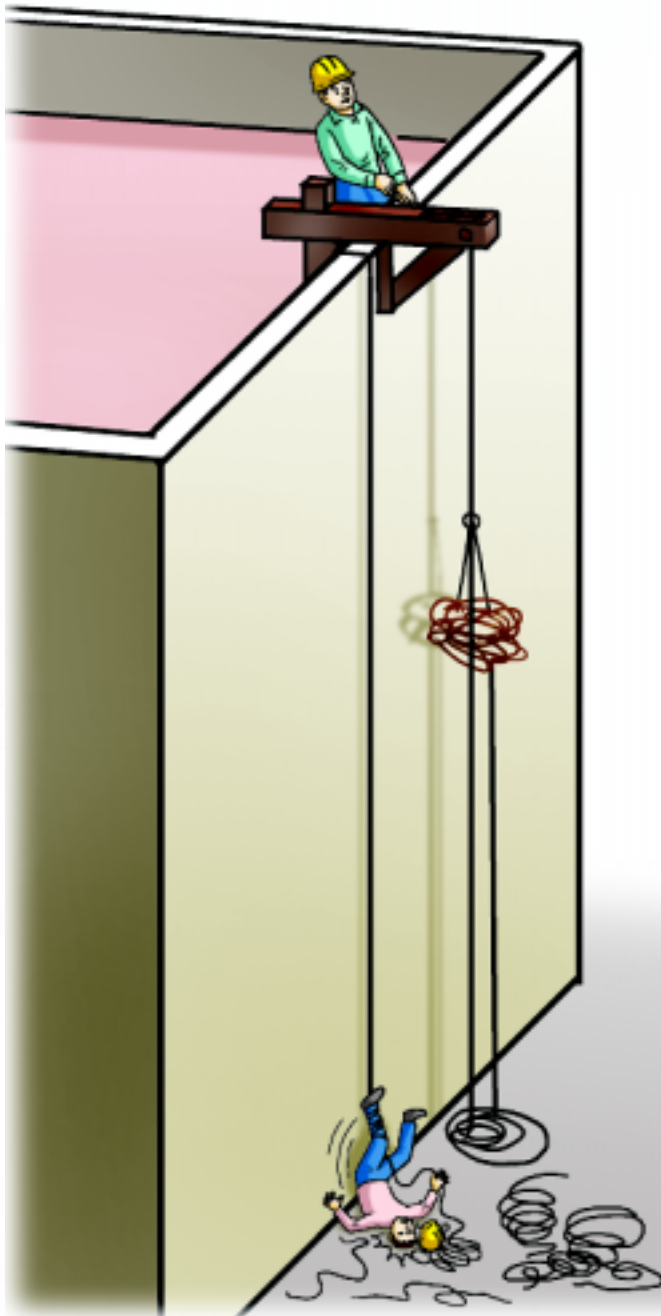
Case 9

A worker entangled and dragged up by a nylon rope while engaging in the dismantlement of a gondola

At a construction site, 4 blocks of multi-storeyed service apartment building were built. After the construction work was substantially completed, gondolas were erected on the roofs to clean the windows before handing over to the clients.

Before accident occurred, the window cleaning work at one of the 4 blocks of building was completed. The gondola erected on the roof was dismantled and lowered to the ground floor. It was separated from its accessories of 4 wire ropes, two nylon ropes and an electric cable and moved a distance away from the building. Two wire ropes of the gondola were also lowered to the ground floor. At the time of the accident, three workers, worker A, worker B and the deceased were engaged in the lowering of the remaining gondola accessories of two wire ropes and an electric cable.

The lowering method was merely manual operation without the assistance of power driven aids. The two wire ropes and electric cable were connected by shackles to a nylon rope (previously used as independent lifeline during the window cleaning operation on the gondola). The nylon rope was then passed through the guiding groove of a outrigger. One end of the nylon rope connecting the wire ropes and electric cable was lowered down to the ground floor by gravity. The other end of the nylon rope was laid freely on the ground floor and it was dragged up and to be collected at the roof. Worker A stayed on the roof to hold the nylon rope and lower the remaining gondola accessories down to the ground floor. The deceased and worker B worked on the ground floor to collect the wire ropes and electric cable. It was agreed that the deceased would give signal to worker A before worker A started to lower the gondola accessories down to the ground floor. As worker A sensed the deceased having given him the signal, he started to lower the gondola accessories down. At this moment, the left foot of the deceased was entangled by the free end of the nylon rope that was laid on the floor. His head struck hard onto the ground when he was being dragged up and the gondola accessories were being lowered down. He sustained serious head injury and passed away in the hospital a few hours later.

- The vertical distance between the outrigger on the roof and the ground floor was 211 metres.
- The total weight of the two wire ropes and an electric cable was 135 kg.

- During the lowering operation, one end of the nylon rope was used to tie the gondola accessories. The rope with the gondola accessories was then passed through the guiding groove and tied around the framework of the outrigger while the other end of the rope would lay freely on the ground floor level. The worker who stayed on the roof would hold the nylon rope by hand and control the down movement speed of the gondola accessories. The harder the worker pulled the nylon rope, the slower the load would descend and vice versa.

- At the beginning of the lowering operation, the worker on the roof had to bear the entire weight of the load. Such a weight of 135kg would be too much for a normal person. He was unlikely able to hold and control the down movement of the load. The gondola accessories were actually lowering down by their own weights in an uncontrolled speed.

- The working condition on the ground floor was in a mess. Nylon ropes and wire ropes were scattered around and this would endanger the safety of workers working nearby, including the deceased. When the gondola accessories were moving down by their own weights in an uncontrolled speed, the force was so great that the scattered ropes on the floor entangled the deceased's foot and dragged him up very rapidly.

- No mechanical equipment was available to assist the lowering of the gondola accessories. There was also no communication system to ensure that proper and clear instruction was given to the workers responsible for the lowering operation.

- There was no safe system of work on the dismantlement of gondola. Neither was there any risk assessment before commencement of the work.
- The workers involved in the operation were not given adequate training, instruction and information on the proper procedures of dismantling a gondola.

1. A safe system of work on the dismantlement of a gondola is developed and implemented before commencement of the work. The system includes (but not be limited to) the following –
