An
Analysis
on

Fatalities

Casebook

Volume 1

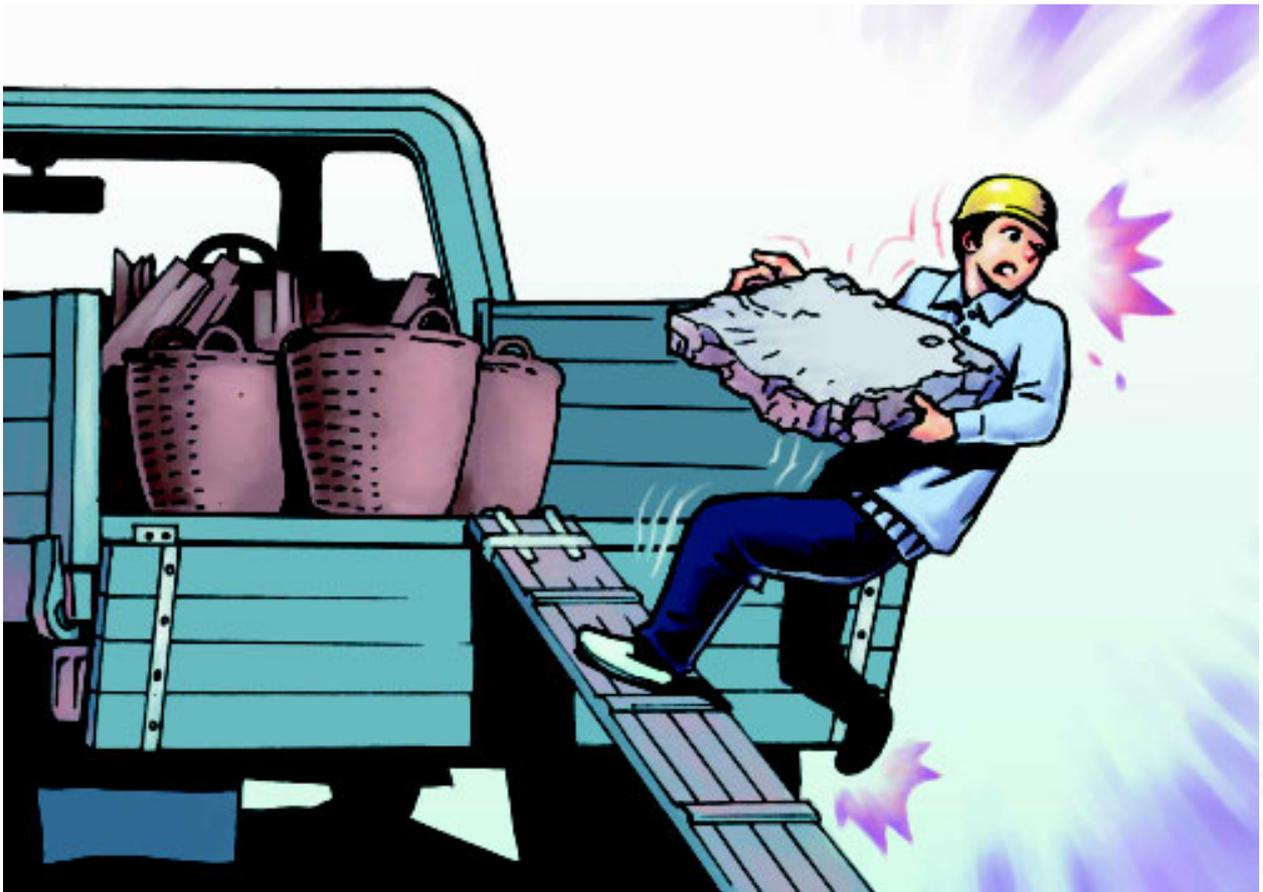
Case 1: A worker fell from an inclined gangway secured onto the end of a lorry parked on a public road

- (a) The gangway involved in the accident was only 0.23m wide. It might have caused difficulties to persons to keep balance while walking on it. It was not considered to be a safe means of access.

- (b) The D/P was having both hands engaged in carrying the concrete block at his front, and the concrete block might have obstructed his view and thus the judgment to the conditions of the gangway.
- (c) The protruding hooks at the anchoring point to the loading platform might have caused the D/P to trip and fall.
- (d) Autopsy report indicated that the blood alcohol level of the D/P might have affected the body coordination of the D/P.

A safe system of work should be provided and maintained for transporting and handling of the load. The system should cover areas such as:

- (a) a preliminary risk assessment before carrying out manual handling operations, which should identify the risks associated with the procedure of the work and formulate safety measures to be taken;
- (b) suitable mechanical means for the lifting and transportation of a load from one level to another;
- (c) when manual lifting of a load could not be avoided, large heavy objects should be broken up into smaller pieces for easy handling.

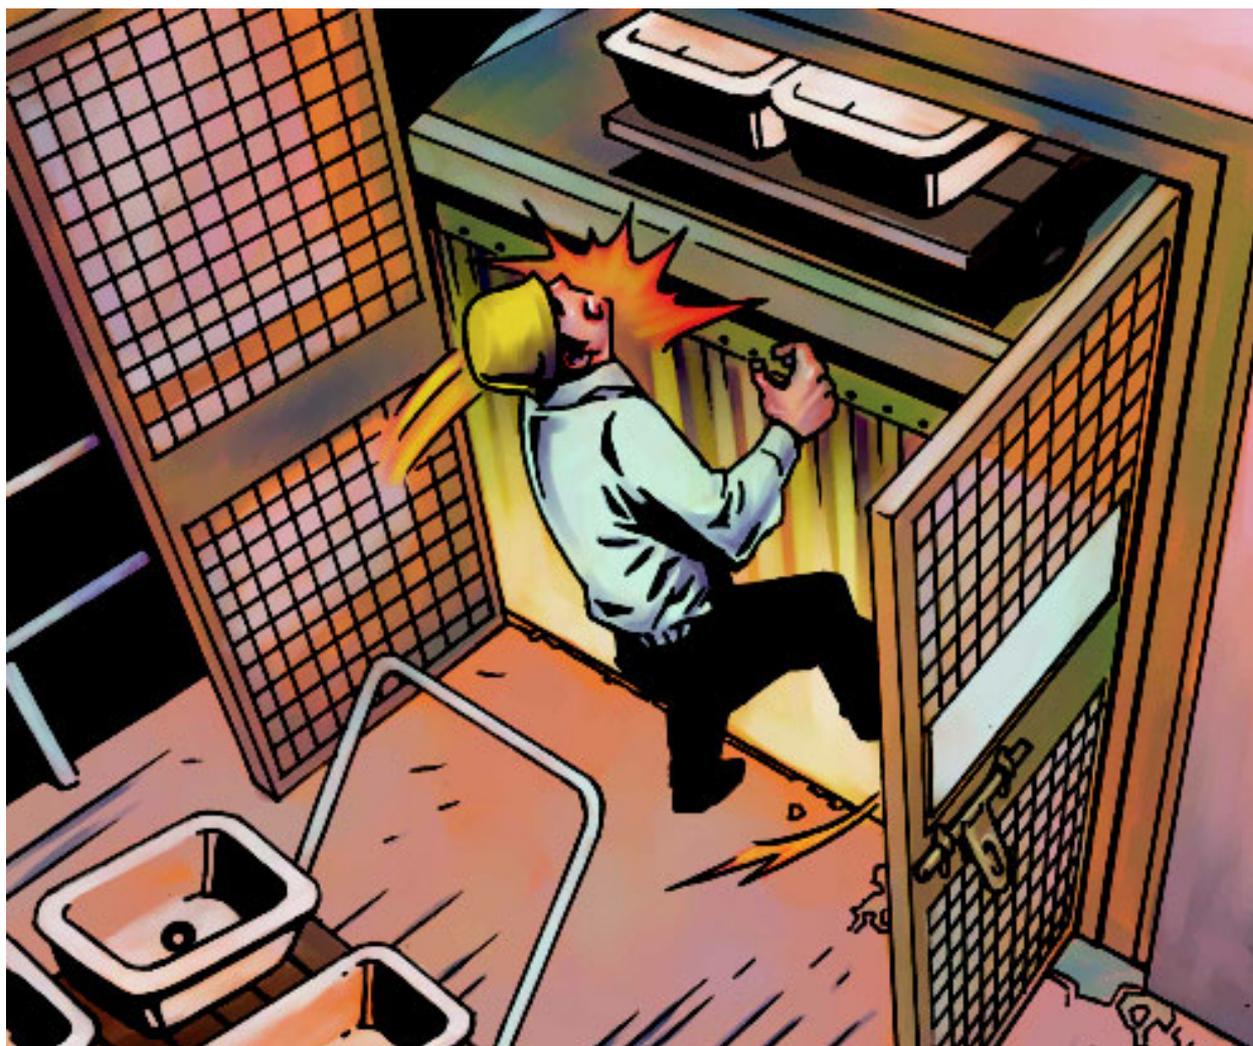
Case 2: A worker fell from a landing platform down the hoistway to the ground

It was also observed that the spring-loaded micro-switch at the hoistway gate on the 3/F, where the D/P was working, was not protected against tampering. It could be jammed, fastened or simply pressed down manually to render the hoist in operative mode even when the gate was opened. A site safety personnel disclosed that the hoistway gate at 3/F was in the open position when he reached there right after the accident. However, he did not notice any tampering of the micro-switch.

- (a) The micro-switch fitted to the hoistway gate could be easily tampered for the purpose of activating the hoist operations even when the gate was opened. Thus, the intent to keep the hoistway gate closed before moving of the hoist platform was defeated.
- (b) As the hoist could be operated with the hoistway gate opened, a worker would face the hazards of falling down the hoistway or being struck by the moving hoist platform.

- (a) An effective interlocking device should be installed on each landing gate of the material hoist to prevent the hoist from being operated before the gates are closed. The device should be designed and constructed to prevent any tampering to defeat its purpose.

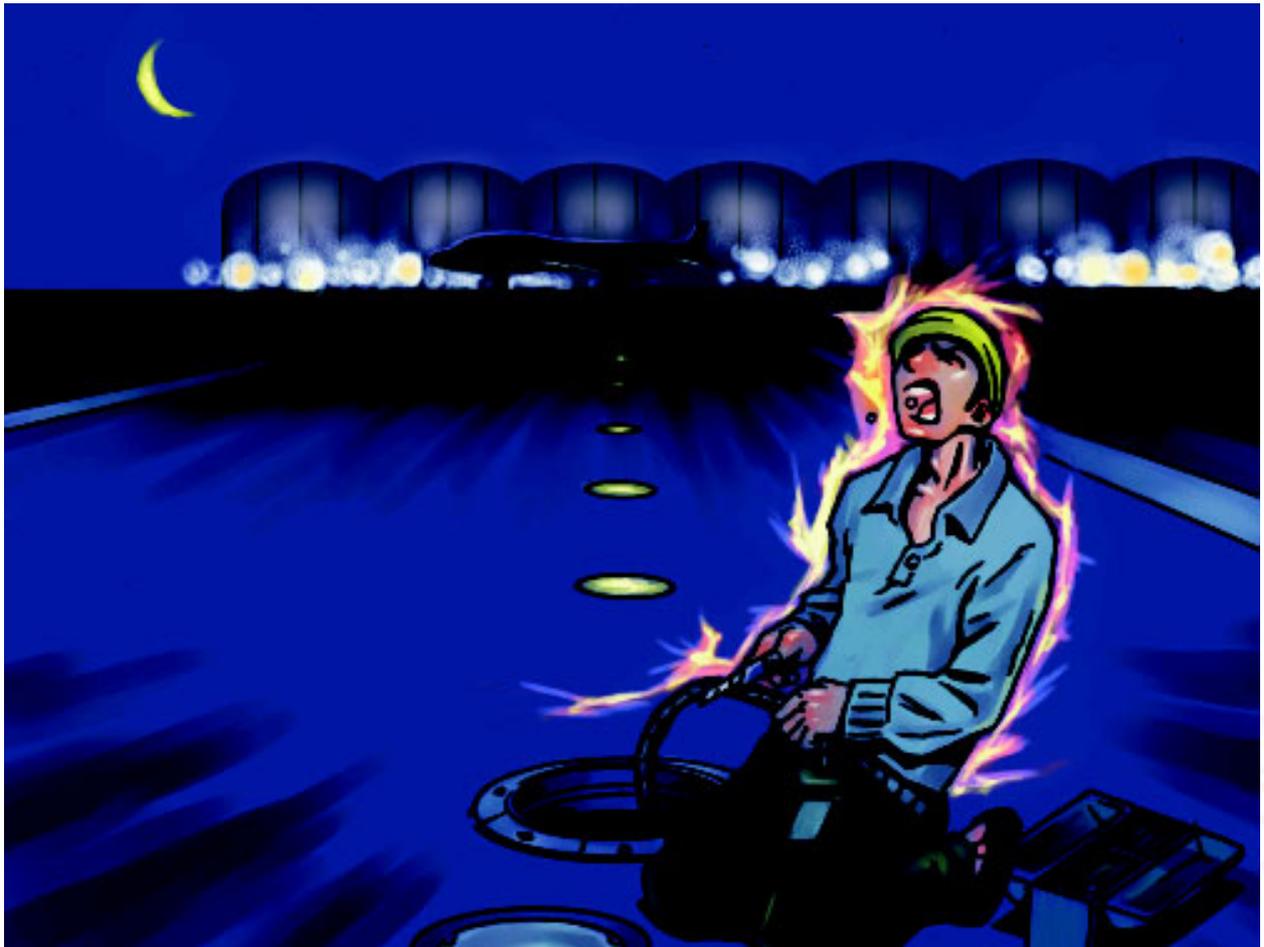
Case 3: An electrician was electrocuted when mistakenly cutting a live electric cable

Autopsy report on the D/P revealed that electric burn marks believed to have been caused by contact with electric current were found on his hands and left leg. Apparently, the electrocution occurred while the D/P was cutting an energized cable mistakenly during the work.

- (a) Details of the job were verbally given by the in-charge to the workmen with the aid of cable routing layout plan and job sheet. However, the information shown on the cable routing layout plan was confusing with the one being cut in the accident AGL No.4651 shown connecting to the circuit of the intended work. In fact, it was linked to another circuit which was live.

- (a) As far as practicable, all circuits of AGLs in the vicinity of the replacement work area should be opened and de-energized.
- (b) Cable routing layout plan and job sheet for showing the AGLs to be worked on should be properly designed to provide clear and accurate information so as to enable the job be carried out safely.
- (c) All AGLs circuits should be proved "dead" before working. The procedure for identifying the status of the circuit should be documented.
- (d) A specific and easy-to-follow permit-to-work procedure should be provided and maintained to ensure that the safe system is properly followed. It should give clear guidance and indication to the workers on which AGL is "dead" and properly isolated from live sources, and is safe to be worked on.

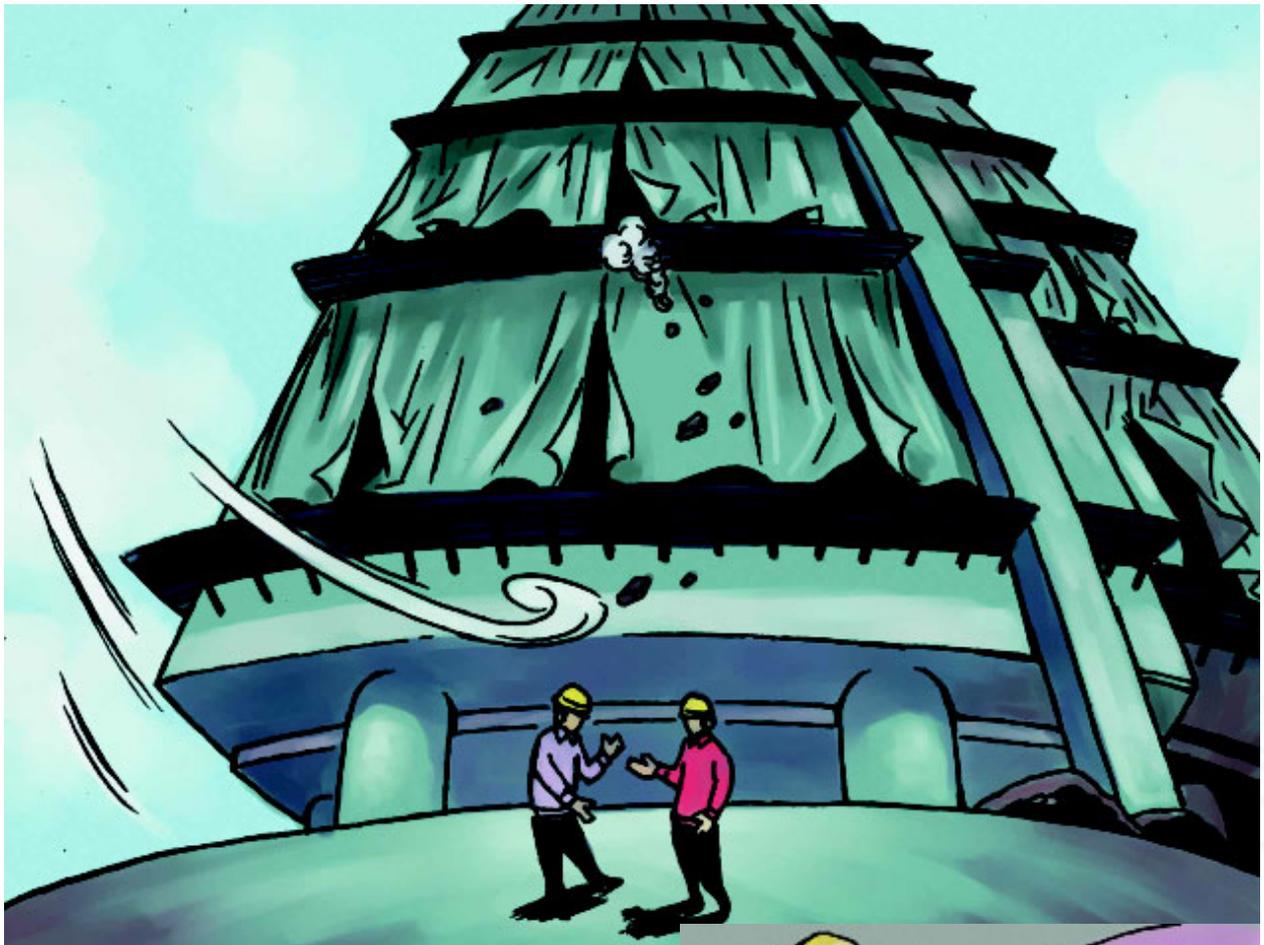
Case 4: A site sub-agent was struck by an object falling from height on the construction site of a building project after typhoon

Hence, the accident might have been caused when one of the concrete slabs on the catch fan at the 38/F level fell through the voids and openings of the safety nets and struck the D/P.

- (a) Construction waste and materials accumulated on the fans and nets should be removed from time to time.
- (b) Employees should avoid carrying out any work on the open ground of a construction site shortly after the typhoon. Work should only be resumed after assessing the effects of inclement weather on the site conditions.

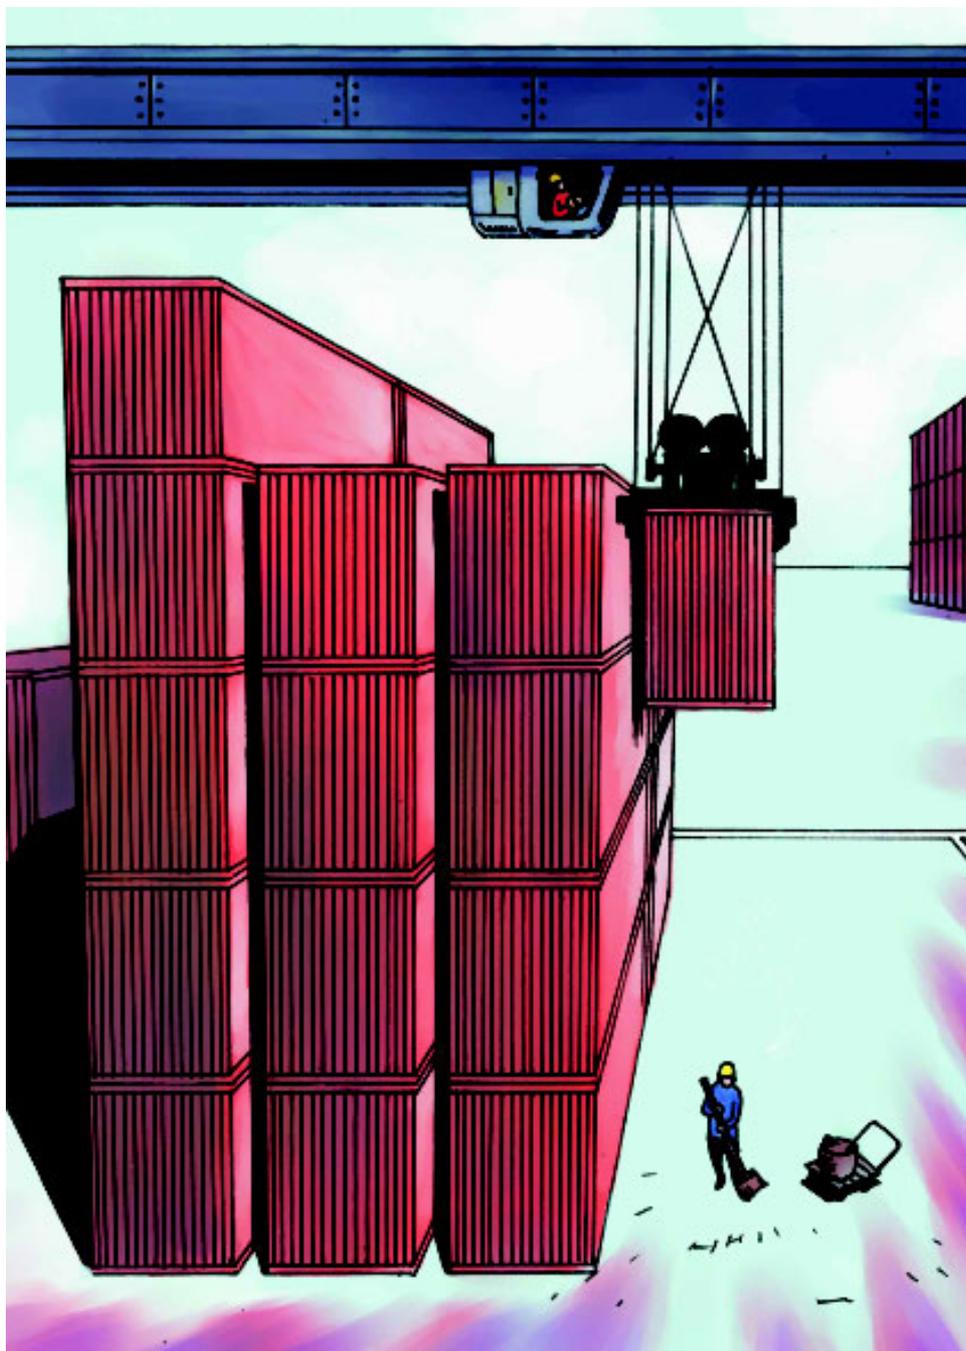
Case 5: A cleaning worker was crushed to death by a container while being lowered by a rubber-tyre gantry crane

The driver's cabin of the rubber-tyre gantry crane involved in the accident was about 18 metres above the ground. The spreader together with its hoisting mechanism was installed in front of the cabin. On the cabin floor, there was a wide window for the operator to watch the movement of the container below. When the cabin was stationed above the 4th Stack, the visible area on the ground of the 5th Row through the floor window was restricted if a container was under suspension of the spreader. While the container was being lowered down gradually, the visible area would be further reduced.

Although a camera of a closed circuit television (CCTV) system was installed at the front of the cabin for the operator to monitor the situation of container yard below, it could not give a detailed condition of the ground. There were blind spots when the yard was viewed from the cabin.

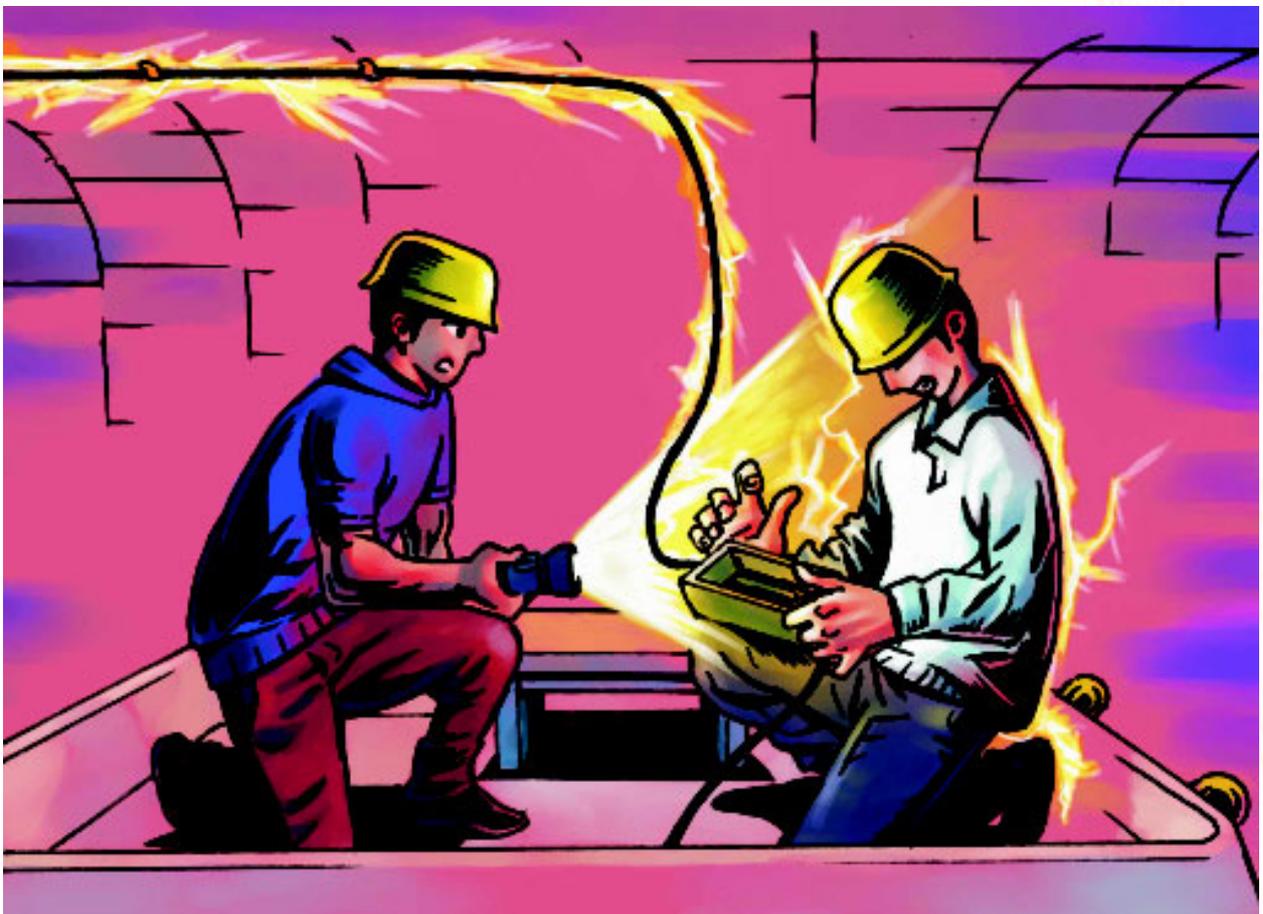
Case 6: An engineer was electrocuted while repairing a telecommunication system inside an effluent tunnel

- (a) When the accident happened, the D/P was kneeling on the top of the tunnel inspection vehicle, which was electrically connected with the tunnel floor. At the same time, there was thunderstorm, with lightning, prevailing at the Shatin Portal. It might be possible that a lightning flash struck on the lightning protection system at Shatin Portal, or on the earth direct in its vicinity. The lightning strike would produce a large current flow in the earth in that general area and caused an instantaneous rise in the earth potential which could be in thousands of volts.

- (a) A competent person should be appointed to carry out risk assessment of the working environment inside the effluent tunnel before the commencement of the work. The risk assessment should identify the hazards likely to be present, recommend the safety measures to be taken, and state the work method, materials and plant to be used when the work is carried out.
- (b) No worker should enter or remain in the effluent tunnel unless the recommendations in the risk assessment report have been implemented and a permit for safe entry has been issued.

- (c) In adverse weather condition, such as thunderstorm or lightning, working inside the tunnel on conductors or conductive parts of any communication system, lightning protection system, or other electrical services should be strictly prohibited.
- (d) When carrying out work on any electrical system inside the effluent tunnel, all workers should stay on an equipotential zone that is bonded to an effective local earth. All equipment, plant and conductive parts at the working place should also be bonded together electrically to an effective local earth to ensure that no hazardous potential difference exists between different parts of a worker's body that would cause a leakage current flow.
- (e) The risk assessment report and the permit for safe entry into the effluent tunnel should be displayed at a conspicuous place at its entrance.

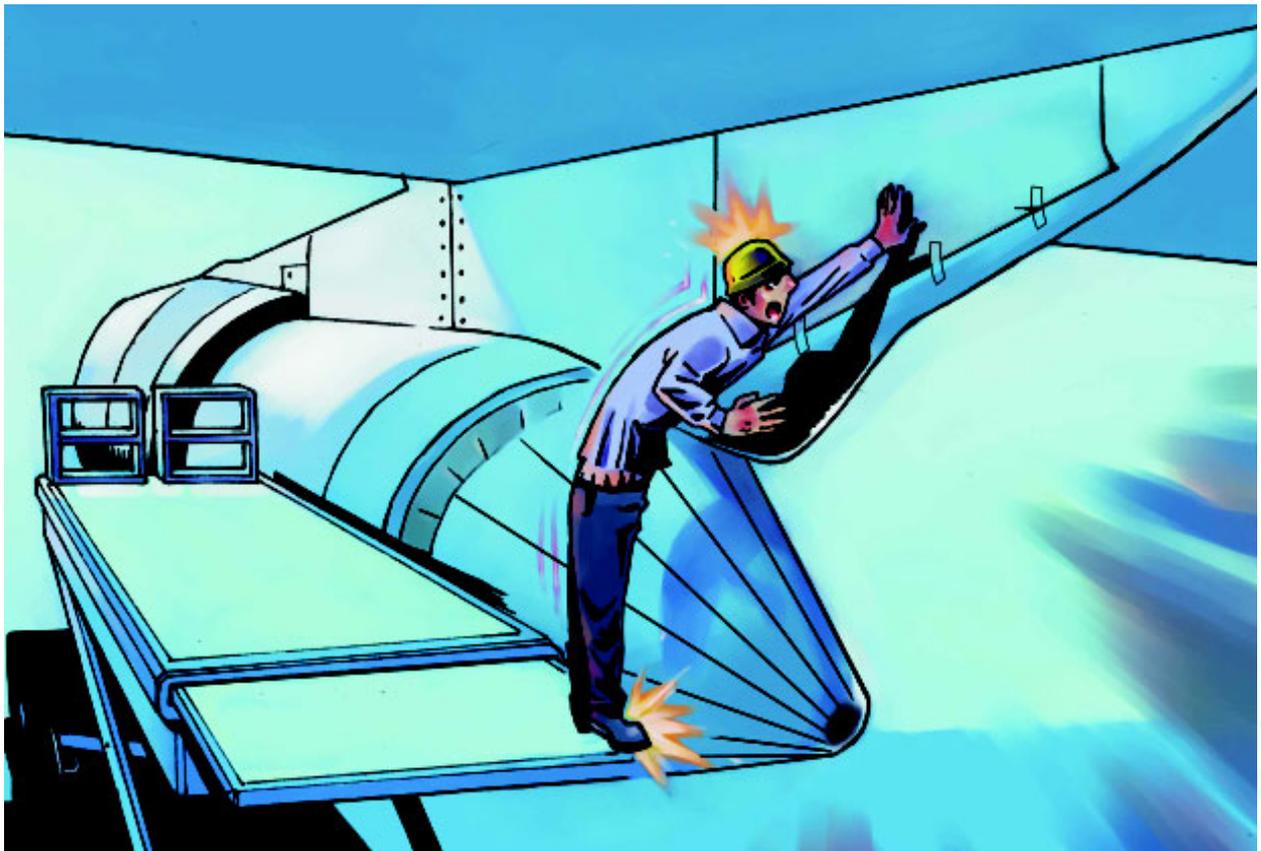
Case 7: An aircraft mechanic fell over the edge of an unfenced elevated platform to the ground when carrying out routine check to an aircraft

- (a) Most of the guard-rails at the platform had not been installed. Guard-rails were provided only at the rear of the platform while the extensible ramp was totally unfenced.
- (b) The door latch was at a horizontal distance of 0.26m away from the left side of the ramp, and at a vertical distance of 1.5m above the ramp.
- (c) The D/P was not wearing any safety belt or harness at the time of the accident, nor was there any anchorage for the attachment of safety belt or harness. He was not protected from falling to the ground while reaching out to latch the door.

- (a) A safe system of work should be developed and implemented to ensure the safety of workers carrying out inspection, maintenance and repair of aircraft at height. The system should include the following :

- carrying out a risk assessment to identify the potential hazards associated with the inspection work;
 - providing the workers with detailed method statement and clear instructions on the working procedures, associated hazards and safety precautions to be adopted during work; and
 - providing the workers with sufficient safety training specific to the inspection work, including the safe operation procedures and the precautionary measures.
- (b) Steps should be taken to prevent workers falling from height during work. Such steps should include the provision, use and maintenance of working platforms with suitable guard-rails or fencing. Where it is impracticable to provide guard-rails or fencing, suitable fall arresting system, such as safety net, safety harness and anchorage, should be provided.

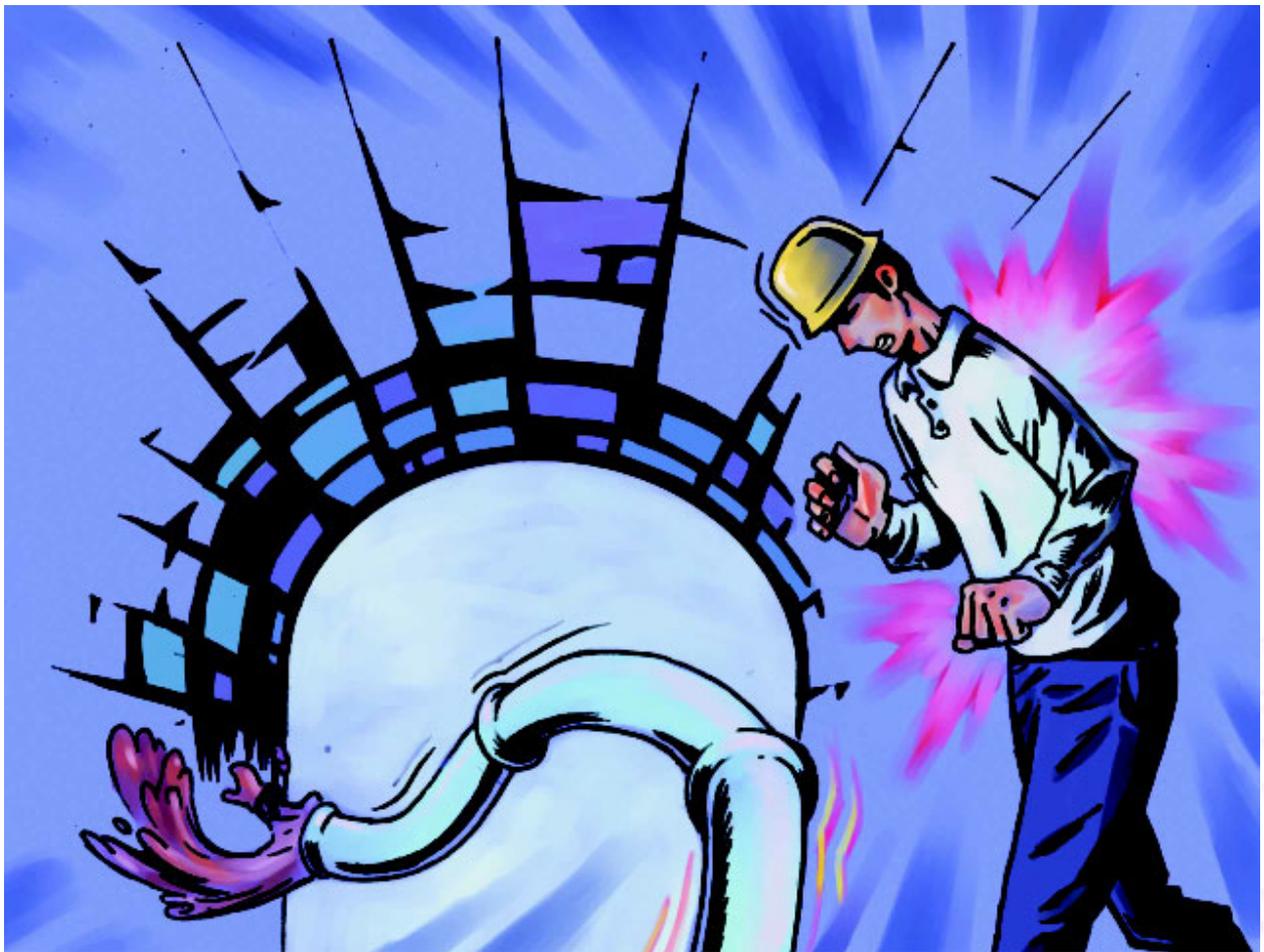
Case 8: A worker was struck by a metal pipe swinging under pressure and hit against a tunnel wall

The tunnel had a diameter of 5 metres. The pipeline involved in the accident was over 100 metres in length and had diameters 150mm externally and 125mm internally. The additional sections of the pipeline to the pit consisted of two 7.5m external arc length bent sections and two straight sections of 3m and 1m respectively. However, these sections were not secured or anchored in position by any means. With a compressed air pressure of about 0.8 MPa, the unsecured pipe end was caused to swing and led to the mishap.

Purging of the pipeline with compressed air would pose great danger if improperly handled. The site management had not established any safe system of work to identify the hazards associated with the operation and to adopt sufficient safety measures to eliminate the danger. The team members were not trained on the hazards in the job and the safety measures to be adopted, nor were they instructed on the proper steps and procedures and supervised to secure the pipeline before carrying out the purging work.

A safe system of work should be developed and implemented to eliminate the hazards and to control the risks arising from the concrete conveyance through pipeline and the associated pumping operations on the concrete residue. The system of work should include the following elements:

- (a) Detailed risk assessment should be carried out to identify the potential hazards associated with the operation of pumping concrete through pipeline and clearing concrete residue from pipeline with compressed air.
- (b) Design and construction of the pipeline should be properly planned by engineer with suitable technical knowledge and experience. Relevant method statement, instruction and plan should be provided in details to the workers for assembling the pipeline.
- (c) Adequate anchorage with suitable design, construction and spacing should be provided and maintained to secure the pipeline in position, especially at the bends and ends both of which forming an integral part of the pipeline,

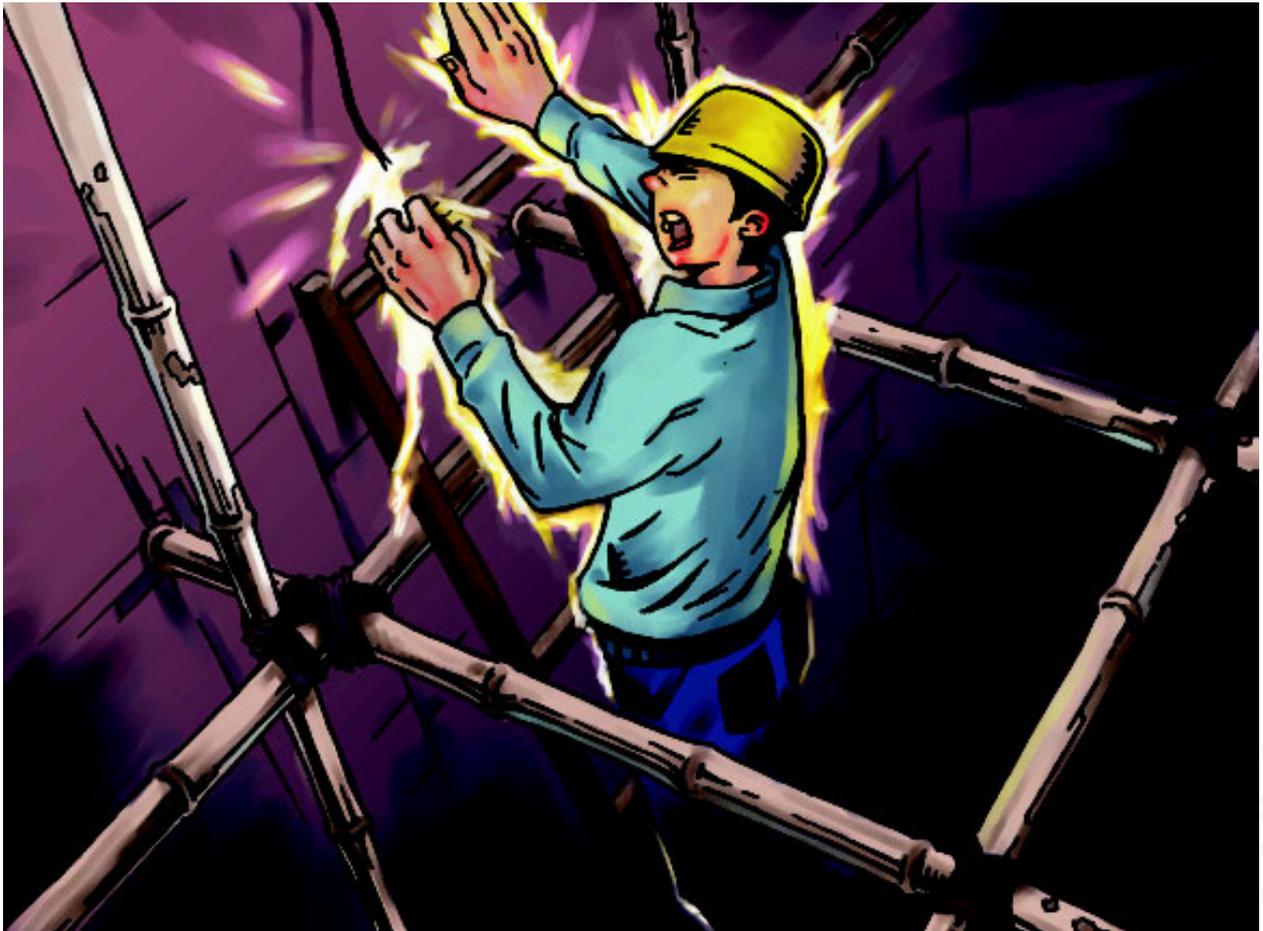
Case 9: A worker was electrocuted while working in a building under construction

After the accident, it was found that the fused spur was energized, and the lights in the shop units were switched on. While the employer was connecting one end of the cable to the fused spur, the cable was hanging on a sprinkler pipe at the ceiling, with its free end 300 mm above the bamboo scaffold, close to the wooden ladder.

It was believed that the cable was energized at time of wire connection and D/P might have touched the other end while climbing up the ladder. Burn marks were found on D/P's right hand.

- (a) Work should be conducted by a Registered Electrical Worker or under immediate supervision of an authorized person.
- (b) Fused spur unit should be rendered dead before commencing cable connection.
- (c) Clear communication should be maintained for work to be safely done.
