A Casebook of Fatal Accidents in
Lift

Installation,

**Maintenance and
Repairing Work**

This publication is prepared by the
Occupational Safety and Health Branch,
Labour Department

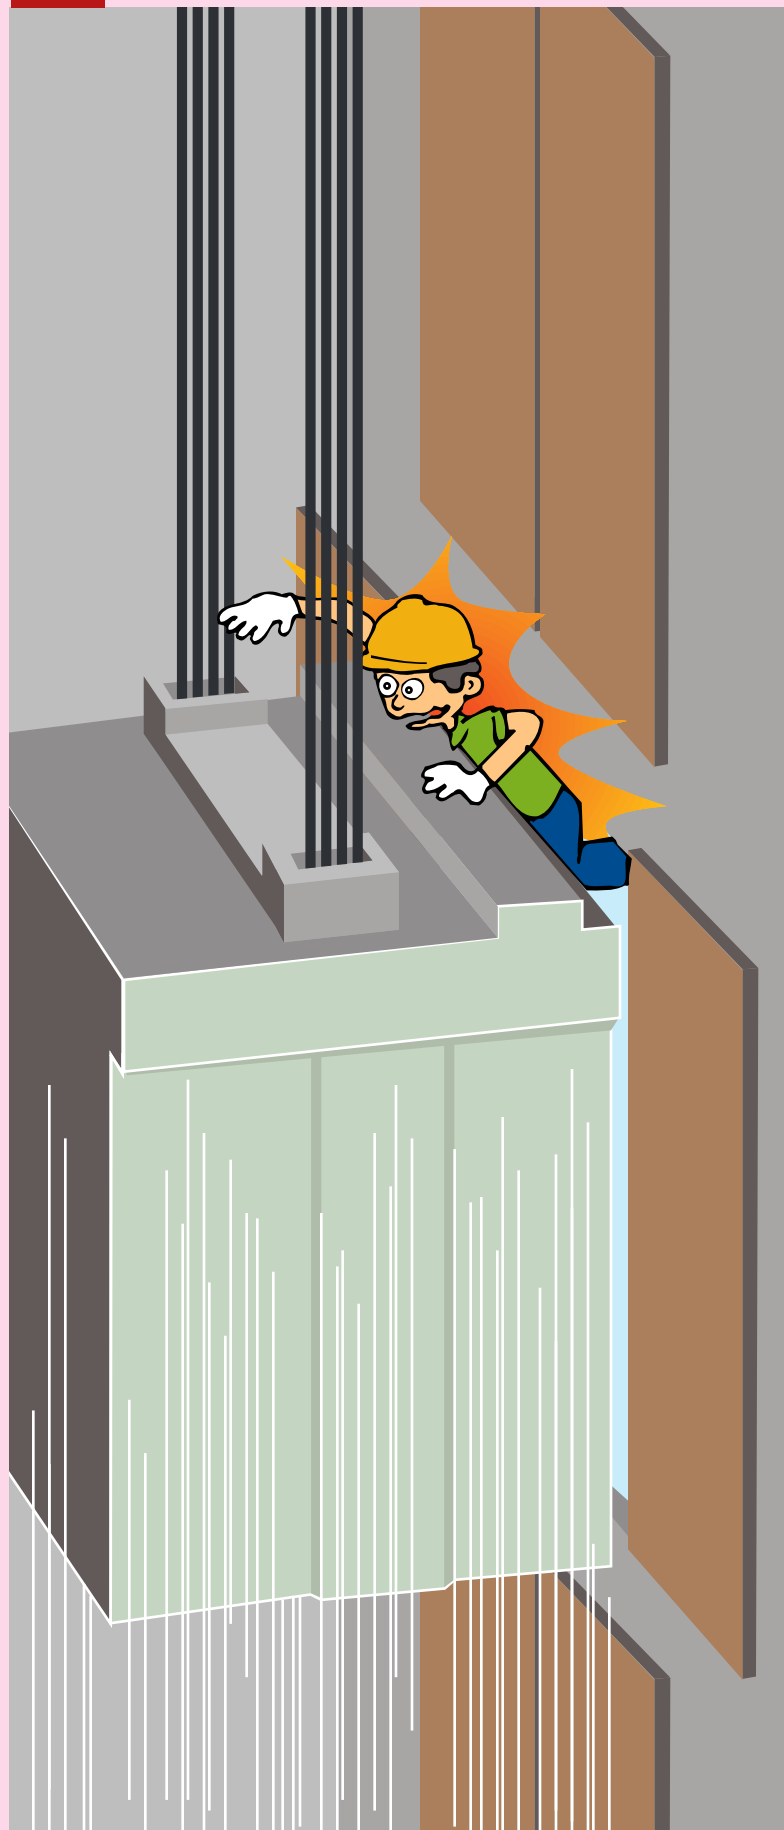
Case 1 A technician was trapped between the wall of the lift shaft and the ascending lift car

The deceased person (D/P) and two workmen were installing a lift in a building under construction. At the time of the accident, they were adjusting the clearance between the lift car and the lift shaft. The lift car was stopped half-way below the B5 floor level with both lift car and landing doors opened for the work. The D/P was standing at the B5 landing close to the top of the lift car and instructing the two workmen to adjust the clearance. Suddenly, the lift car doors closed and the lift car ascended. The D/P was dragged into the lift shaft and was trapped between the top of the lift car and the wall of the lift shaft at B4 floor level.

1. The brick that jammed on the B5 lift car doors to keep them open was displaced, and the lift car doors closed automatically.
2. There were other work activities carried out by other workmen at the lift machine room. The control unit of the lift was tampered. When the lift car doors closed, the lift car responded to calls and ascended.
3. The D/P might have worked close to the lift car with his body leaned over the car top, and was trapped by the ascending lift car.

1. Installation work to the same lift by different teams of workers should be well-planned and coordinated to prevent incompatible activities being performed at the same time.
2. As far as practicable, work at the lift machine room should be temporarily suspended with the doors locked to prevent interference to the system by other persons when work at the lift shaft is in progress.
3. The lift car should be rendered inoperative properly according to standard working procedures.
4. The workmen should be properly supervised to ensure that the safety rules are followed.

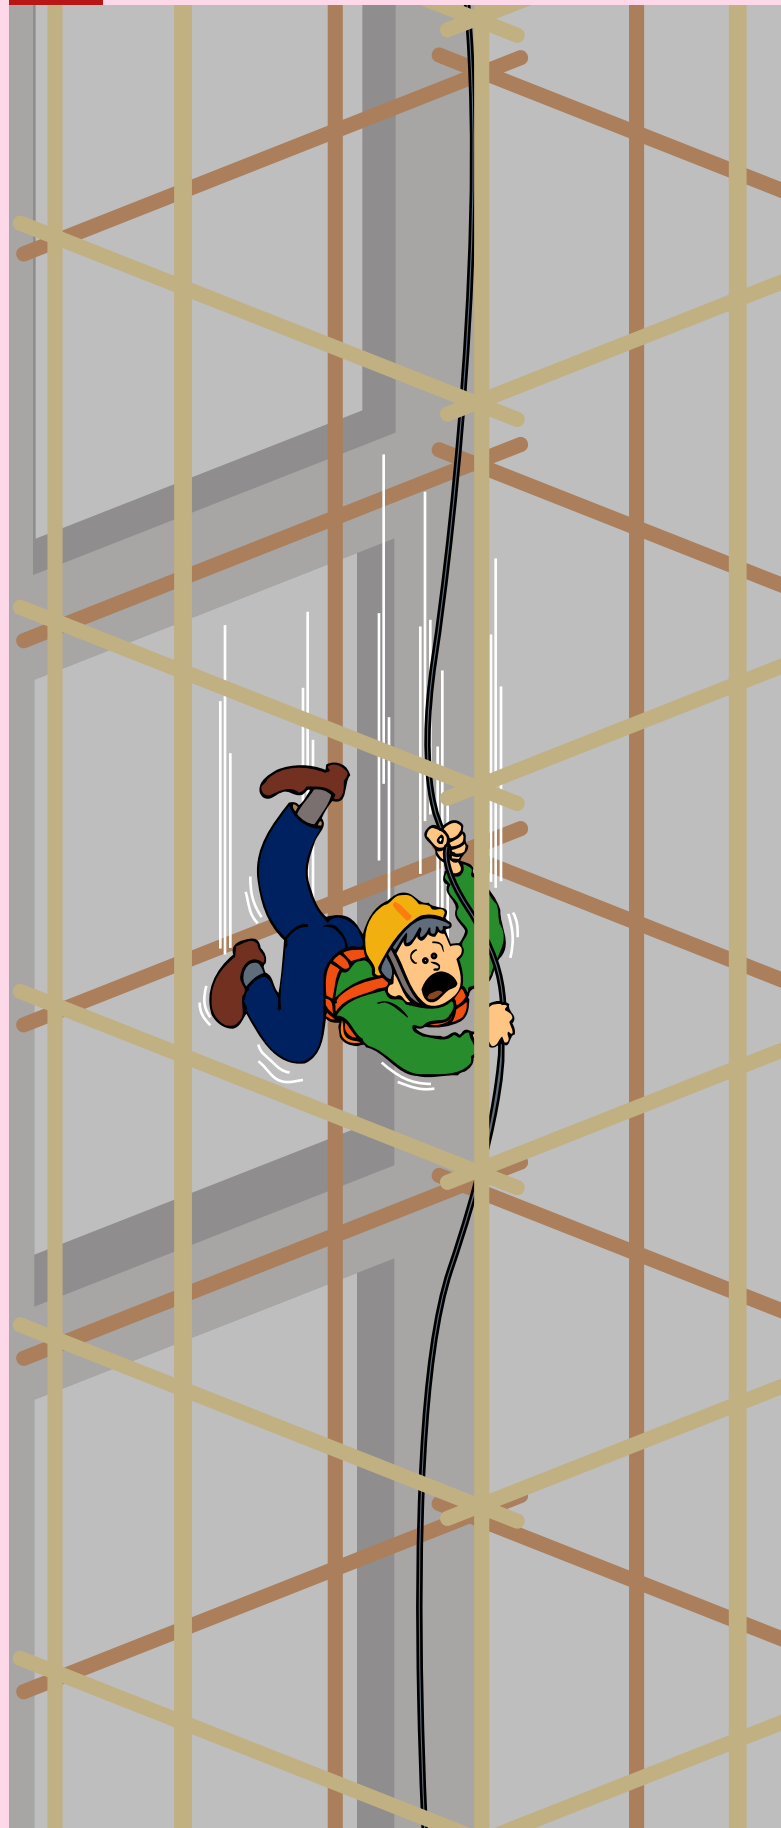
Case 2 A lift installation worker was dragged down the lift shaft by a falling wire rope

Three workmen were installing the wire rope of a lift of a building under construction. One workman stayed at the machine room on the roof to manually lower the rope down the lift shaft. The deceased person (D/P) and another workman climbed on the bamboo scaffold in the lift shaft at 35/F and 15/F levels respectively to guide the rope down. The workman at 15/F left the scaffold when the lower end of the rope reached the bottom of the lift pit. At that moment, the rope suddenly slid down from the machine room, and the D/P was dragged by the falling rope from 35/F down to the lift pit on 1/F.

1. No mechanical means was used to lower the rope down the lift shaft. In the course of its being manually lowered from the machine room, the rope might have slipped from the hands of the workman. As a result, it fell down the lift shaft.
2. No working platform was provided on the scaffold. The D/P had to climb on the scaffold to receive the rope and then attach it to a temporary suspension wire at the scaffold to support its weight after the lower end of the rope reached the bottom of the lift pit. The falling rope broke the temporary suspension wire and dragged the D/P off the scaffold down to the lift pit.
3. The D/P was wearing a safety belt but the lanyard was not attached to any anchorage.
4. There were no suitable anchorages for the attachment of safety belt.

1. Risk assessments should be conducted to identify the hazards involved in the lowering of ropes down the lift shaft and the precautionary measures to be taken. As far as practicable, mechanical means should be used for the handling of heavy load.
2. Suitable working platforms should be provided for workmen working on the scaffold in the lift shaft.
3. When the provision of working platforms in the lift shaft is impracticable, safety harnesses and suitable anchorages should be provided to prevent the fall of persons.

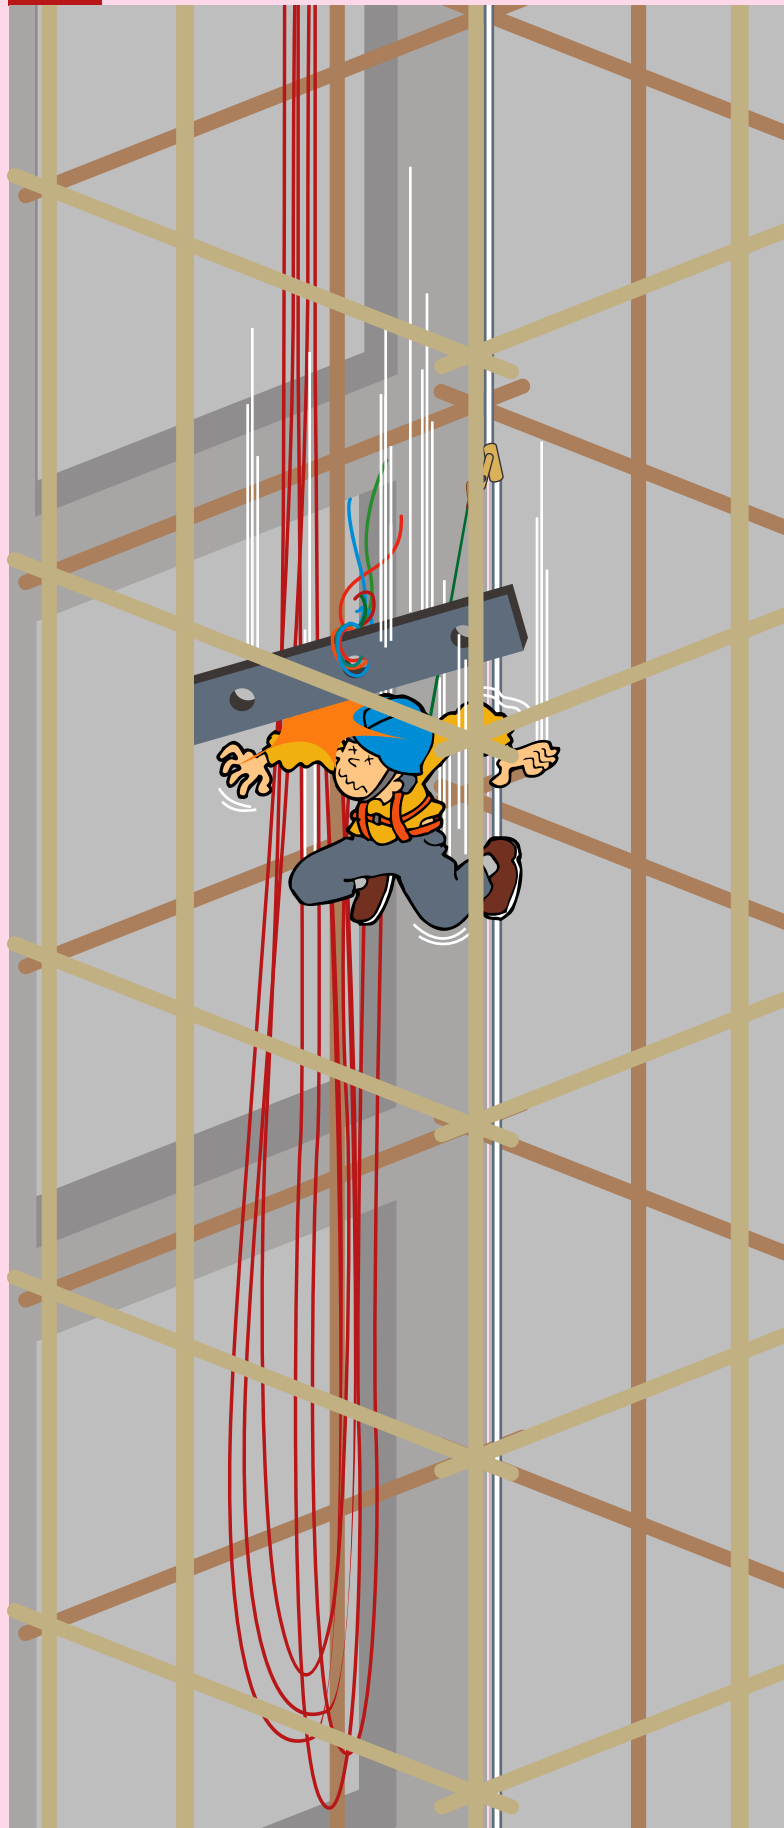
Case 3 An electrician was struck by a metal plate tied at the end of a bundle of electrical wires inside a lift shaft

Bundles of electrical wires were lowered from the machine room down a lift shaft of a building under construction. A metal plate was tied to the end of the bundles as a balance load to guide the electrical wires down. During their lowering, the metal plate was trapped at members of the bamboo scaffold inside the lift shaft. The deceased person (D/P) climbed onto the scaffold at 25/F level and tried to free the metal plate that was trapped at a higher level by pulling the loop of electrical wires that were slacking down from the above. In doing so, the metal plate became detached from members of the bamboo scaffold and fell down from floors above and hit onto the head of the D/P. The safety helmet worn by the D/P was broken by the strong impact. As a result, the D/P fell off from the scaffold but was arrested by his safety belt that was attached to an independent lifeline. The D/P subsequently died of head injury.

1. No suitable equipment were provided for guiding the bundles of electrical wires down the lift shaft steadily.
2. The metal plate used for guiding the bundles of electrical wires down the lift shaft was irregular in shape and large in size and could easily get trapped at the scaffold during the lowering of the plate and wires.
3. No proper job method was provided for removing the metal plate that was stuck at the bamboo scaffold. The job was left to the free hands of the worker.

1. A suitable balance load or guide rope should be used for guiding the electrical wires down the lift shaft to prevent the balance load or the electrical wires from being trapped at the scaffold.
2. The balance load or the electrical wires that were trapped at the scaffold should be freed at the point of entanglement and not by pulling the electrical wires from the floors below.
3. Suitable working platforms should be provided for workers working on the scaffold inside the lift shaft.

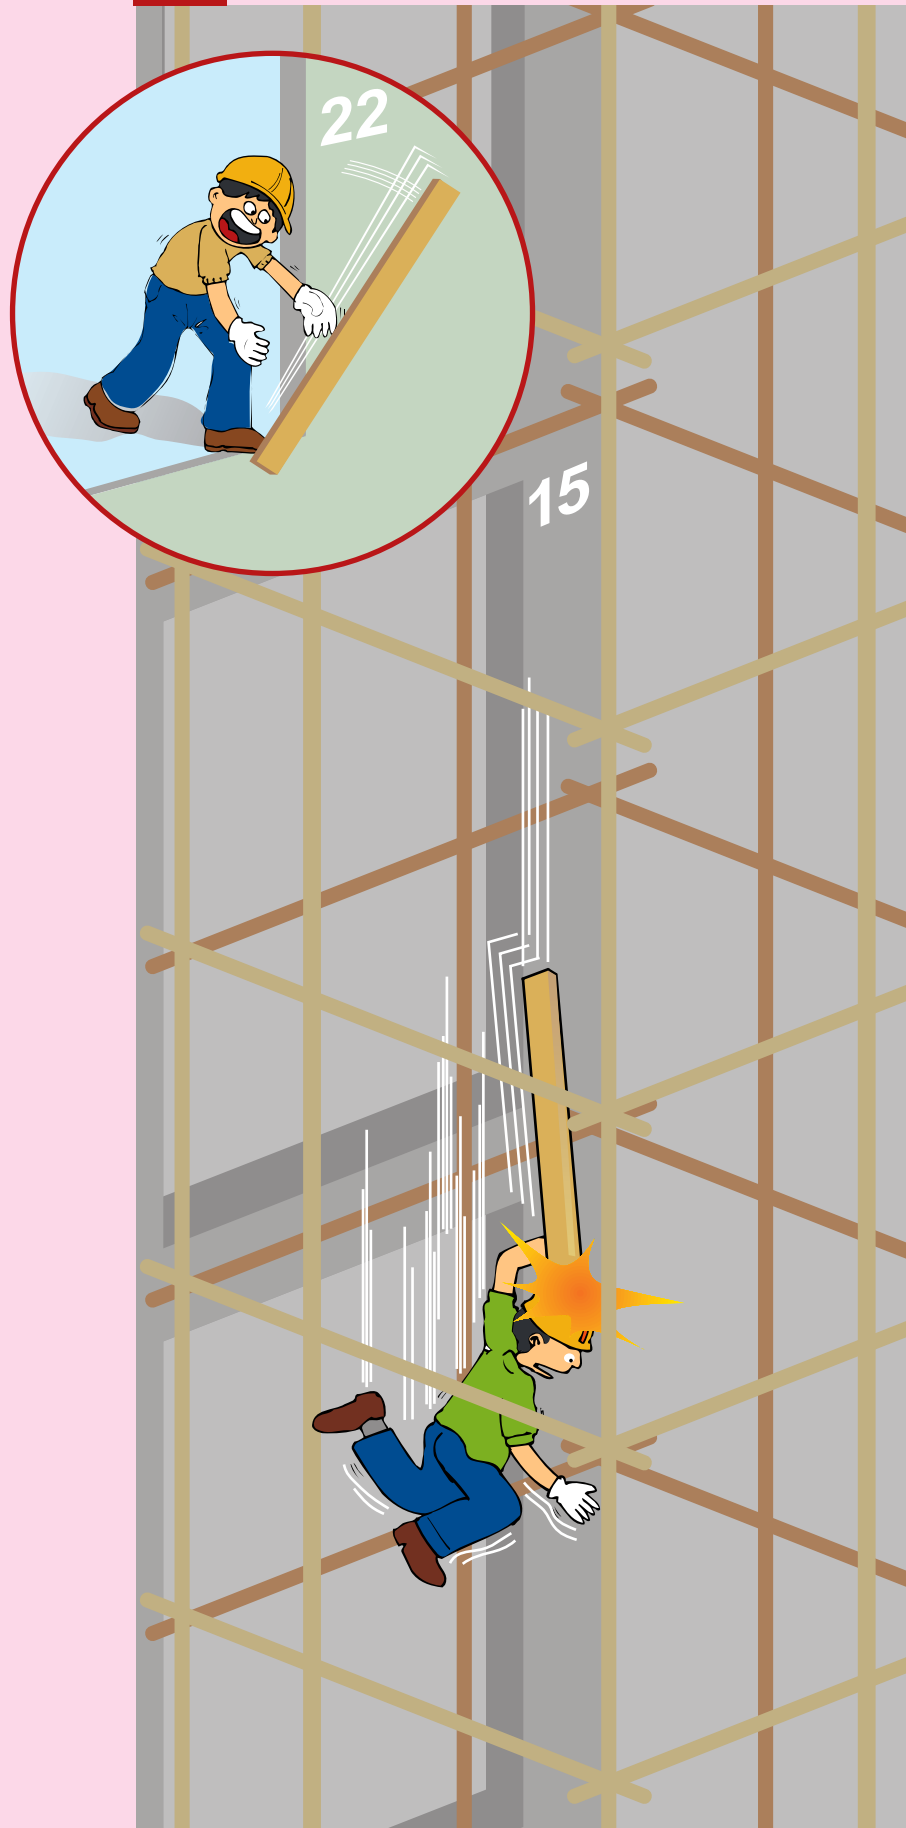
Case 4 A lift installation worker was struck by a plank fallen from height inside a lift shaft

Two groups of workers were working at different levels inside a lift shaft on a building construction site. The plastering workers were breaking the concrete of the lift door entrances on upper floors while the lift installation workers were carrying out electrical fitting-out work at the lower floors. At the time of the accident, a plank of a temporary working platform inside the lift shaft on which the plastering workers were working fell from the 22/F level of the bamboo scaffold and struck onto a lift installation worker who was riding on the scaffold at the 15/F level below. As a result, the lift installation worker fell off from the scaffold down to the lift pit on G/F.

1. There were no co-ordination and supervision for jobs inside the lift shaft to prevent incompatible activities from being performed by different parties at the same time.
2. No precaution was in place to prevent falling objects from endangering the workers working inside the lift shaft.
3. No proper working platform was provided on the scaffold inside the lift shaft to prevent the fall of persons and falling objects.
4. There were no personal protective equipment such as safety harnesses and fall arresting system provided to workers working at height.

1. Incompatible work performed by different trades at the same workplace should be properly co-ordinated to ensure the safety of the workers and other persons at work.
2. Suitable arrangement should be provided to prevent falling objects from endangering the workmen working at the site.
3. Suitable working platforms should be provided for workmen working on the scaffold in the lift shaft.
4. When the provision of working platforms in the lift shaft is impracticable, safety harnesses and suitable anchorages should be provided to prevent the fall of persons.

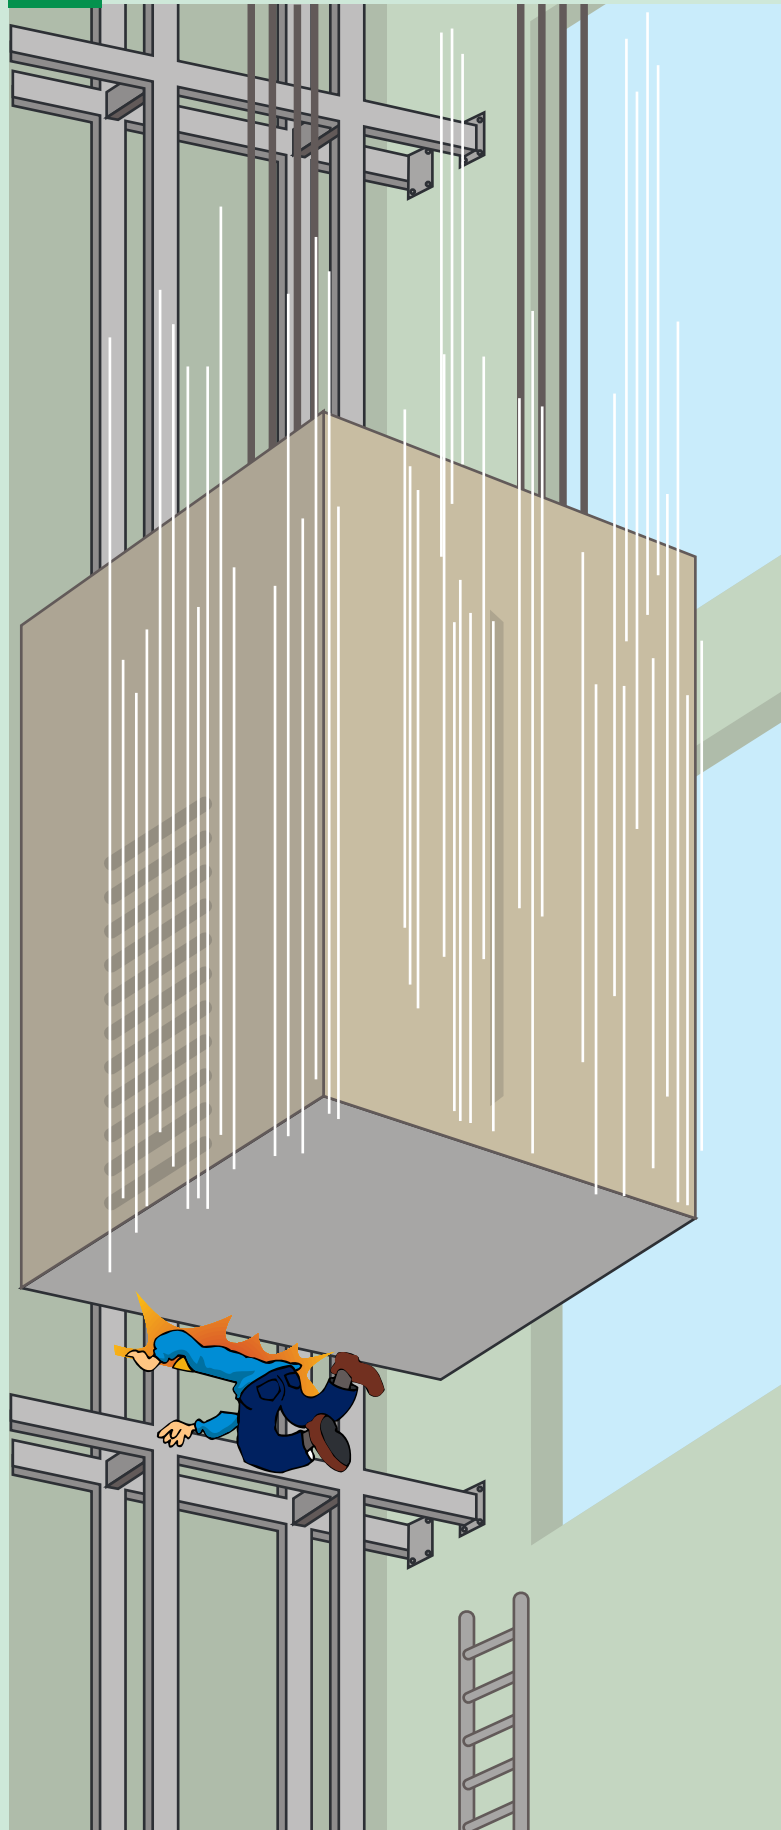
Case 5 An apprentice was trapped between the metal structure at the wall of the lift shaft and the descending lift car

The deceased person (D/P) was a lift maintenance apprentice. At the time of the accident, the D/P was standing on a cat-ladder at the bottom of a lift pit to open the lift landing doors at G/F manually. When he found the lift car approaching the G/F level from the top, he tried to stop the lift car by activating the emergency stopping device installed at a metal beam of the runway structure of the counter-balance adjacent to the cat-ladder, but was trapped there by the descending lift car.

1. The D/P was assigned to work alone in the lift pit with the landing doors at G/F closed. No one assisted him to open the landing doors from the lift lobby. Thus, the D/P had to open the landing doors inside the lift pit by himself before the lift car descended to stop at the G/F landing.
2. Workers working at different locations could not see each other but they were not provided with any effective communication devices. They communicated with one another by shouting only.
3. The D/P had not been fully trained on the job and was inexperienced in tests and trial runs of the lift.
4. No supervision was provided on the tasks performed by the team of workers.

1. Opening and closing of landing doors for entering or leaving the lift pit by workers should be safely arranged, and preferably be conducted at the lift lobby.
2. Effective means of communication, such as walkie-talkies, should be provided for the job.
3. Emergency lift car stopping device in the lift pit should be at a position such that workers can operate it safely.
4. Adequate training should be provided to the workers. As far as practicable, a worker should not be assigned to work alone and should be supervised from time to time.

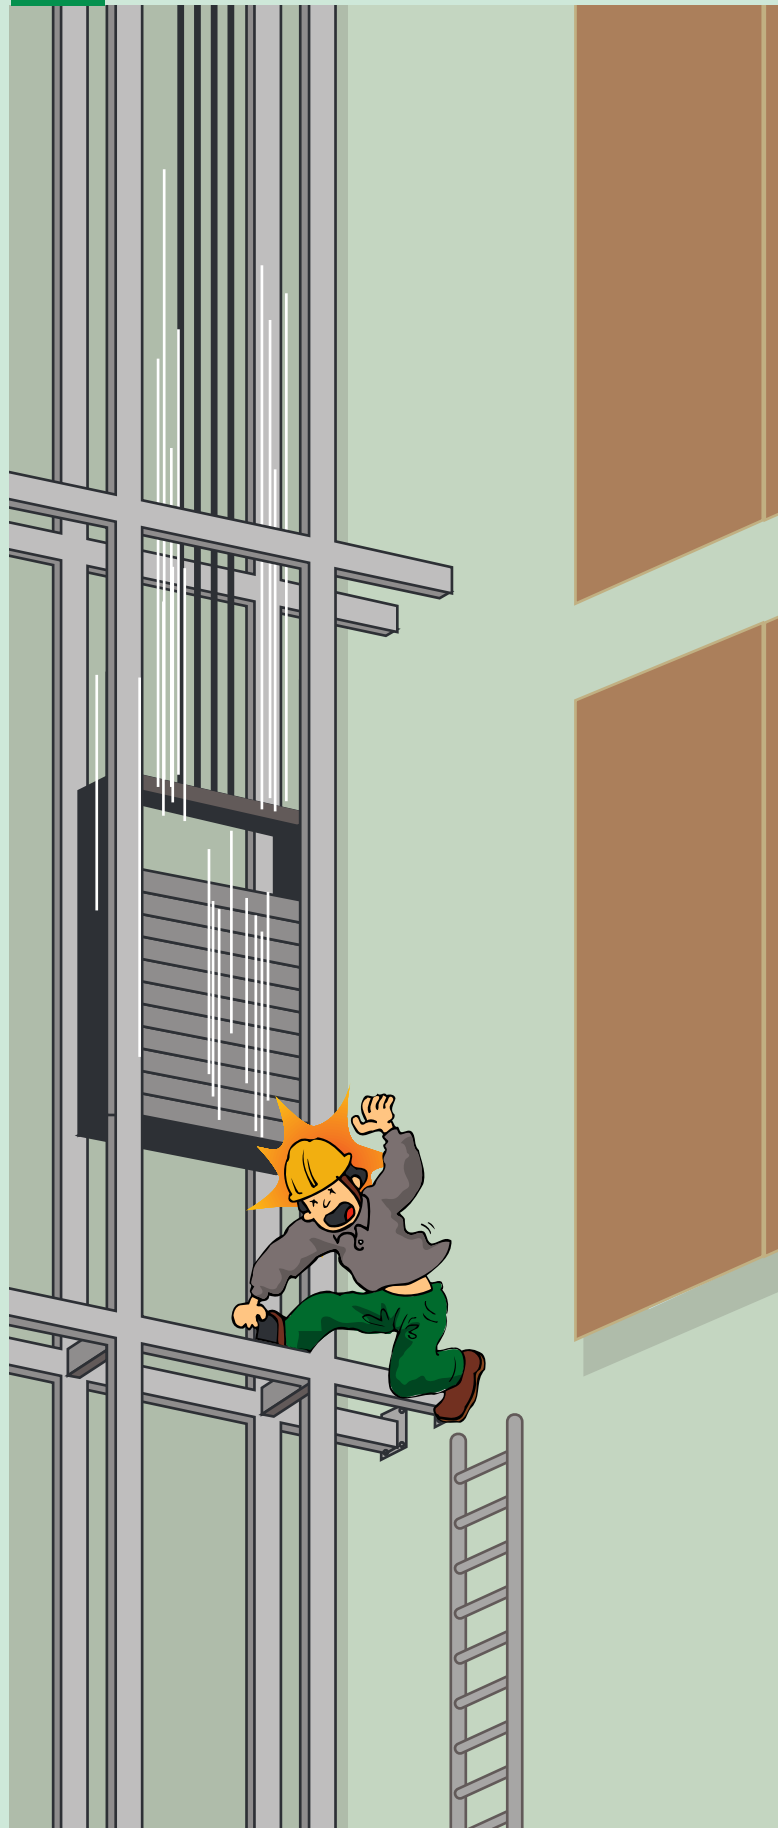
Case 6 A technician was trapped between the runway and the descending counterweight

The deceased person (D/P) was the team leader of a gang of three workmen. They were carrying out trial runs of a lift car after replacing the steel tape at the bottom of the lift pit. At the time of the accident, the lift car was stopped at the 1/F level. The D/P entered the lift shaft to make some adjustments. After that, he shouted to instruct his co-workers to ascend the lift car. When the lift car moved to the top level of the building, the counterweight, which was running in opposite direction to the lift car, reached the bottom of the lift pit and trapped the D/P who was staying at the runway of the counterweight.

1. The frame of the runway guiding the travel of the counterweight was only fenced from Upper G/F downwards. Trapping hazard existed between the frame and the moving counterweight for locations above Upper G/F.
2. There were no clear instructions and guidelines on the safe working positions for the workmen inside the lift shaft.
3. No communication devices were provided to the workmen working at different locations.

1. Risk assessments should be conducted before the commencement of lift maintenance work to identify the hazards involved and the precautionary measures to be taken.
2. Detailed working procedures in connection with working inside the lift shaft should be devised and documented.
3. Trapping zone created from the moving parts of plant should be effectively guarded.
4. Safe working positions inside the lift shaft should be clearly marked and shown, and the dangerous zone should be demarcated.
5. Effective modes of communication should be arranged with appropriate devices provided.
6. Adequate information, instruction, training and supervision should be provided to persons engaged in lift maintenance work to ensure their safety.

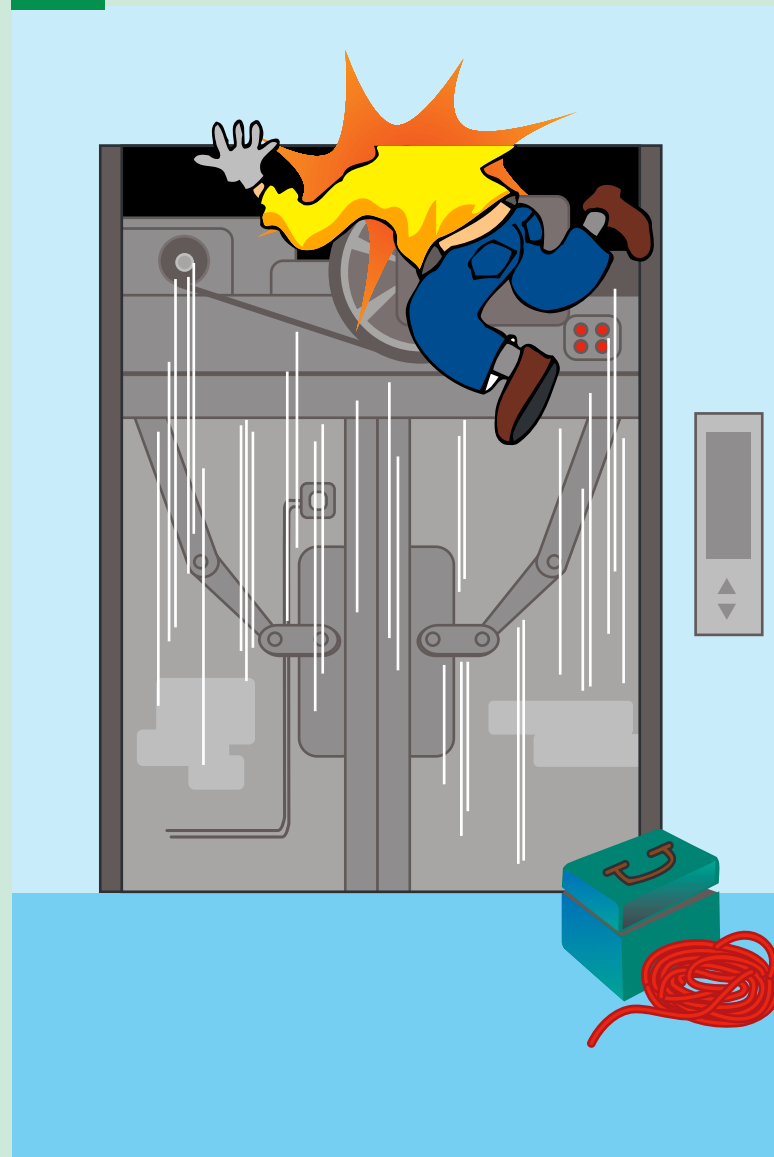
Case 7 A worker was trapped between the header of the doorway and the ascending lift car

The deceased person (D/P) was a lift maintenance apprentice. He was checking a lift together with a technician. The lift car was stopped half-way below the 1/F level. The landing doors were opened by bridging the interlock mechanism, and the control of the lift was switched to 'Inspection' mode. At the time of the accident, the technician left the site for a while, and the D/P attended the scene alone. When the technician returned, he found that the D/P was trapped between the top of the lift car and the landing door header of the doorway entrance. The control of the lift was found in the 'Normal' mode.

1. The D/P had not been fully trained and was inexperienced, but was left alone to attend the scene with the landing doors opened.
2. The D/P might have unintentionally switched the control of the lift from 'Inspection' to 'Normal' mode of operation and might not be aware that the lift would respond to new calls from other floors.
3. The D/P might have leaned his body over the top of the lift car to operate the switches, and was trapped between the top of the lift car and the header of the doorway when the lift car ascended suddenly.
4. There were no notices posted at other floor landings of the lift to inform the occupants that lift maintenance work was in progress.

1. Sufficient training, in particular the design and construction of lifts and the safety precautions associated with the maintenance work of lifts, should be provided to all workers.
2. No unskilled workers or apprentices should be left unattended in the lift machine room, on or adjacent to the top of the lift car.
3. Where the maintenance work of a lift is temporarily suspended, the landing doors should be kept closed and under lock to prevent any unauthorized entry into the car top control station.
4. A notice to prohibit the use of the lift should be posted at every floor before and during the lift maintenance work.

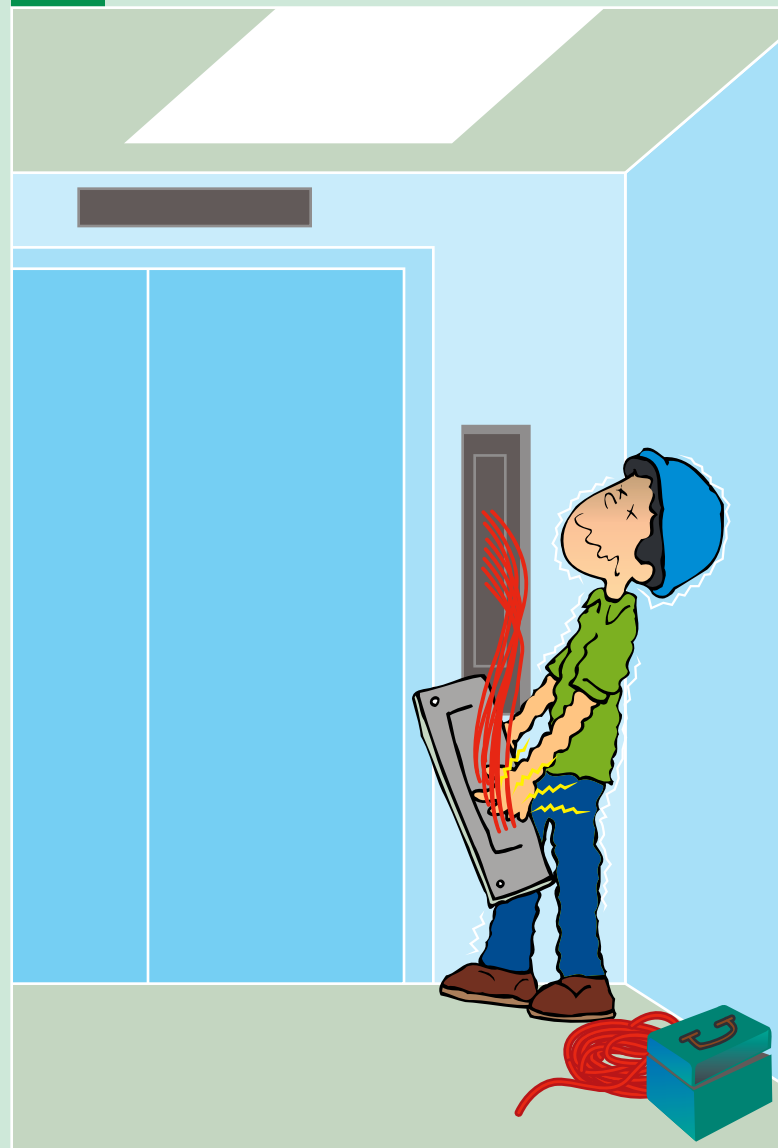
Case 8 A technician was electrocuted while repairing the electrical circuit inside the lift car

The deceased person (D/P) was a lift maintenance technician. He was repairing the faulty alarm system of a lift with another technician. At the time of the accident, the D/P removed the control panel inside the lift car and checked the electrical circuit system behind. The other technician went into the lift pit to apply lubricating oil to the jammed mechanical parts of the switches at the bottom of the lift pit. The D/P was suddenly electrocuted by the exposed wire connection of the control panel which became live when the switches at the bottom of the lift pit resumed normal operation.

1. As lighting was required inside the lift car, the main electrical supply to the circuit systems at the control panel of the lift was not switched off.
2. When the D/P was examining the control panel, he inadvertently touched the exposed conductor of the system which became live when the switches at the bottom of the lift pit resumed normal operation.
3. The D/P was not wearing any insulating hand gloves during work.

1. The electricity supply to the control panel should be switched off before carrying out repairing work on it.
2. The electricity supply to electrical circuits of the lift car should only be switched on after all the repairing work had been completed.
3. Electrically insulating protective equipment such as gloves and mats should be provided to and properly used by the workmen engaged in electrical work.
4. Lighting independent of the electrical supply system to the lift car should be provided when the electricity supply to the lift car is switched off for repairing or examination work.
