An Analysis on

Occupational Fatalities - Casebook Volume No. 2

OCCUPATIONAL SAFETY AND HEALTH BRANCH
LABOUR DEPARTMENT

This edition December 2003

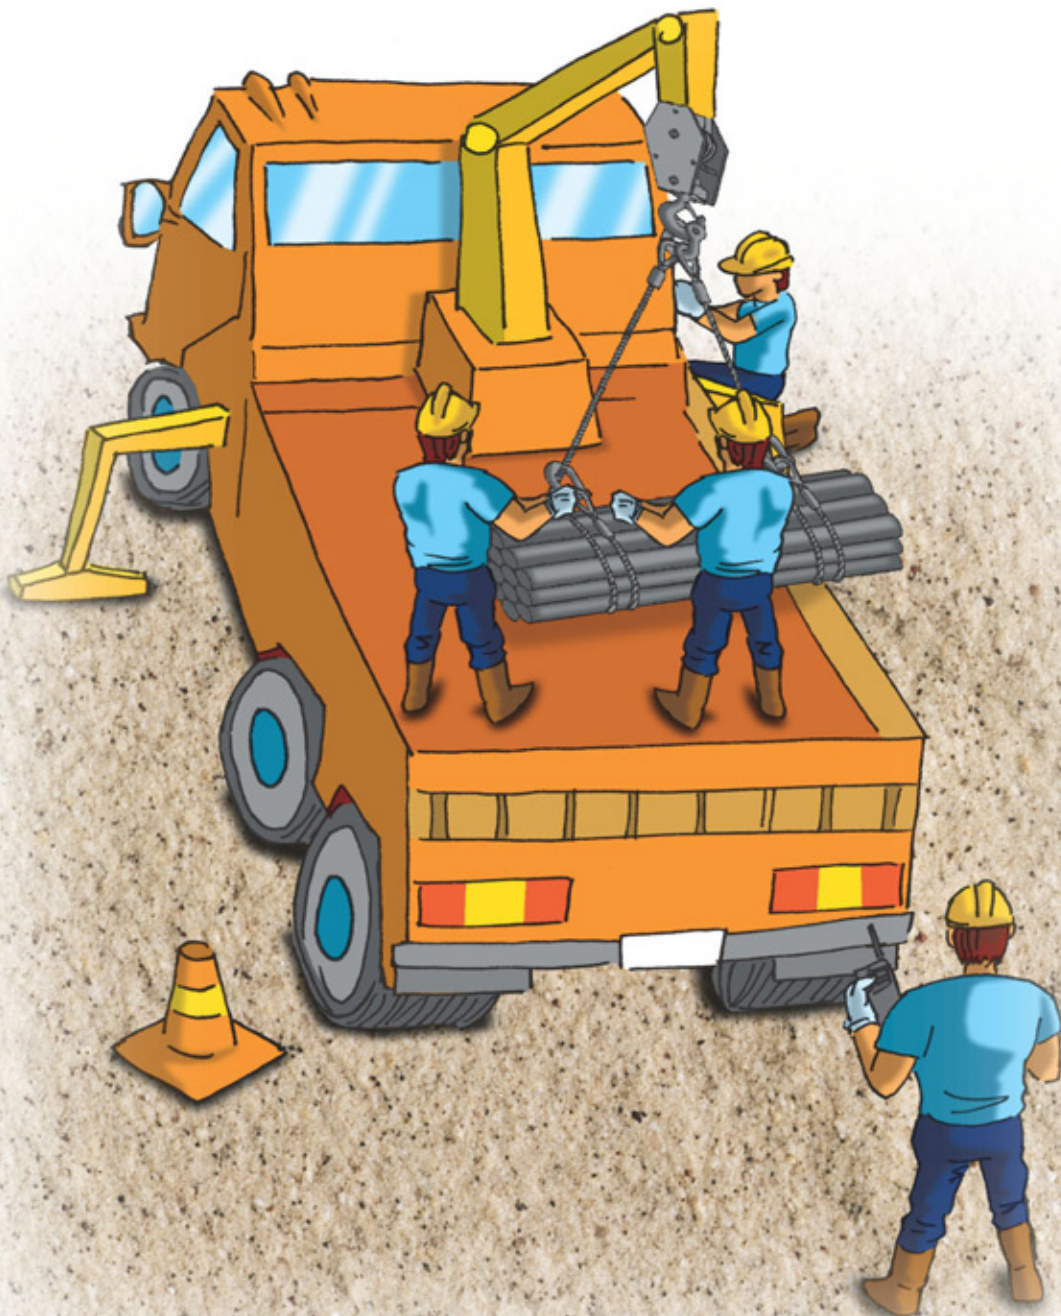
A worker sustained fatal injury during unloading work at a building demolition site

During the lifting work, the crane operator had clear and unrestricted view between the loading platform and the ground where the bundle of U-channels would be unloaded. The load was safely lifted away from the platform.

Nobody witnessed what exactly had happened to the D/P at the material time of the accident. However, based on the circumstances, it was probable that the D/P, for some reasons unknown, fell 1.25m from the loading platform down to the ground and sustained fatal injury.

- (a) Before any lifting operation begins, workers should leave the loading platform and stay away from the lifting path of the load;
- (b) Guide rope should be attached to the load being lifted and controlled by a worker at a suitable distance so as to prevent any undue movement of the load.

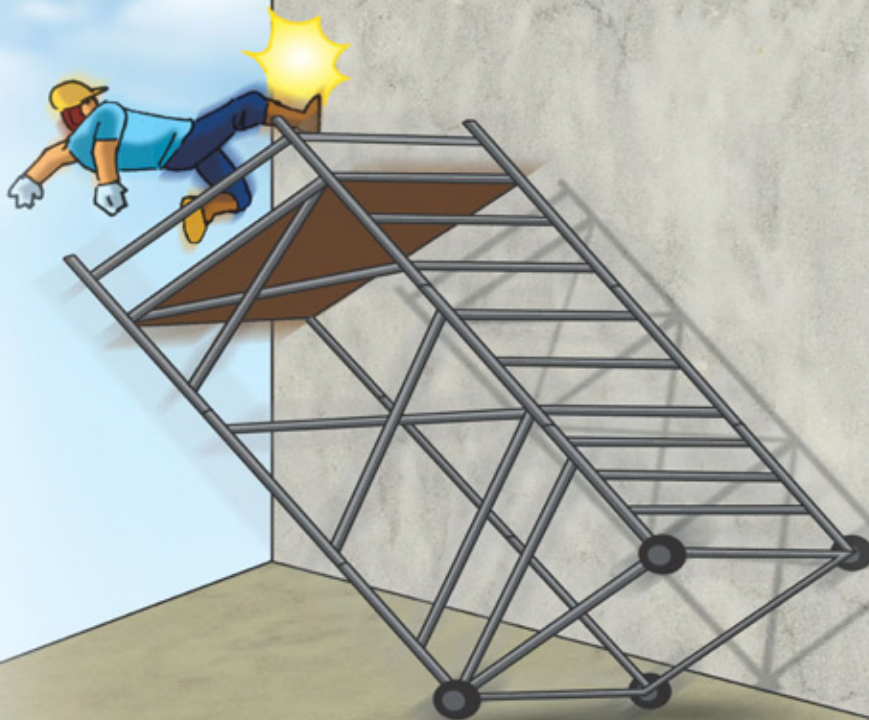
A cleaning worker fell with a collapsed mobile metal scaffold

The mobile scaffold was a 3-layered (with bottom, middle and top frames assembled together) metal scaffold. Each layer was about 2.3m high. The

end of each frame was secured together by metal sleeve couplers. The height of the scaffold was about 7.2m with base area 1.93m x 0.72m. Hence, the height to the least base dimension ratio of the scaffold was not satisfactory for stability.

The scaffold consisted of the main frames, castors, horizontal bracings and diagonal bracings. The diagonal bracings were provided for each layer, and for connecting the middle and bottom layers, but not for linking with the top layer. Hence, the scaffold was not effectively braced.

A piece of board of dimensions 1.8m x 0.6m x 8mm thick was put at a level of about 6.5m high to form a working platform. Horizontal members at a height ranging from 0.46m to 0.68m were erected around the working platform. The horizontal members above the working platform were too low to act as guardrails. There was no toe-board on the working platform.

The scaffold did not have stabilizer, nor was it tied to any structure for stability. Furthermore, for the four castors of the scaffold, only the locking devices of three of them were engaged.

The scaffold was not effectively braced, suitably assembled in accordance with the height to least base dimension ratio, adequately stabilized or secured. Movement of worker on the platform together with gust of wind appearing at the time of the accident contributed to the collapse of the scaffold.

- (a) Provision of a suitable scaffold and a working platform with particular attention to the following:
 - The height to the least base dimension ratio of the scaffold should not be greater than 3.

- When the scaffold is used outdoor, it should be tied to the building it is serving.
 - When the scaffold is used in a location exposed to high winds, the wind forces should be considered and the scaffold should be restrained by kentledge or guys.

- The scaffold should be effectively braced to ensure its stability.
 - Every side of the working platform of the scaffold should be provided with suitable guard-rails. The height of the top guard-rail should be between 900mm and 1150mm above the working platform. The height of the intermediate guard-rail should be between 450mm and 600mm above the working platform.

- Every side of the working platform should be provided with toe-board of a minimum height of 200mm.
 - The scaffold together with the working platform should be inspected and certified safe by a competent person before use.

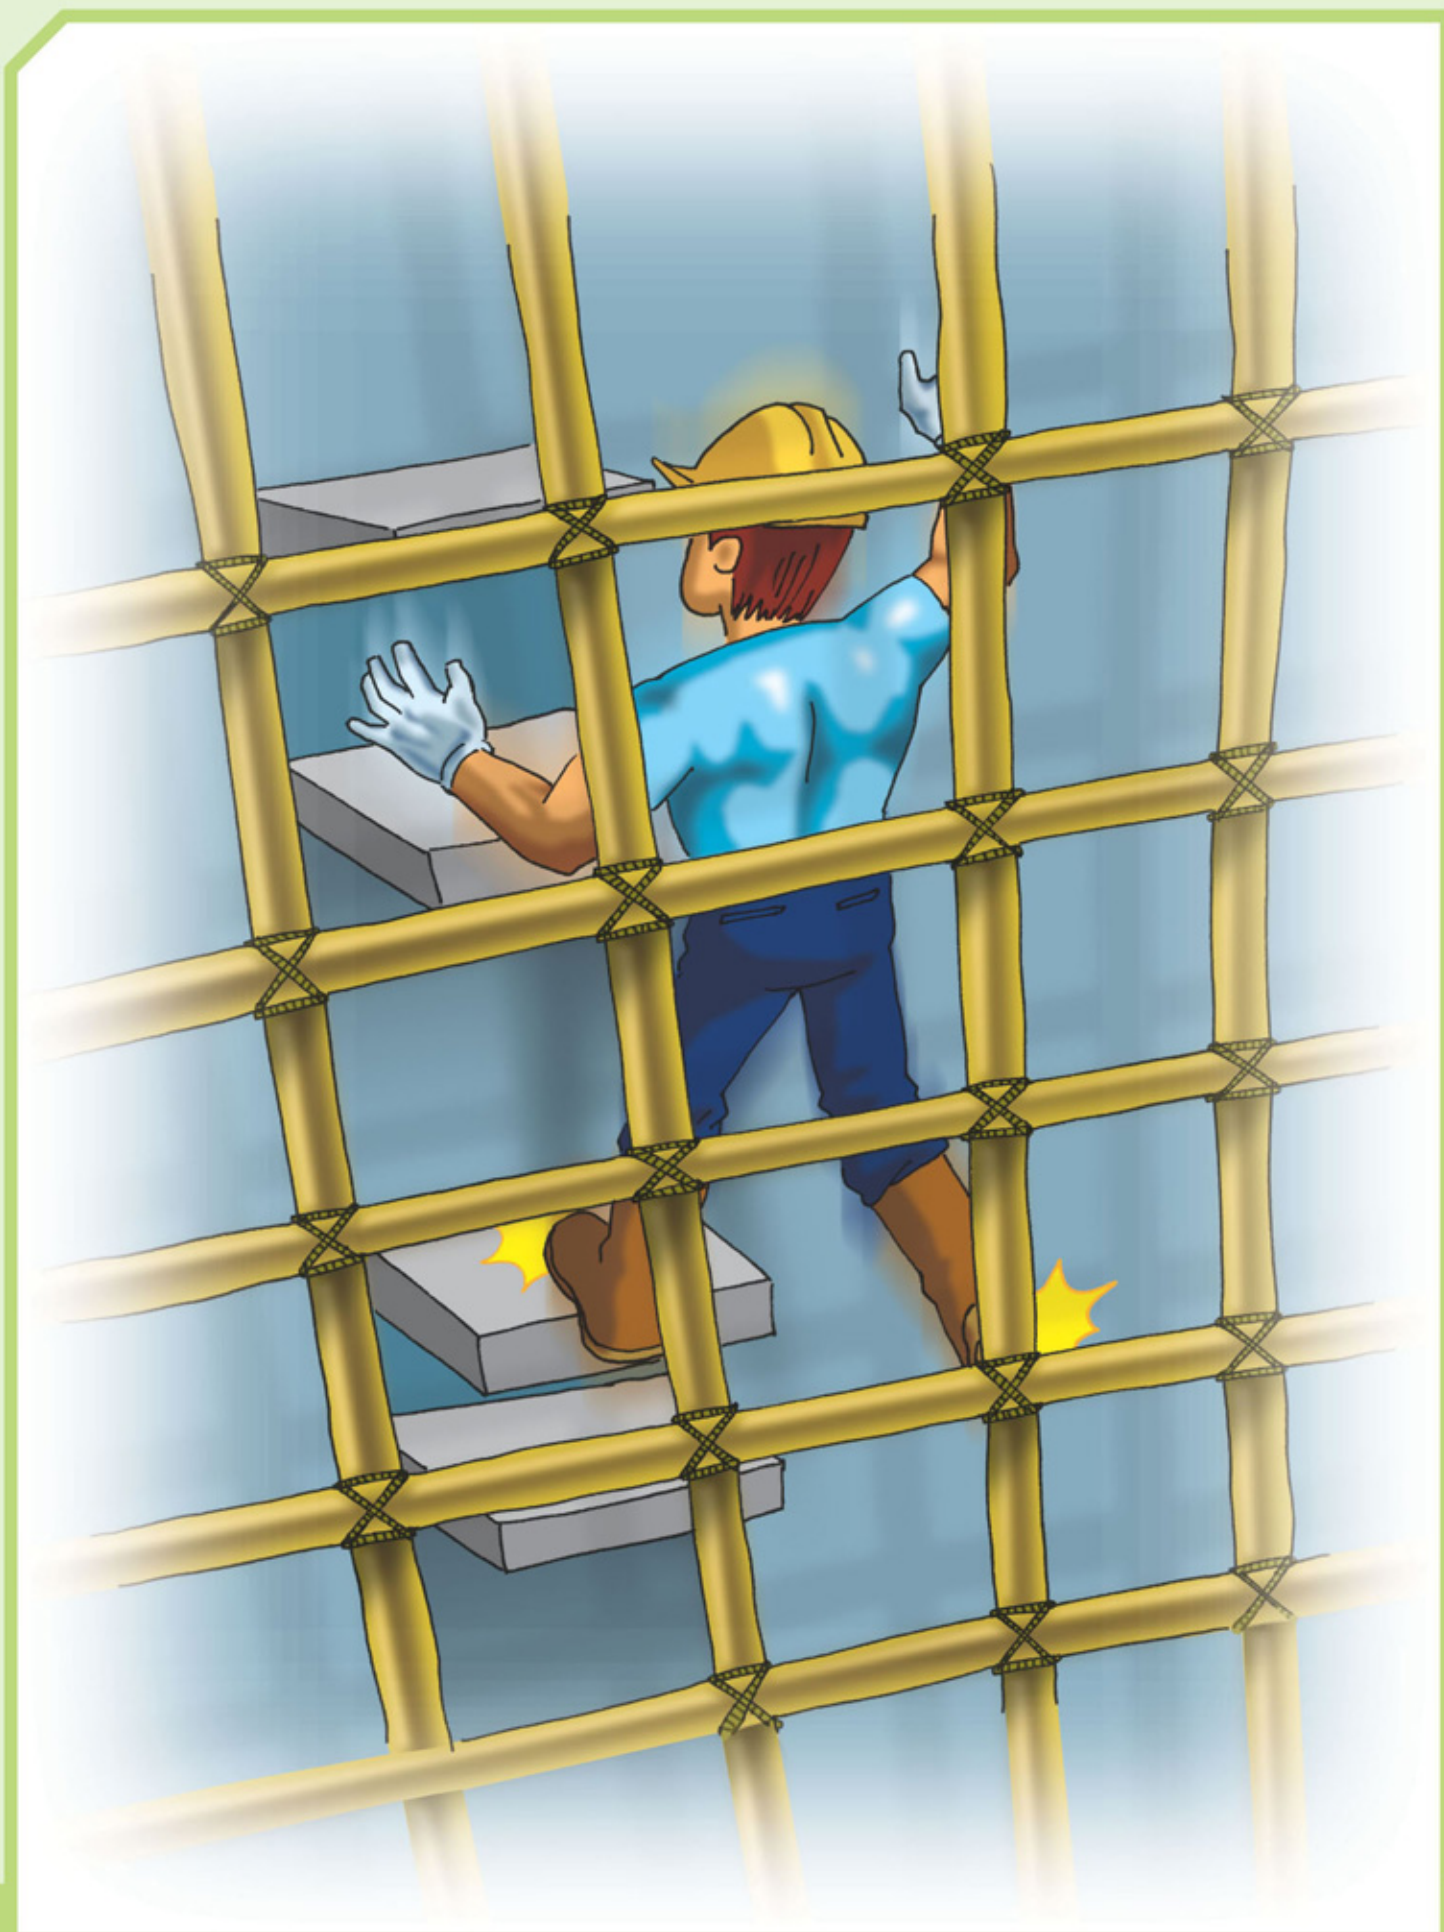
The bamboo scaffold at the external wall where the D/P was working on was a single-row bamboo scaffold, erected at a distance of 600 mm away from the external wall.

There was no plank placed on this bamboo scaffold to serve as working platform for the D/P to work there.

The lighting condition at the external wall where the accident happened was very poor. The only lighting provided was ten spotlights installed on the jib of a tower crane above the building. Sometimes, the tower crane slewed around over floor slab for other operations.

The D/P was wearing a waist type safety belt but there was no independent lifeline or other anchorage for attachment of the safety belt.

As the external wall of the 13/F was inadequately lit and there was no working platform provided on the single row bamboo scaffold, the D/P had to work in the dark and at the same time, keep balance of the body on the scaffold. It was likely that the D/P might have lost balance in the course of work and fell.

- (a) Suitable working platform for worker performing concrete smoothing work at the external wall of the building should be provided and properly maintained.
- (b) Suitable and adequate safe access to and egress from the working place at the external wall should be provided and properly maintained.
- (c) Every working place and the approach to such place should be adequately and suitably lit.

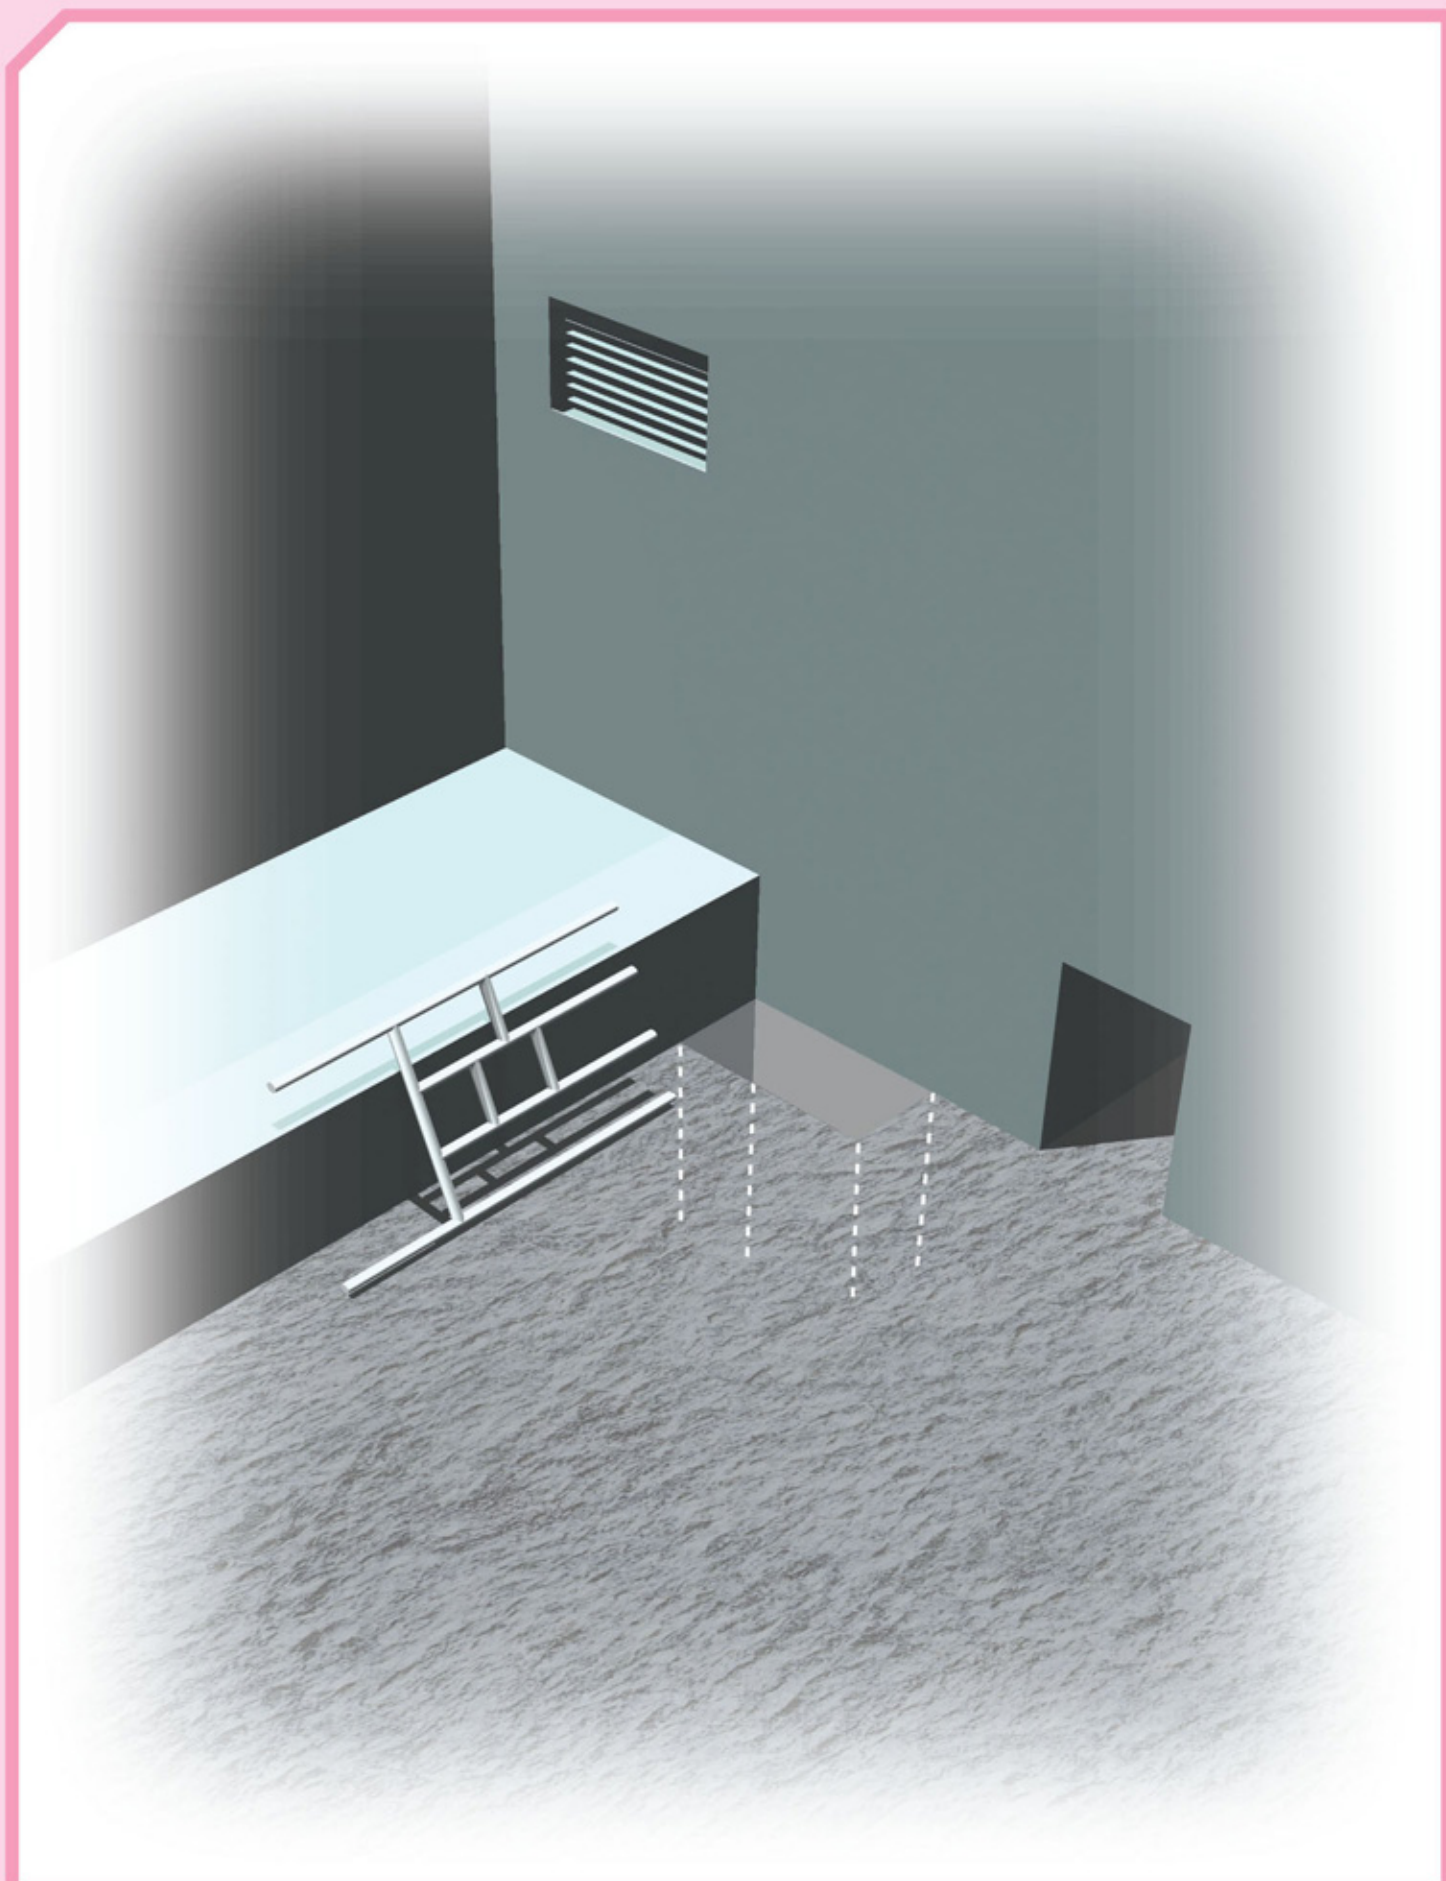
On the 1/F, a wooden board was found near the entrance of the duct chamber. It was believed that the board should have been used to prevent entry but somehow it was removed. Inside the duct chamber, there was a floor opening of about 0.7 m x 1.7 m at the right side of the entrance. This was the opening of the vertical shaft that led to the basement 14 m below where the dead body of the D/P was found. The floor opening was not protected against fall of person.

There was a raised concrete stage of 1380mm high by the side of the floor opening inside the 1/F duct chamber.

The crevice to be sealed up was 1510 mm above the stage. A metal scaffold component of 1080 mm wide and 1500 mm high was leaning against the stage. This scaffold component might have been used for access to the stage.

No eyewitness could confirm what the D/P was actually doing prior to the accident. Judging from the circumstantial evidences, it was believed that the D/P might have entered the 1/F duct chamber, probably for preparing the sealing up work. Somehow, he fell through the vertical shaft 14 metres to the basement.

- (a) If any work inside the duct chamber is required, the floor opening has to be properly fenced or covered against fall before the work commences.
- (b) A safe system of work should be developed and implemented, including proper authorization for entry into a place where falling hazard exists.
- (c) Suitable and sufficient training, information, instruction and supervision should be provided to ensure the work could be completed safely.

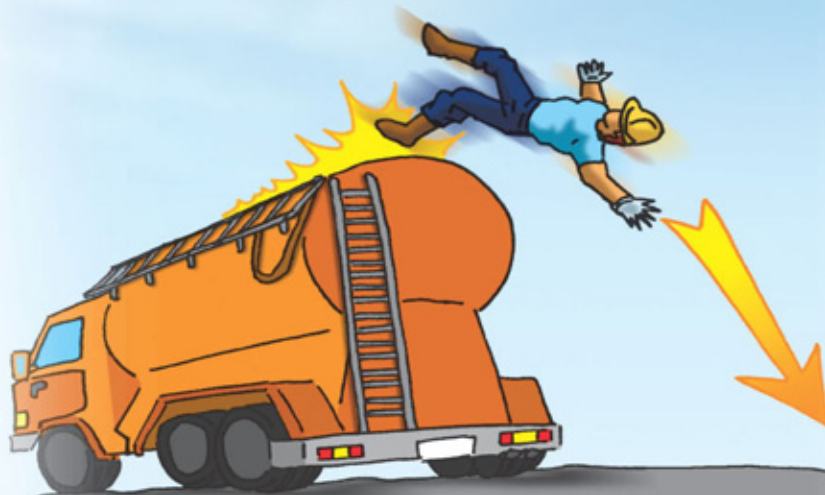
A driver fell from the top of a cement tanker at a concrete batching plant

The concrete batching plant was not equipped with automatic sprinkler system, nor proper working platform for cleaning of a cement tanker. In order to clean the top of cement tankers, the practice of cement tanker drivers was to climb up the rear ladder to the top of the tanker with a water hose.

tanker, he should have been protected from falling from the sides by the foldable guardrails had they been properly erected. However, falling hazard still existed at the front and rear ends at the top of the cement tanker where no guardrail was available. Furthermore, falling hazard also existed when a cement tanker driver was climbing on the rear ladder in particular with one hand carrying a water hose, since no fall arresting equipment was provided.

Worker must be prohibited from working on the top of a cement tanker unless a safe system of work has been established and adopted. The safe system of work should include:

- (a) The carrying out of a risk assessment for working on the top of the tanker;
- (b) The development and implementation of safe procedures for relevant work;
- (c) The provision and maintenance of suitable guardrails on the top of the cement tanker to prevent persons working thereon from falling;
- (d) The provision and maintenance of suitable means of access to and egress from the top of the cement tanker;
- (e) The provision, maintenance and use of suitable fall arresting equipment and anchorage where necessary;
- (f) The provision of training, information, instruction and supervision to the worker in relation to safety at work on the top of the cement tanker.

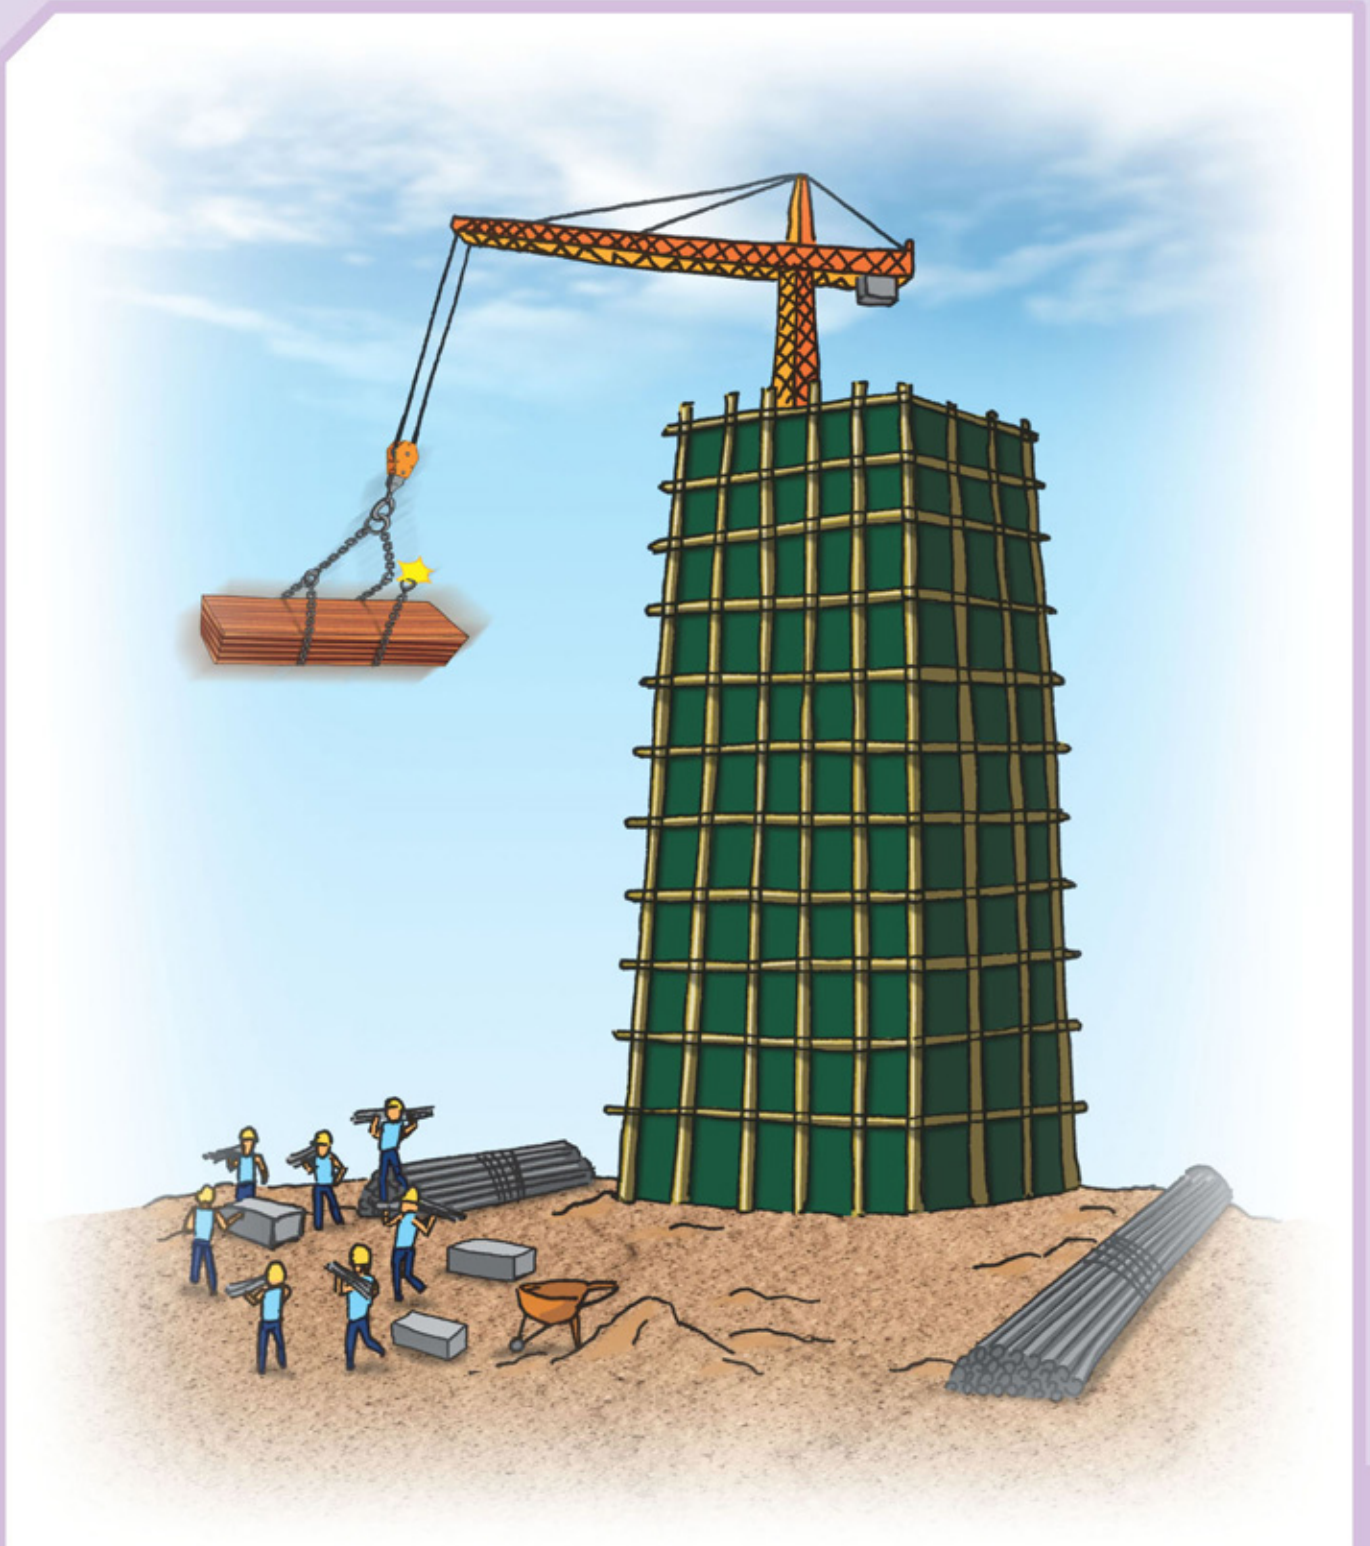
Two workers struck by wooden boards that fell during a lifting operation on a construction site

No damage or defect was found on the metal chain slings. The latch hooks of the sling were in normal condition and their locking mechanisms could work properly. Workers had to close the latch hooks properly in order to actuate the locking mechanisms. Since the latch hooks could appear to have been locked, they should check them with hands on each occasion. However, the rigging worker only conducted a visual check.

The choker hitch formed by each metal chain sling could not completely grip the wooden boards which were loosely gathered. Besides, the wooden boards had been used before and some of them had even deformed with nails and debris on the surfaces. They might slip or displace during lifting when there were no other means to tighten them up.

It was believed that the stack of wooden boards detached at the material time of the accident because the latch hook of a leg of the metal chain sling had not been fully locked. In the course of the lifting, the latch hook detached from the sling due to the swaying motion of the wooden boards. Consequently, the wooden boards scattered and fell.

- (a) The wooden boards should be adequately secured before lifting. Suitable receptacle could be used to contain them to prevent slipping or displacement.

- (b) A safe system of work for lifting of wooden boards should be established and adopted so as to ensure the safety of workers and other persons who are likely to be affected by the work. The system of work should include, but not limit to, the following:

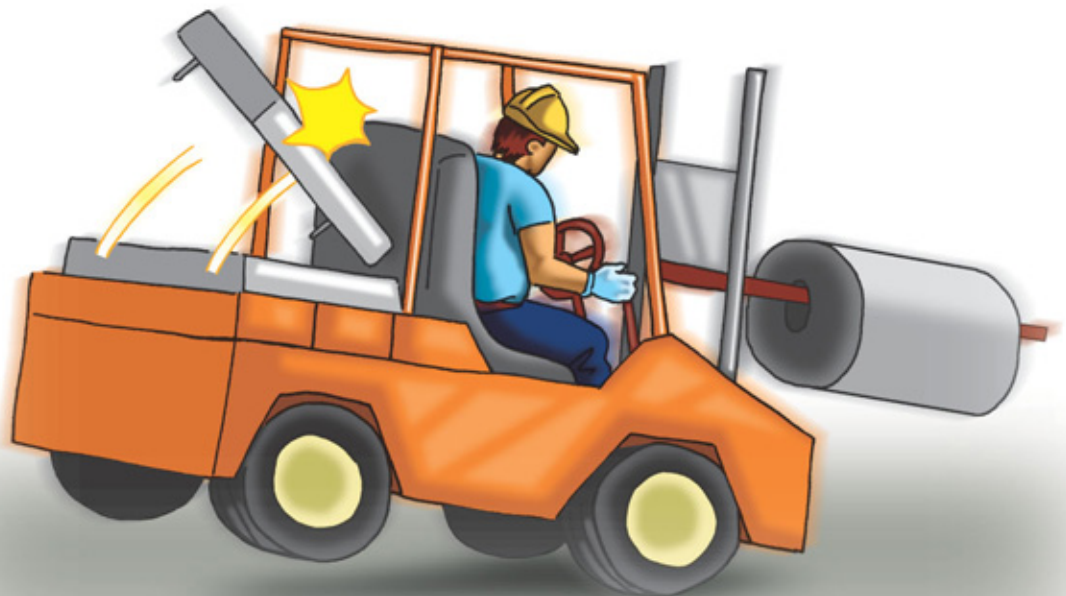
An operator of a forklift truck hit by a detachable counterweight of the truck

The forklift truck had 4 front wheels and 2 rear wheels. The threads of the front wheels had worn out. Only the front wheels were linked to the braking system while the rear wheels were for steering purpose only. In case of an emergency braking during travelling with excessive load at high speed, the chance of tipping up would increase.

A homemade metal counterweight of semi-circular shape (110 mm diameter, 140 mm thick and 760kg in weight) was affixed to another counterweight at the tail part of the truck so as to increase the lifting capacity. It had two projecting rods (30mm in diameter and 180 mm in length) on its underside for inserting into the holes of the counterweight of the truck.

It was possible that the D/P, while operating the forklift truck at quite a speed and coming close to the railway track, might have applied brake upon entering the undulated surface there. The metal sheet roll shifted forward, and so did its centre of gravity. That caused the forklift truck to tilt forward. Since the extra counterweight had not been secured in position, it dislodged and hit the D/P from the back.

- (a) No forklift truck should be allowed to lift a load that exceeds the safe working load of the truck.
- (b) Use of forklift truck with additional counterweight should be prohibited unless it has got approval from the manufacturer.
- (c) A safe system of work should be provided and maintained for operating forklift trucks. The system should include:
 - Risk assessment and proper planning for the work;
 - Provision and use of suitable forklift truck;
 - Provision of safe work procedure, instruction and supervision; and
 - Specification of safe driving speed within the workplace.

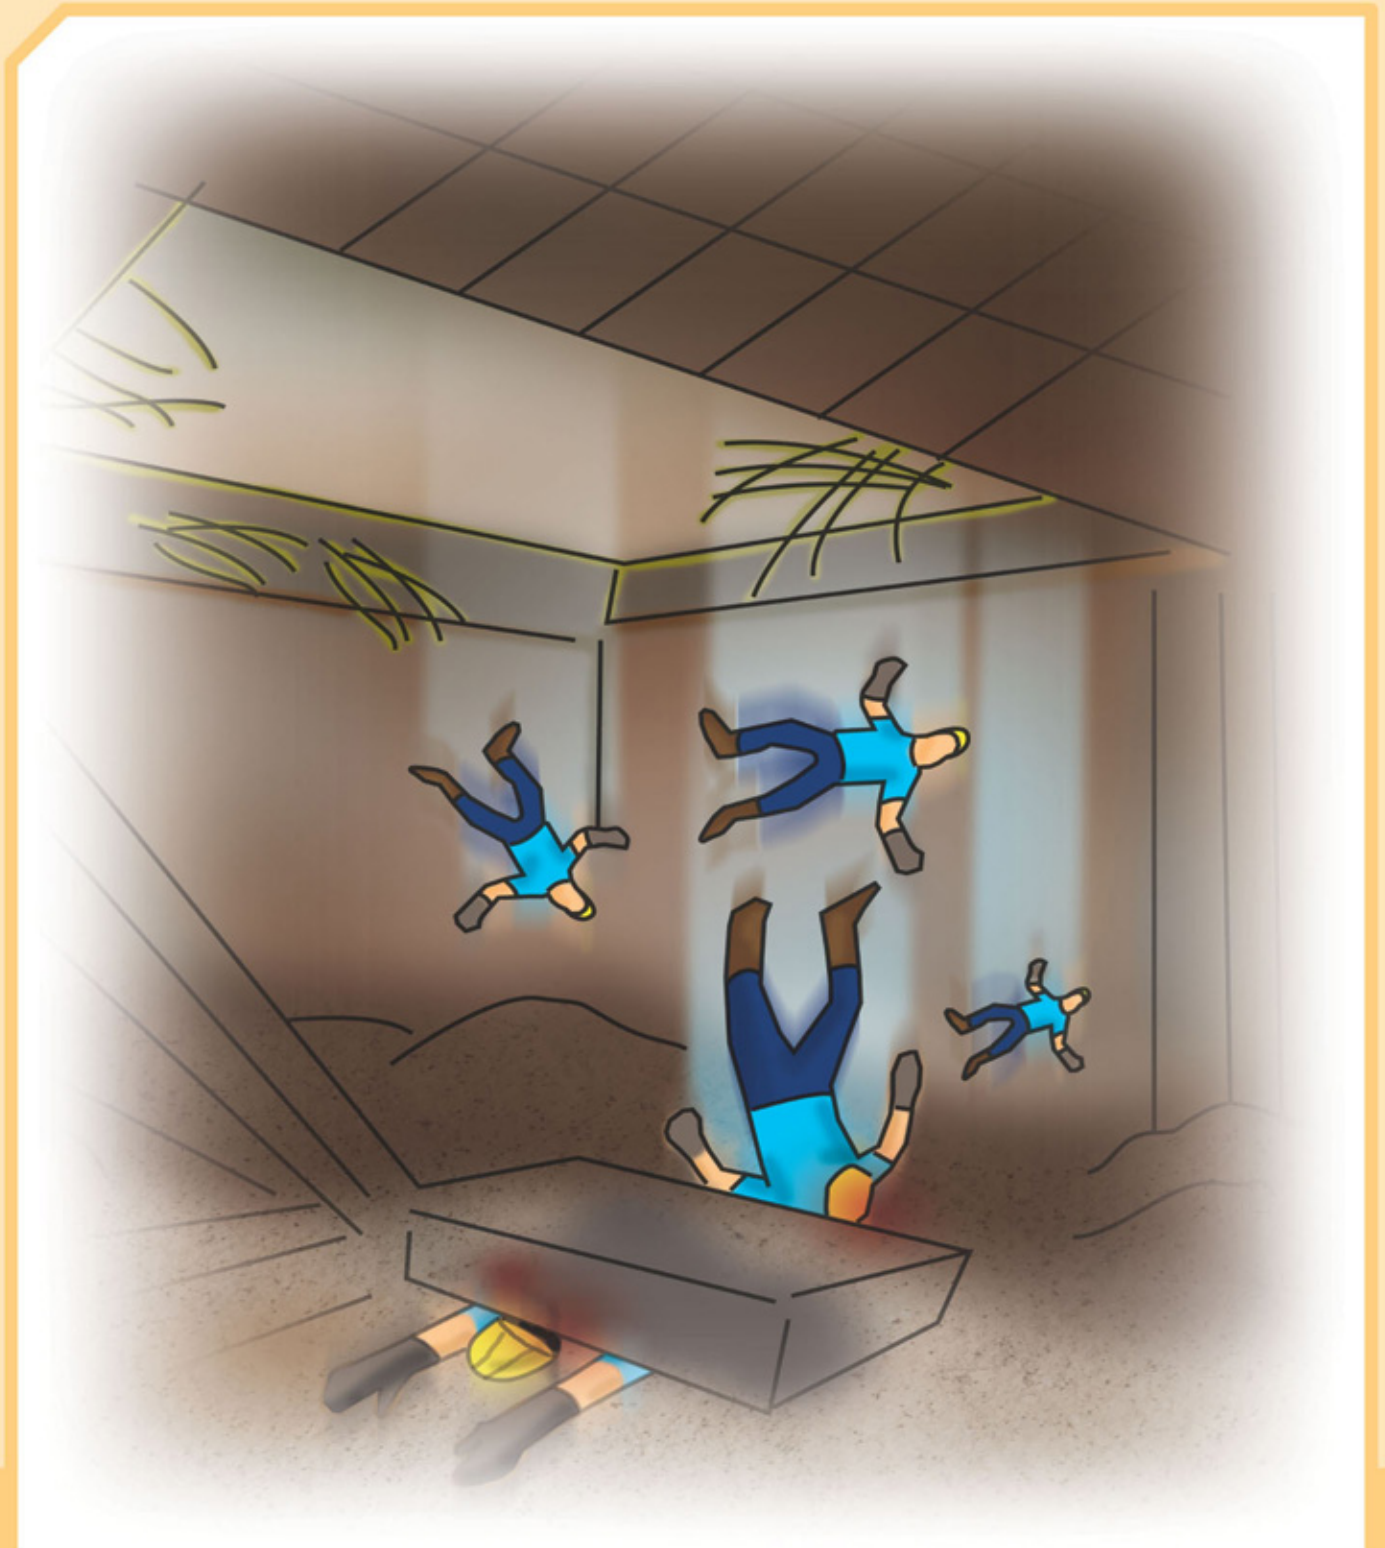
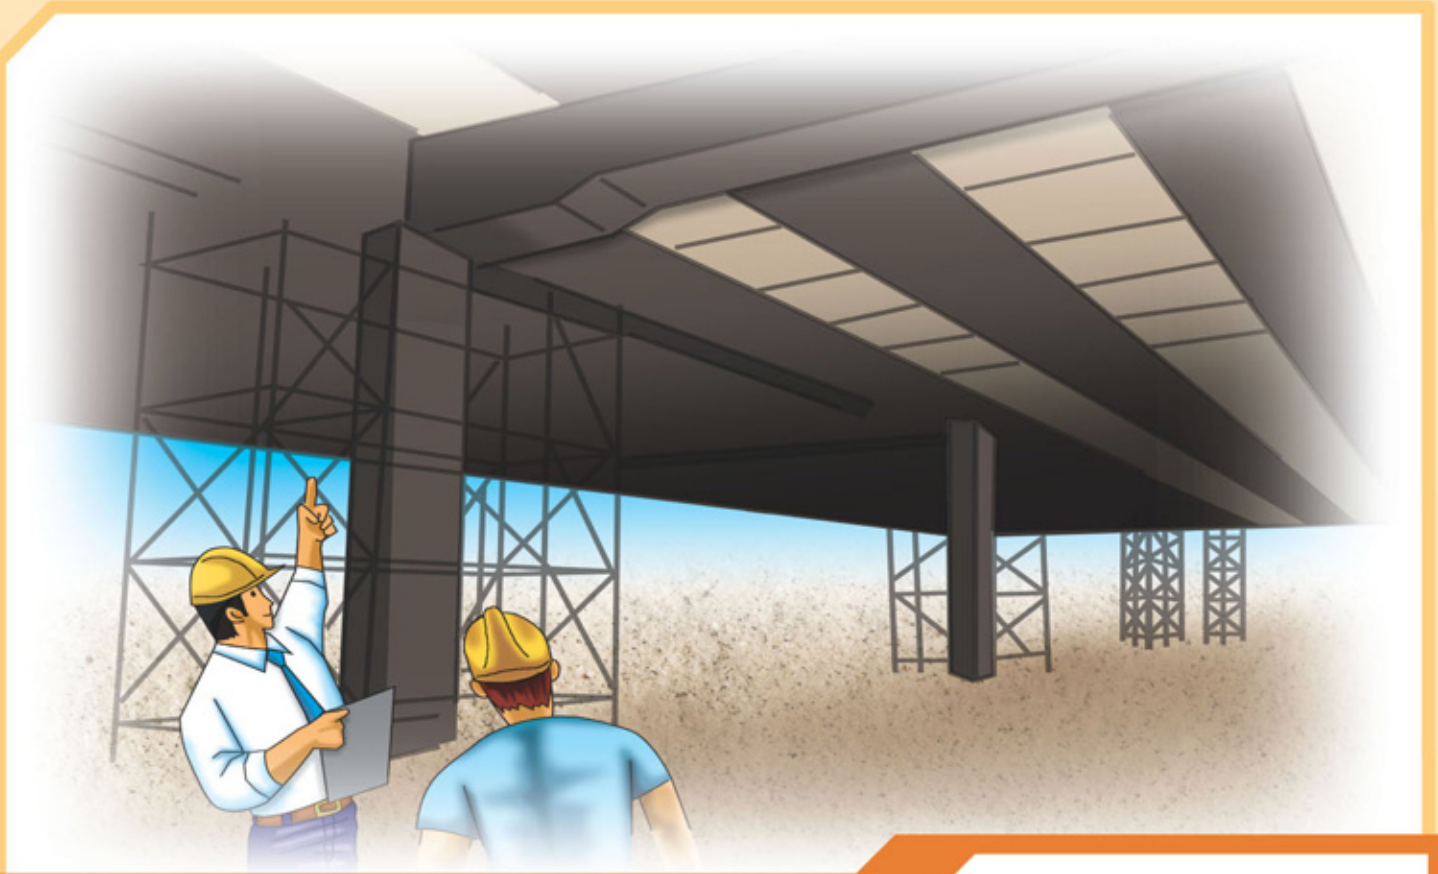
A worker was crushed to death by collapsed structures during concreting work

(a) Missing members of the collapsed tubular tower

No diagonal braces were fitted to the two vertical faces of the tower, thereby greatly reducing its lateral resistance. Moreover, there were no lateral braces for tying the tower to any existing structures to secure its lateral stability. As the concrete was being laid at the time of the accident, the tower failed under the increasing superimposed load.

(e) Vibration due to the concreting

Although the concreting workers did not notice any abnormal vibration from the concrete delivering pipe and the concrete vibrator during the concreting, it was probable that these operations and related work activities emanated considerable disturbance causing the supporting tubular towers below to sway.

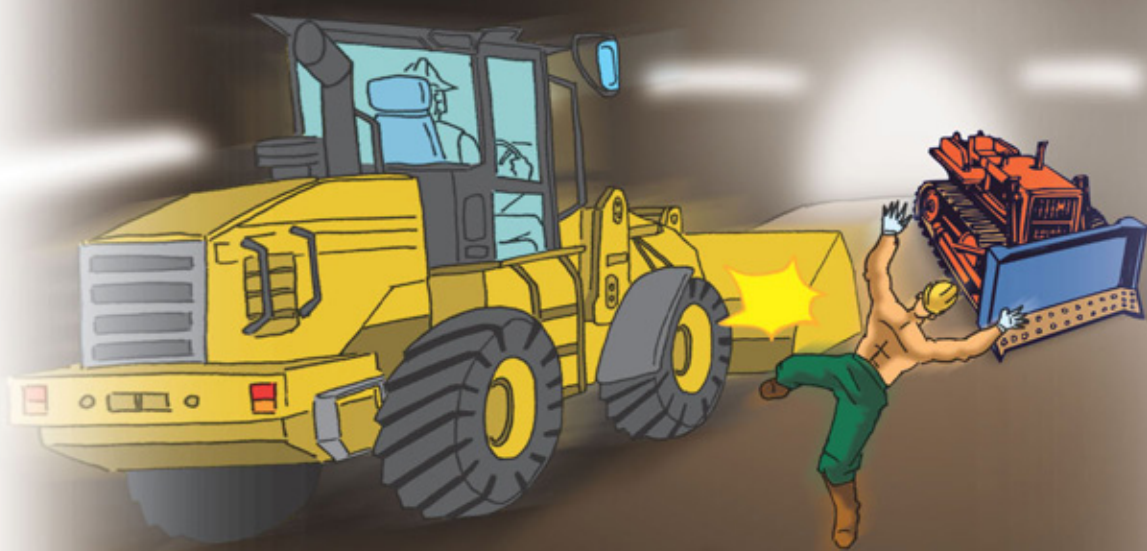
When the D/P reached a position where a vehicle was parked by the right side of the tunnel, he was knocked down by the wheel loader from behind. He sustained fatal injury as a result.

The original width of the tunnel was 7.2 m. There were 3 vehicles parked at right side of the tunnel. As a result, the width of the passageway was reduced to 4.7m.

insufficient. Fluorescent lighting was installed at every 3.5 m interval on the right side along the tunnel wall whilst on the left side of the tunnel, only a spotlight was mounted at height near the entrance. The glare of the spotlight affect the eyesight of the wheel loader driver. The D/P was wearing dark green trousers with naked upper body. It would not be easy for the wheel loader driver to spot him against the concrete surface of the tunnel.

- (a) Pedestrian footway should be demarcated inside the tunnel to separate pedestrians from traffic.
- (b) Adequate lighting, free from glare, should be provided inside the tunnel.
- (c) The road surface of the tunnel should be rendered even and non-slippery.
- (d) Parking of vehicles inside the tunnel should be avoided, especially when it affects traffic safety.
- (e) Worker should wear reflective clothing while working inside the tunnel.
