**Brief Accident Cases
of Boilers and Pressure Vessels
in Hong Kong**

This guidebook is prepared by the
Occupational Safety and Health Branch
Labour Department

First Edition *March 2000*

This Edition *June 2008*

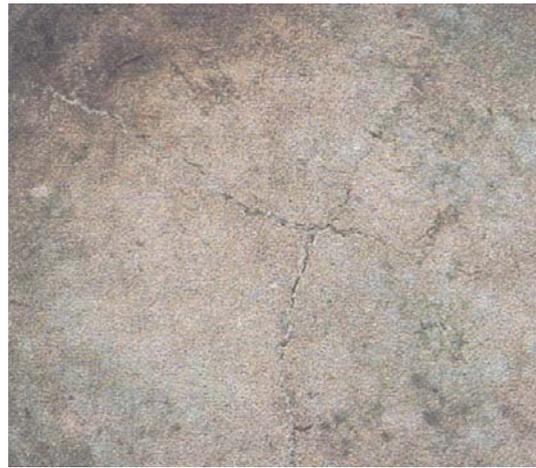
3. The bottom of the pressure cooker was cracked and six axle screws for the securing bolts were fractured.
4. The pressure cooker was used to boil herbal tea for commercial purpose, therefore it fell under the control of Boilers and Pressure Vessels Ordinance. The pressure cooker was classified as a special purpose boiler.

Photo 1.2 Crack on the bottom

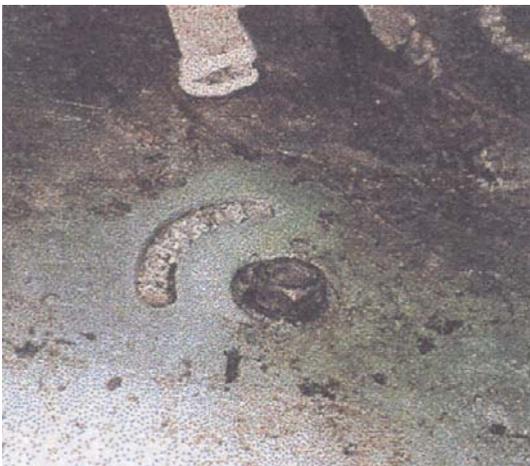
5. The working pressure was estimated to be over 450 kPa based on the results of investigation.
6. The pressure cooker safety valve had been replaced with a common stop valve. The relief valve was removed and plugged with bolt and nut. If the above safety fittings had not been removed, the excessive steam pressure inside the pressure cooker should have been released and explosion could be avoided.

Photo 1.3 Hole for relief valve was fitted with bolt and nut

1. Register any boiler and auxiliaries with the Boilers and Pressure Vessels Authority and have a Certificate of Fitness issued by an Appointed Examiner.
2. Engage Competent Person(s) to operate the boiler and auxiliaries.
3. Do not tamper with the pressure parts of the boiler without the prior approval of the Boilers and Pressure Vessels Authority.

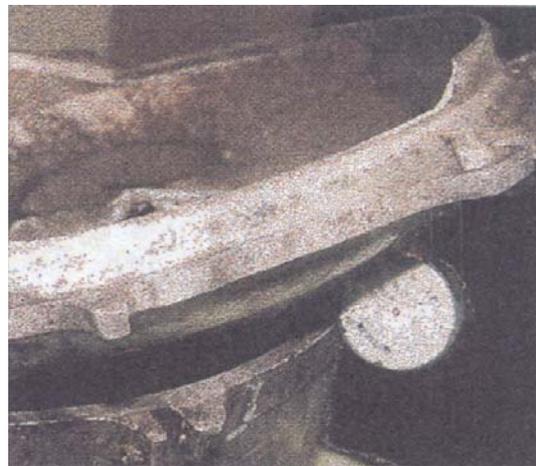
1. The lid was found buckled and cracked. The lip seal rim of the lid was broken and the handle on the lid was deformed.
2. The pressure gauge was damaged and the stop valve was found missing.

Photo 1.4 Broken lip seal rim of the lid

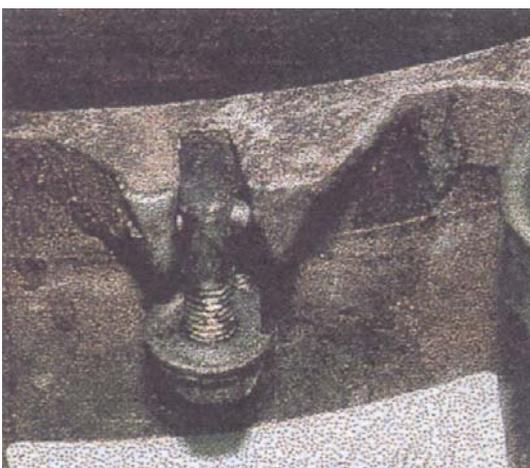
Photo 1.5 Axle screw and securing bolt

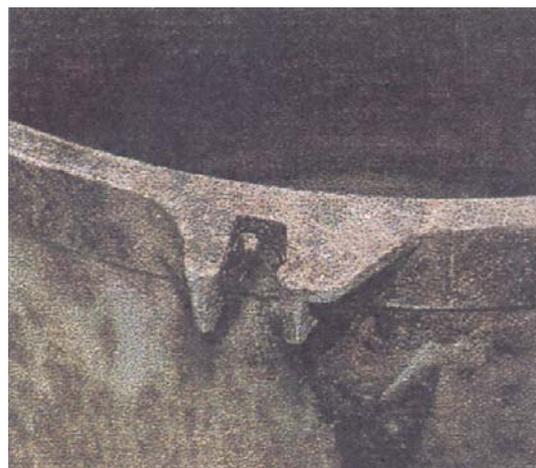
Photo 1.6 Sheared axle screw

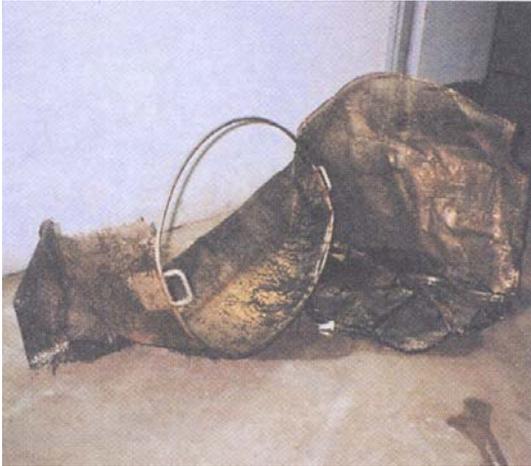
Photo 3.1 Damaged strainer of the cauldron

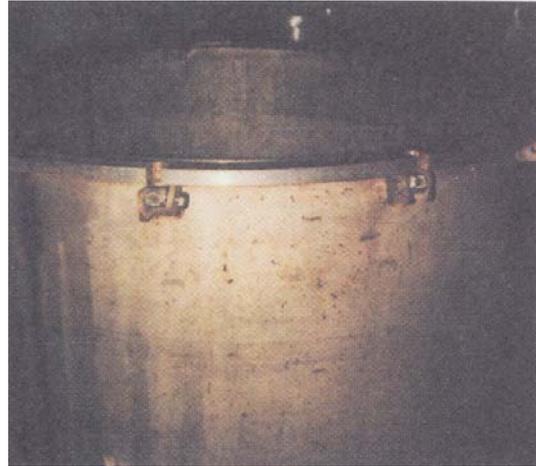
Photo 3.2 Fracture securing bolts and bush holdings

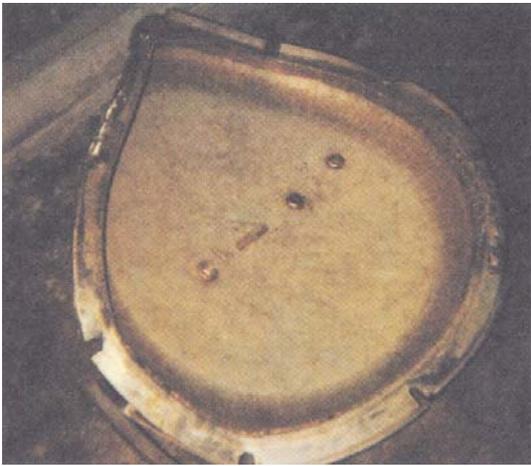
Photo 3.3 Damaged lid with fittings

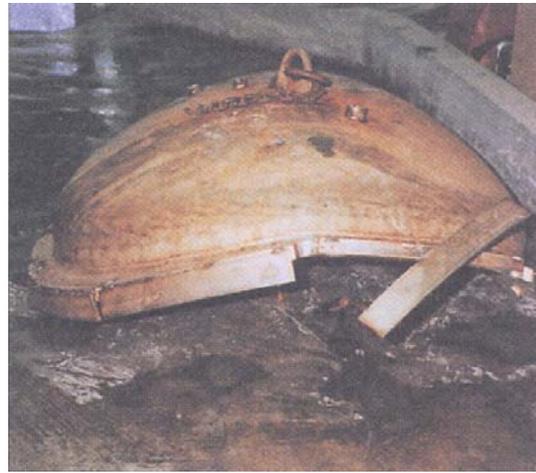
Photo 3.4 Damaged lid with fittings removed

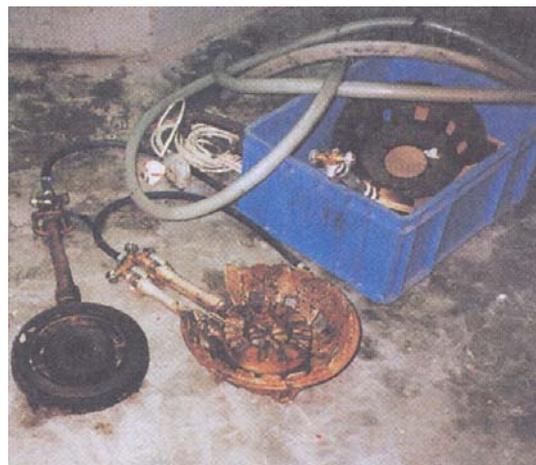
Photo 3.6 LPG stove

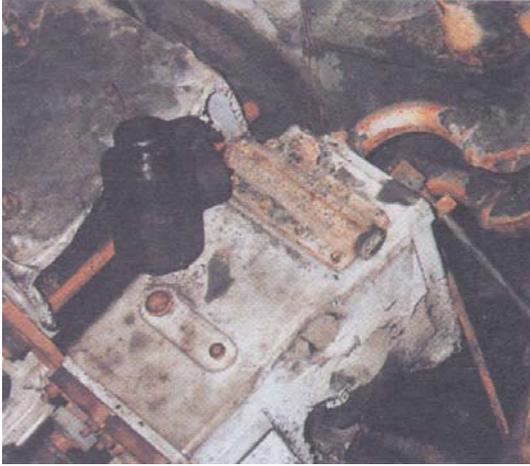
1. Small leakage of fuel oil was observed since the boiler fuel was changed from heavy oil to diesel oil.
2. The damage was minimal and was confined to the fuel burning gear and the associated control panel.
3. The cause of fire could not be established. However, the fuel oil leakage might be a contributing factor.

Photo 4.1 Damaged burner gear

1. Maintain every boiler and its auxiliary equipment properly.
2. Any fuel oil leakage should be rectified immediately.

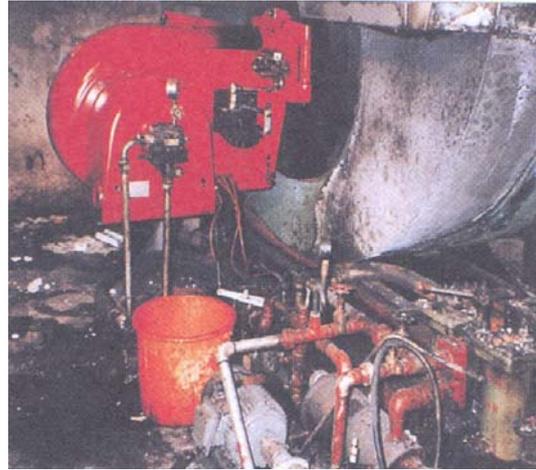
Photo 5.2 Damage to boiler and fuel oil system

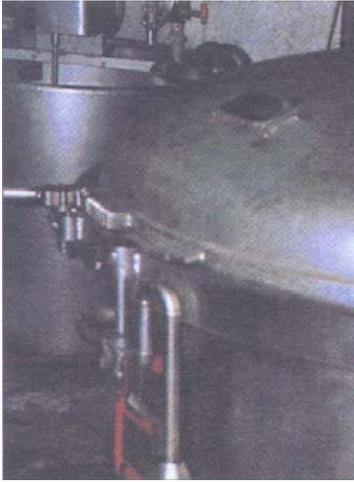
Photo 6.1 Kier cover is being unlocked

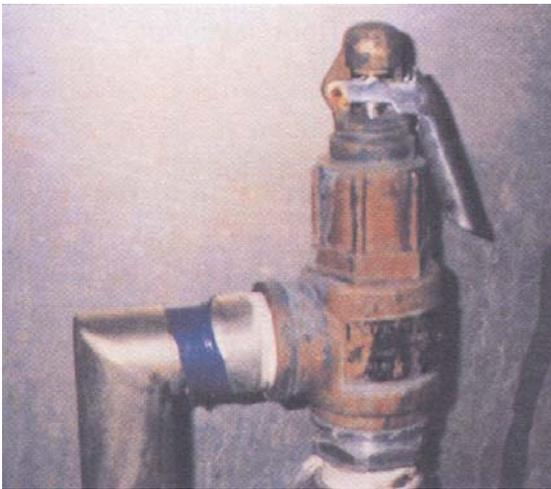
1. There were two Competent Persons holding the relevant certificates of competency.
2. The victim working on the steam kier on his own at the time of accident did not possess a certificate of competency.
3. The seal on the safety valve of the steam kier was missing. The temperature interlock set-point on the dial thermometer was set to 7°C above the maximum temperature setting of 85°C.
4. There was a very large amount of hot water left inside the steam kier at the end of the run.
5. A properly set safety valve should blow at a pressure of 450 kPa but it did not blow at a testing pressure of 700 kPa after the accident.
6. The temperature indicated on the defective dial thermometer was 12°C lower than the actual measuring temperature.

Photo 6.4 Seal for safety valve was missing

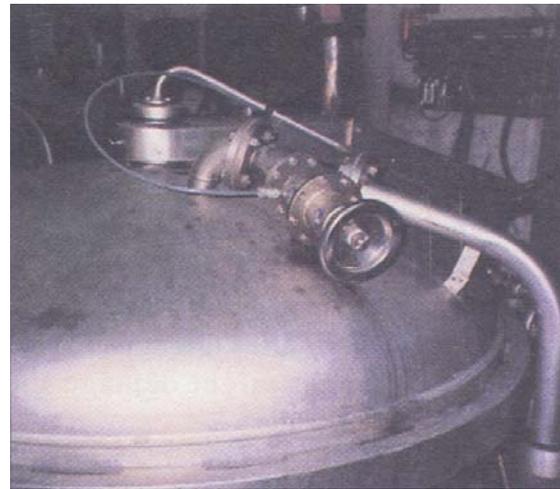
Photo 6.5 Pneumatic overflow valve at the kier cover

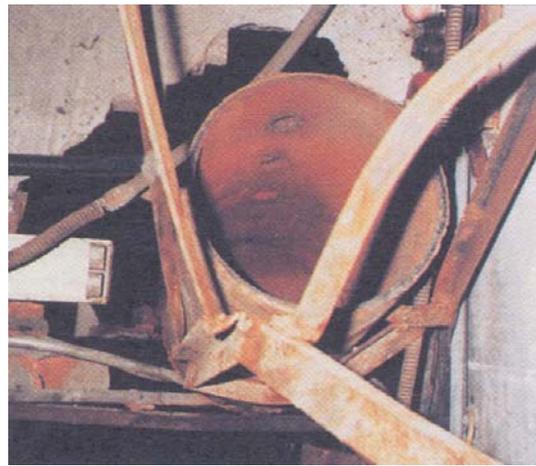
Photo 7.2 End View of the steam manifold

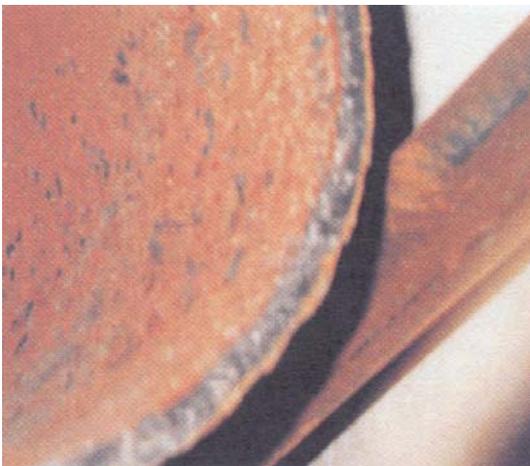
1. The preparation of the welding edge and welding workmanship of the steam manifold end plate were poor.
2. Incomplete root penetration in the welding joint of the steam manifold end plate was found. This welding defect together with the improper operation of the steam plant and auxiliaries might have resulted in the failure of the joint in the manifold. Water hammer might damage the end plate if the steam manifold was not properly drained.

Photo 7.3 Close-up view to show the failed edge of the steam manifold

1. Register any boiler and auxiliaries with the Boilers and Pressure Vessels Authority and have a Certificate of Fitness issued by an Appointed Examiner.
2. Engage Competent Person(s) to operate the boiler and auxiliaries
3. Maintain every boiler and pressure vessel and its auxiliary equipment properly.

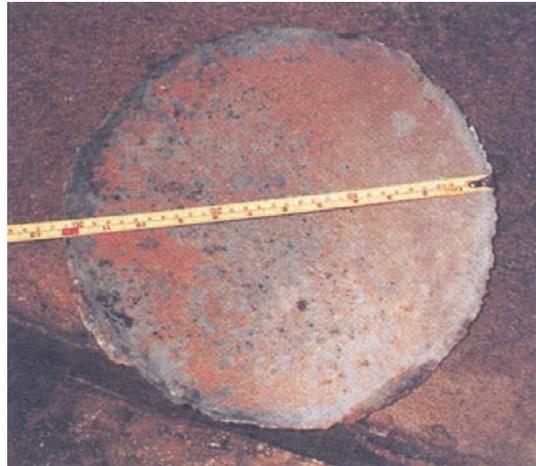
Photo 7.4 Detached end plate of the steam manifold

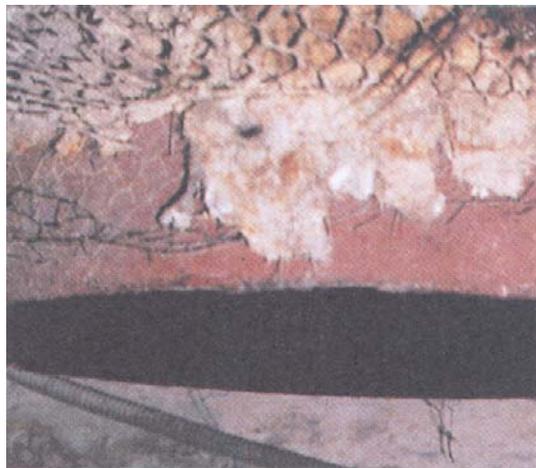
Photo 8.4 View of the edge of the steam manifold viewing from top

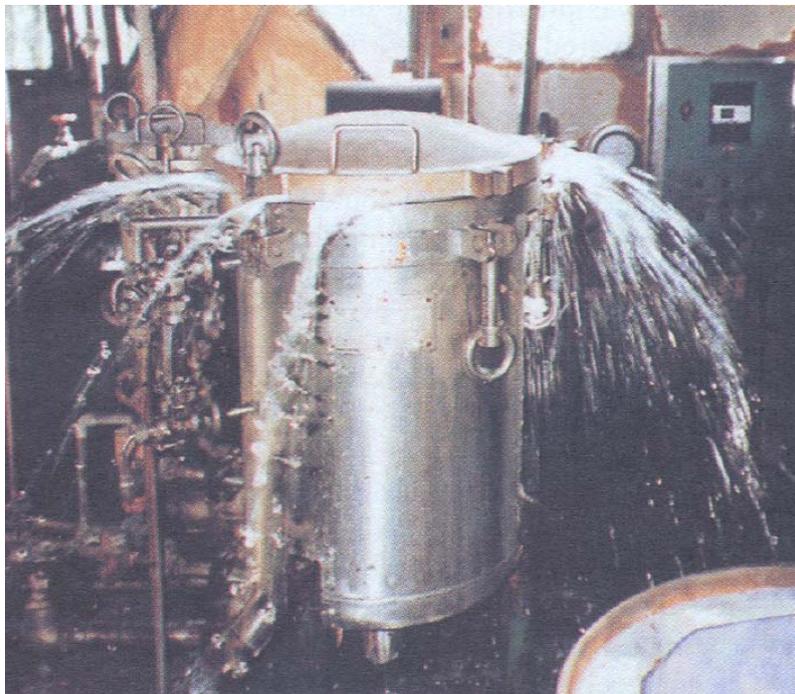
The operator failed to observe the usual safe working practice in steam kier operation. The receiver cover was partially locked by two locking bolts. Admission of fresh water with incorrect procedure during the rinsing process resulted in hot fluid being forced out from the partially tightened lid. The worker was seriously scalded by the hot fluid spilled over him.

Photo 9.2 Reconstruction of accident on water spray pattern

1. Steam kiers should be properly maintained at all times, all safety devices should be fitted and regularly tested to ensure they are functioning properly.
2. Steam kiers should be operated under the direct supervision of competent persons of steam receivers.
3. Owners should provide adequate training to the operators for the safe operation of steam kiers.
4. Proper operating procedures and safety precautions should be conspicuously displayed and readily available in the vicinity of the steam kiers.

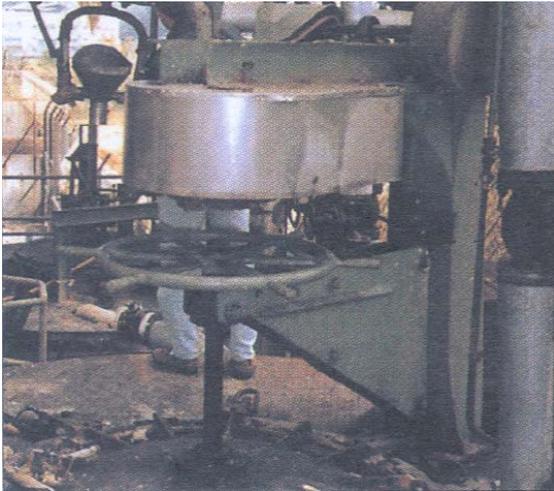
Photo 11.1 The metal cover, lifting gear and the mechanical piler

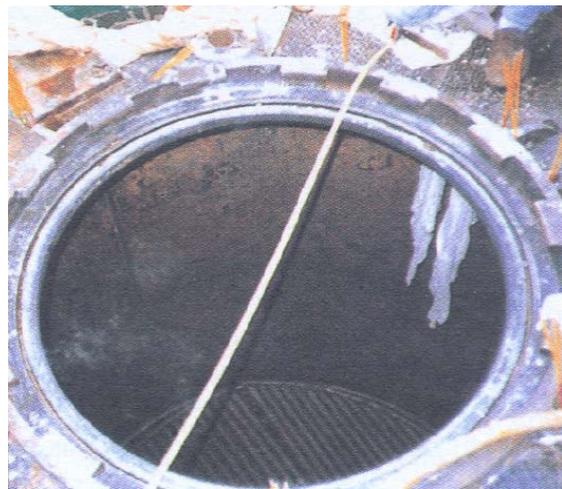
Photo 11.2 Close-up of the interior of the steam kler

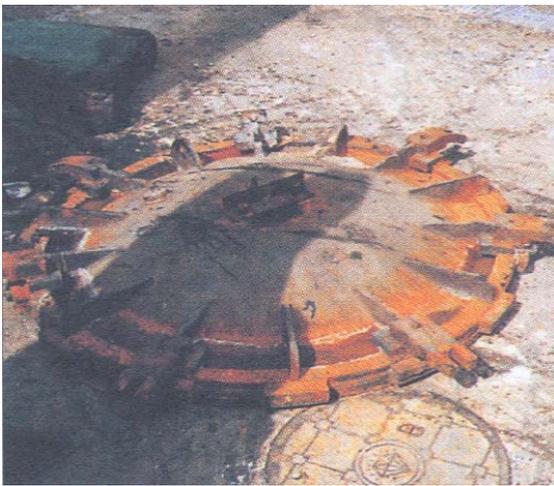
Photo 11.3 The bent cover lugs of the kler cover

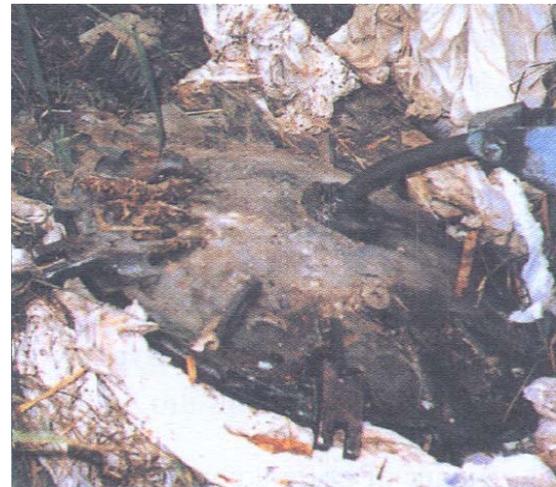
Photo 11.4 The bent lifting spindle of the kler cover

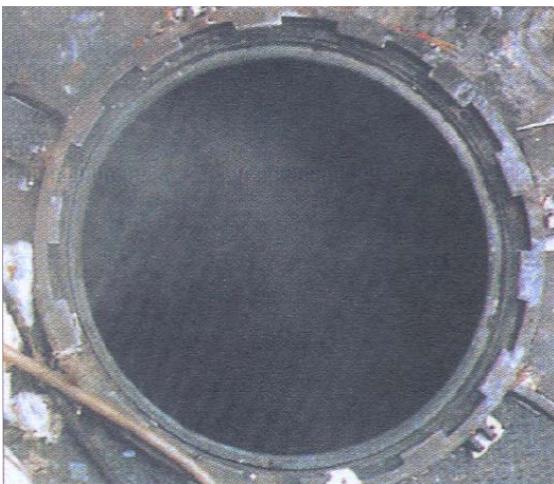
Photo 11.5 5 of the 7 cover locking bolts were sheared away

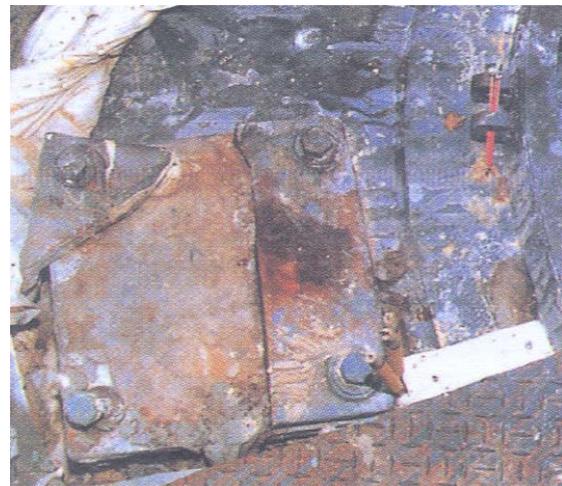
Photo 11.6 Full-width crack on flat base of the cast-iron pedestal column

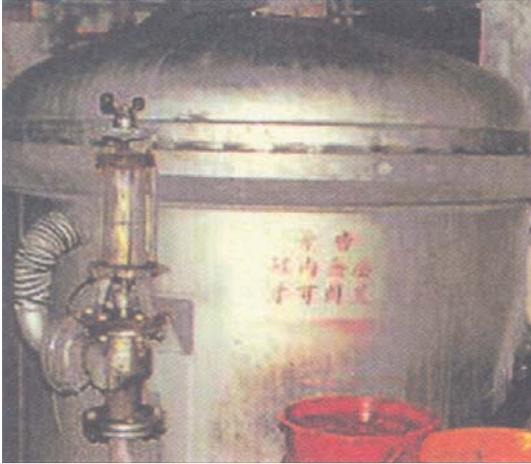
Photo 13.1 The kier (steam receiver)

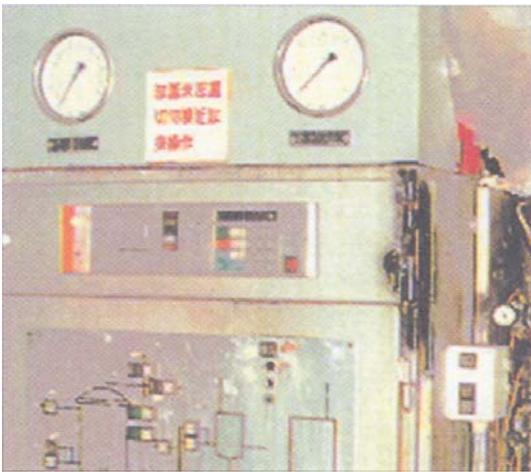
Photo 13.3 Control panel for the kier

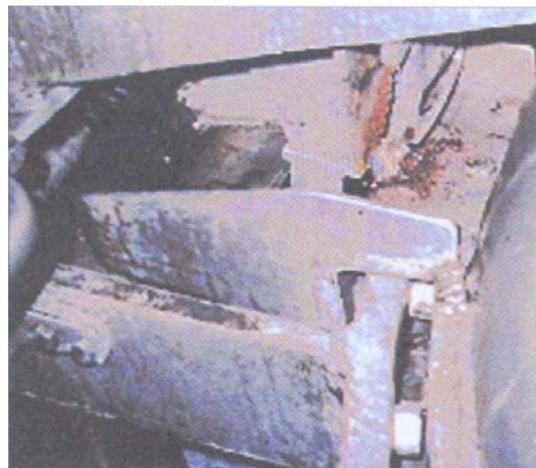
Photo 13.6 Broken level indicator, broken guide-pin and its bracket

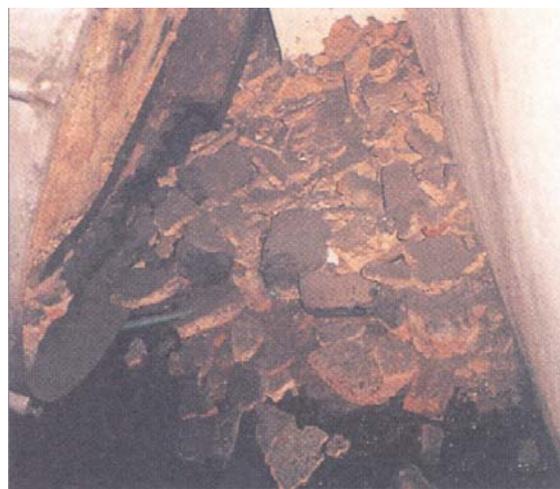
Photo 15.4 Blown off rear end cover with collapsed refractory

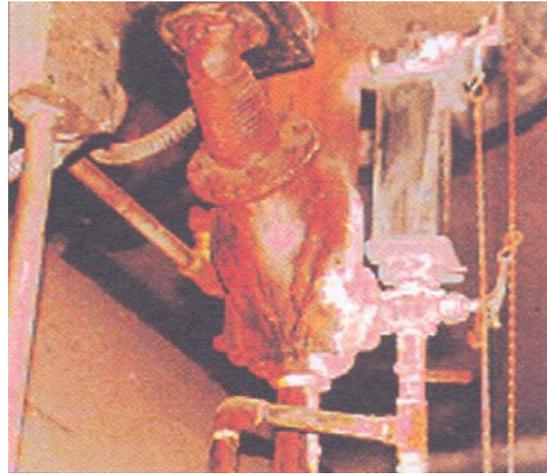
Photo 19.2 White deposits were lodged on the water level gauge glass

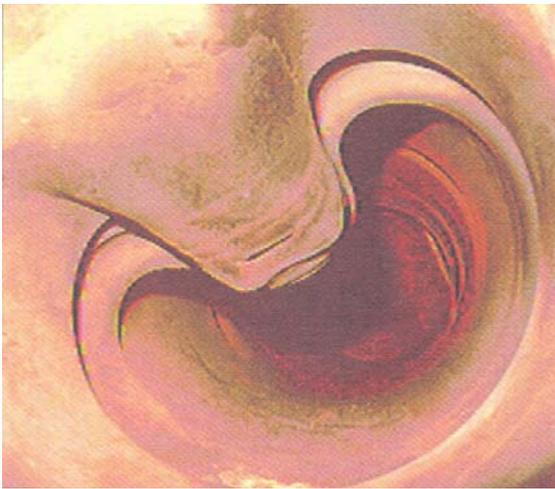
Photo 19.3 and Photo 19.4 Furnace bulged in (view from both ends)

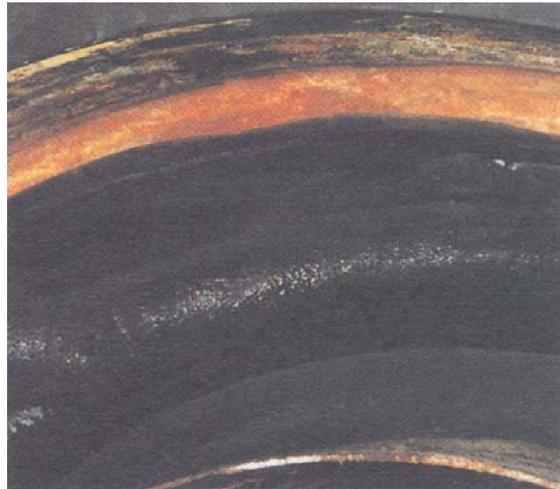
Photo 22.2 Through crack on the shell of the thermal oil heater

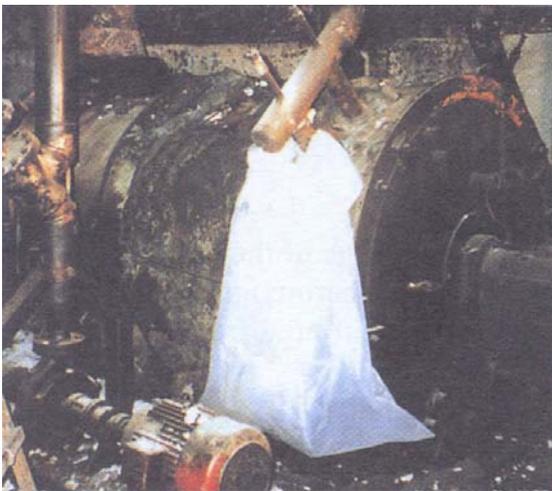
Photo 22.3 No save-all was fitted underneath the circulating pump

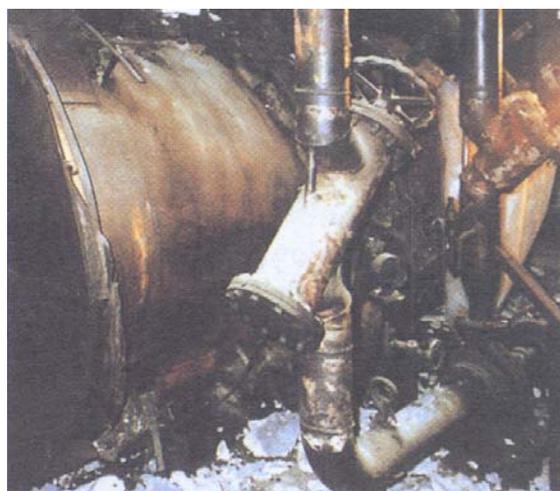
Photo 22.4 Whole boiler room was badly damaged

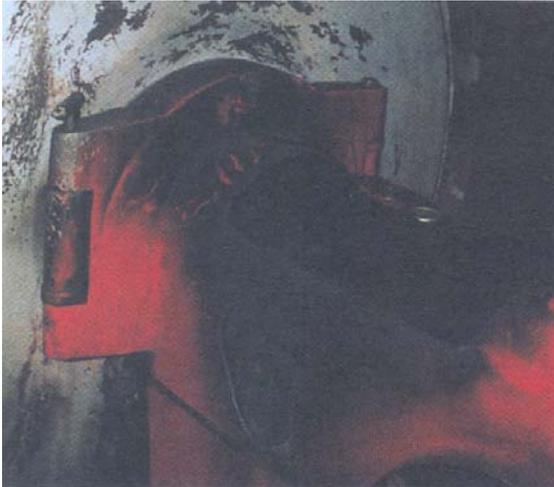
Photo 23.1 The damaged and blacken burner unit

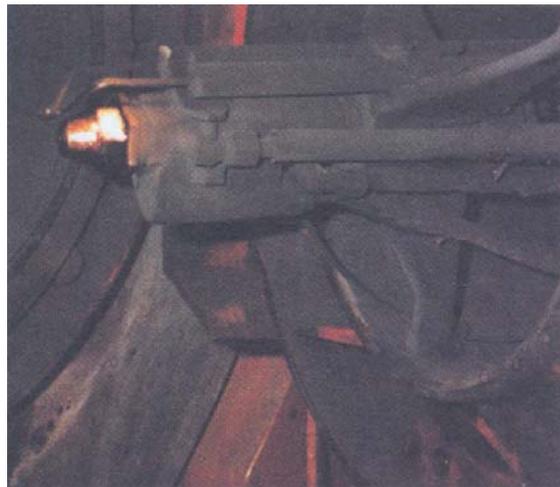
Photo 23.2 The leaky burner tips and air diffuser with carbon deposits

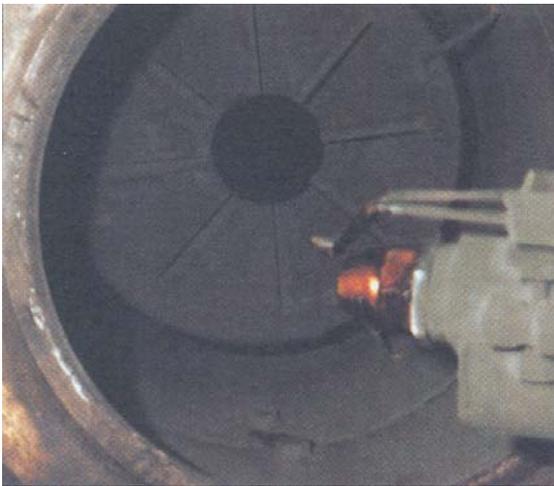
Photo 23.3 Air diffuser and wet burner tip

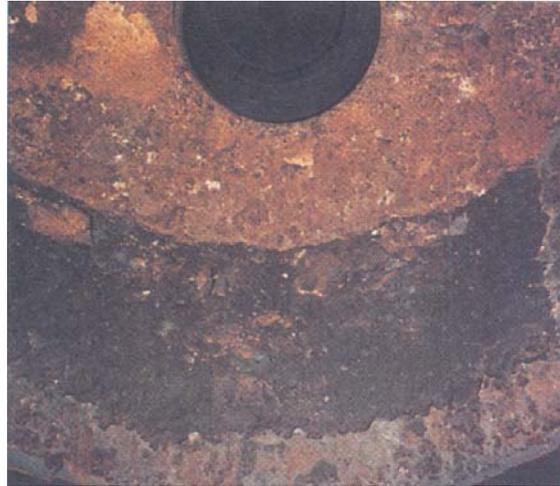
Photo 23.4 Damaged furnace refractory

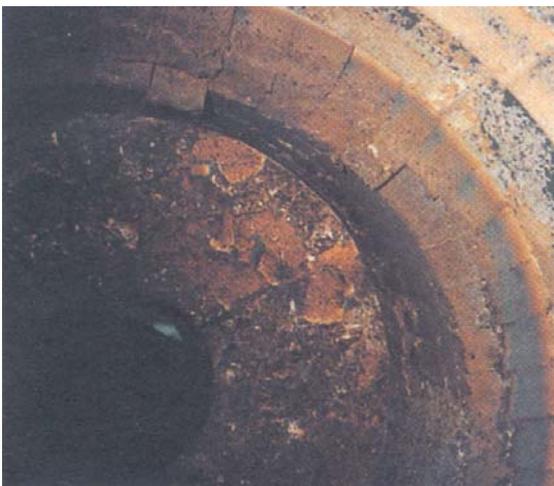
Photo 23.5 Built-up slag at combustion crown

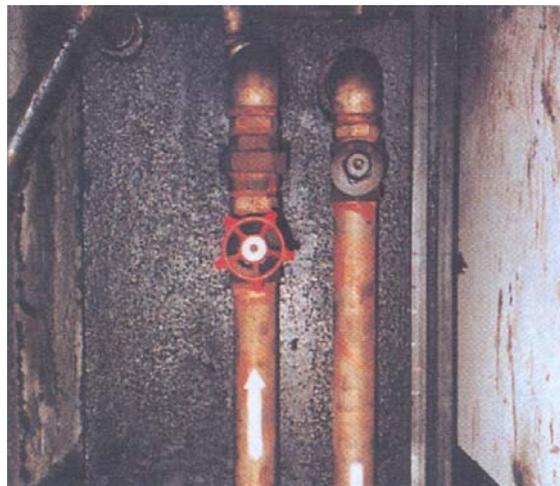
Photo 23.6 Fuel oil tank with supply & return fuel pipes

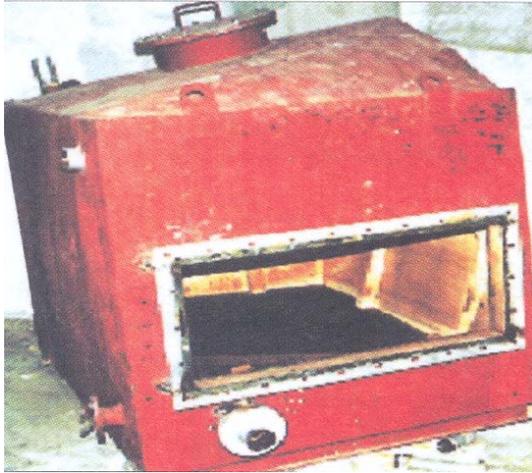
Photo 24.1 The blow-down tank was deformed and opened up

1. The Appointed Examiner should ensure that the boiler auxiliaries were constructed and installed according to the recognised standards before issuing the Certificate of Fitness.
2. Any modifications made to the boiler and its auxiliaries should be examined by Appointed Examiner before they are put back to use.

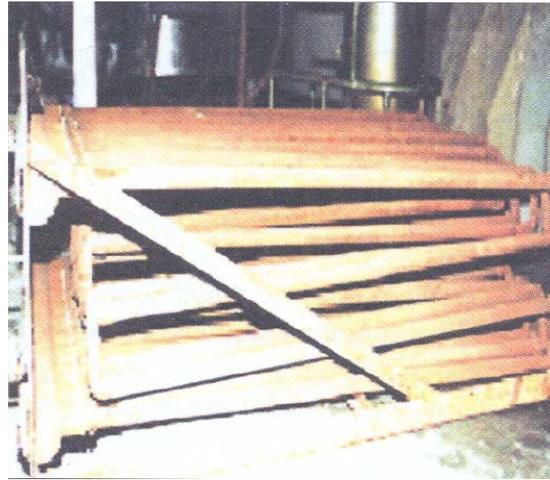
Photo 24.2 Cooling coil inside the blow-down tank

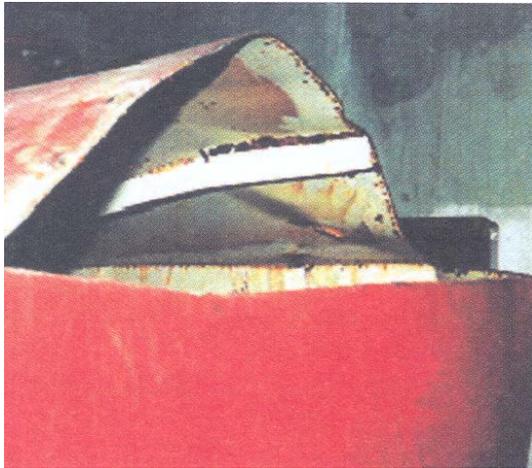
Photo 24.3 and 24.4 The blow-down tank was deformed and opened up

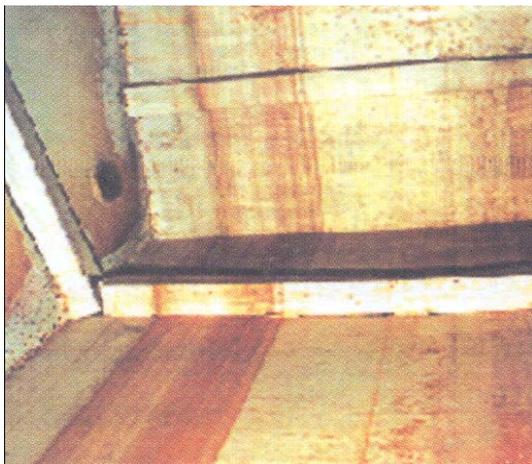
Photo 24.5 Inadequate stiffeners were installed inside the poorly constructed blow-down tank

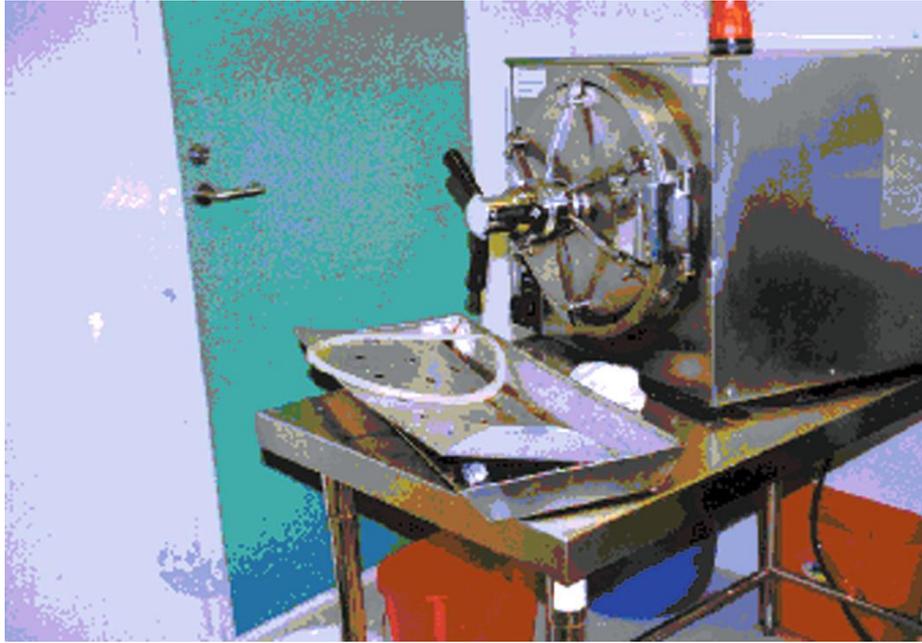
Photo 25.1 Autoclave door without pressure safety interlocking device

1. Autoclaves must be operated by persons who are fully conversant with the safety requirements for autoclaves.
2. Warning signs and notices should be posted near autoclaves.
3. Safe operating instructions and precautions must be strictly observed and followed.
4. Suitable personal protective equipment should be used during the operation of autoclaves.
