A Casebook of Occupational Fatalities in the Container Handling and Storage Sector

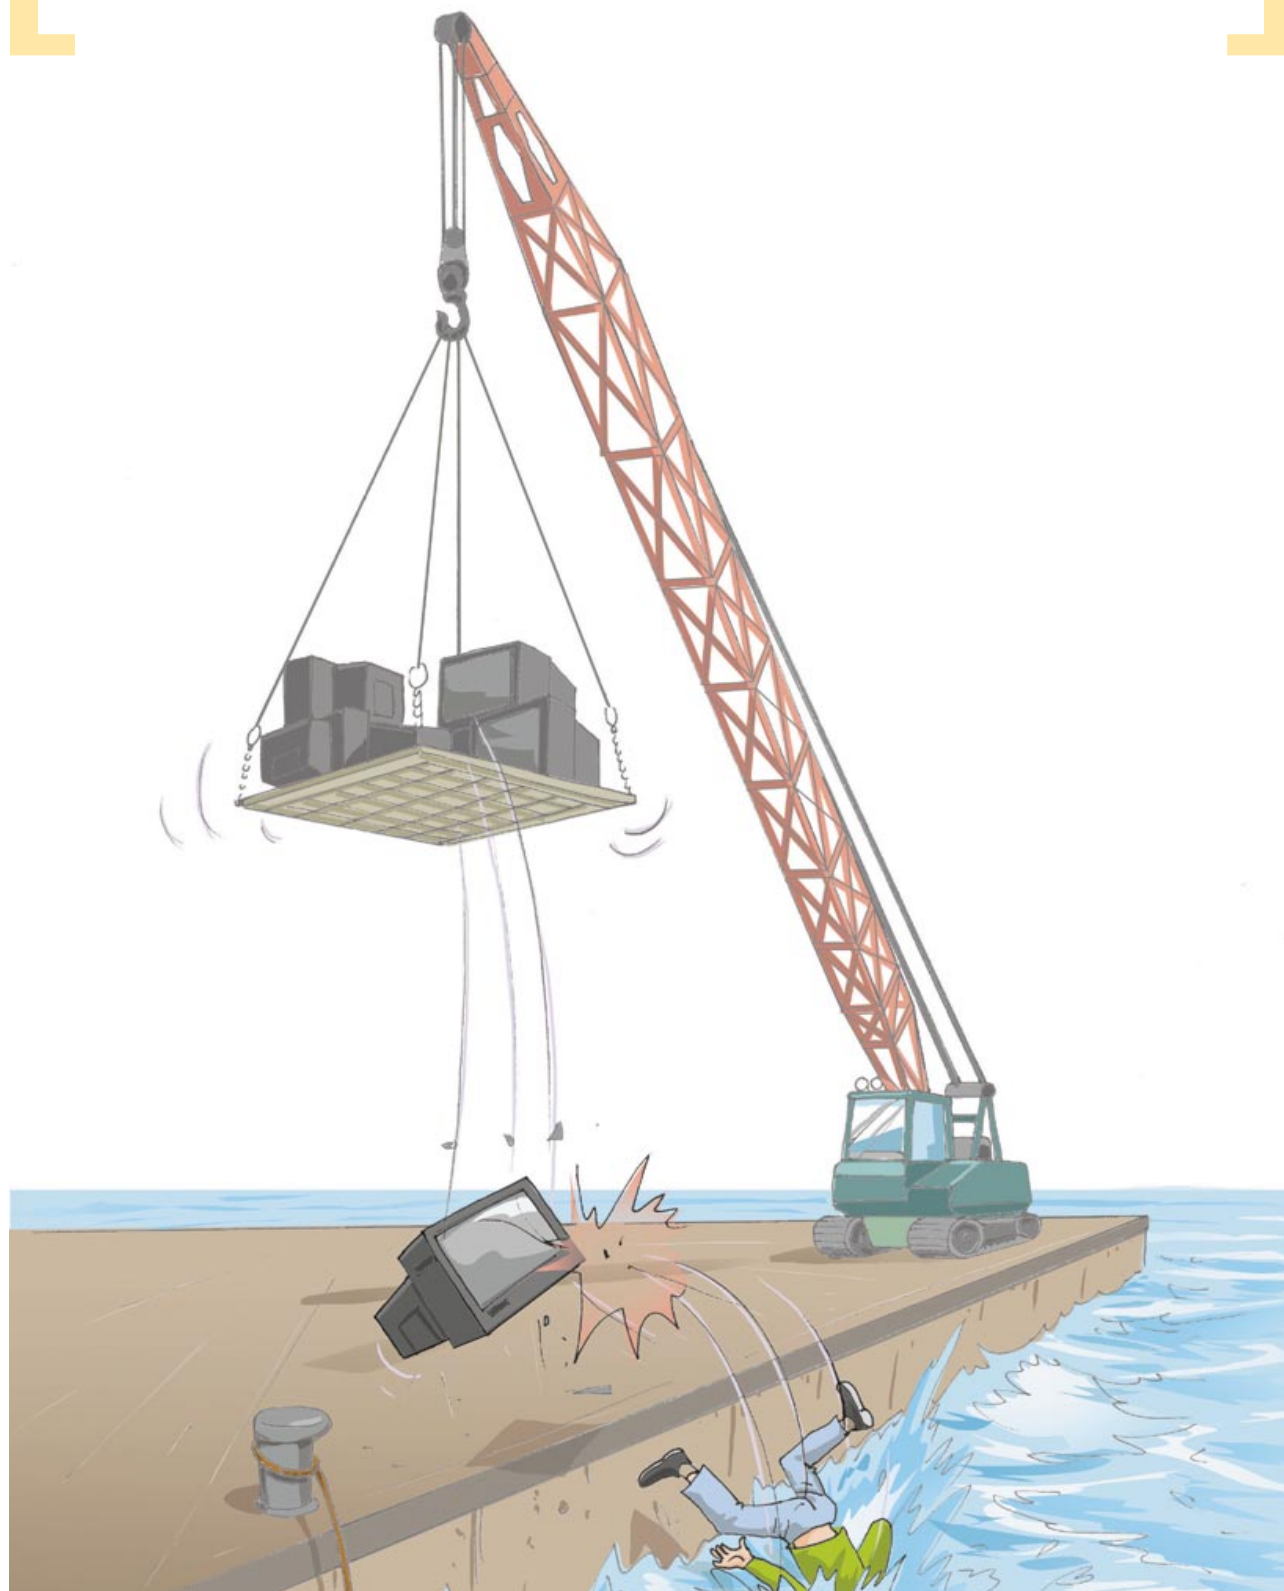
Case 1

The captain of a cargo vessel drowned as a result of a loose load falling from the receptacle suspended by a mobile crane.

The deceased person and his team of workers were engaged in transferring used electrical appliances that were stored in a container on the shore to a river trade cargo vessel berthed alongside a cargo handling area. The electrical appliances were removed from the container and stacked onto a receptacle by the deceased person and his team of workers. The receptacle containing the electrical appliances was then transferred to the cargo vessel by means of a mobile crane. In one lifting operation, an electrical appliance in the receptacle fell and landed in the close vicinity of the deceased person. As the deceased person was standing close to the edge of the berth, he fell into the sea and eventually drowned.

- The used electrical appliances were loosely stacked in the receptacle. They were not fastened or tied to the receptacle.
- The receptacle holding the electrical appliances was not provided with suitable enclosure. Some of the electrical appliances protruded beyond the edges of the receptacle.
- Under undue external disturbance during the lifting operation, the electrical appliances stacked on the receptacle would be easily displaced and fell outside the receptacle.
- No fencing or railing was erected along the edges of the shore.

- Every load being raised, suspended or lowered by a lifting appliance should be properly stacked and adequately secured to prevent slipping or displacement.
- Receptacle with suitable enclosure should be used to hold loose loads when being raised, suspended, lowered and transported.
- As far as practicable, with regard to the cargo handling operation, suitable guardrails or fences should be erected along the edges of the shore to protect workers from falling into the sea.
- Steps should be taken to ensure that no person stays in the path of travel of a lifted load.

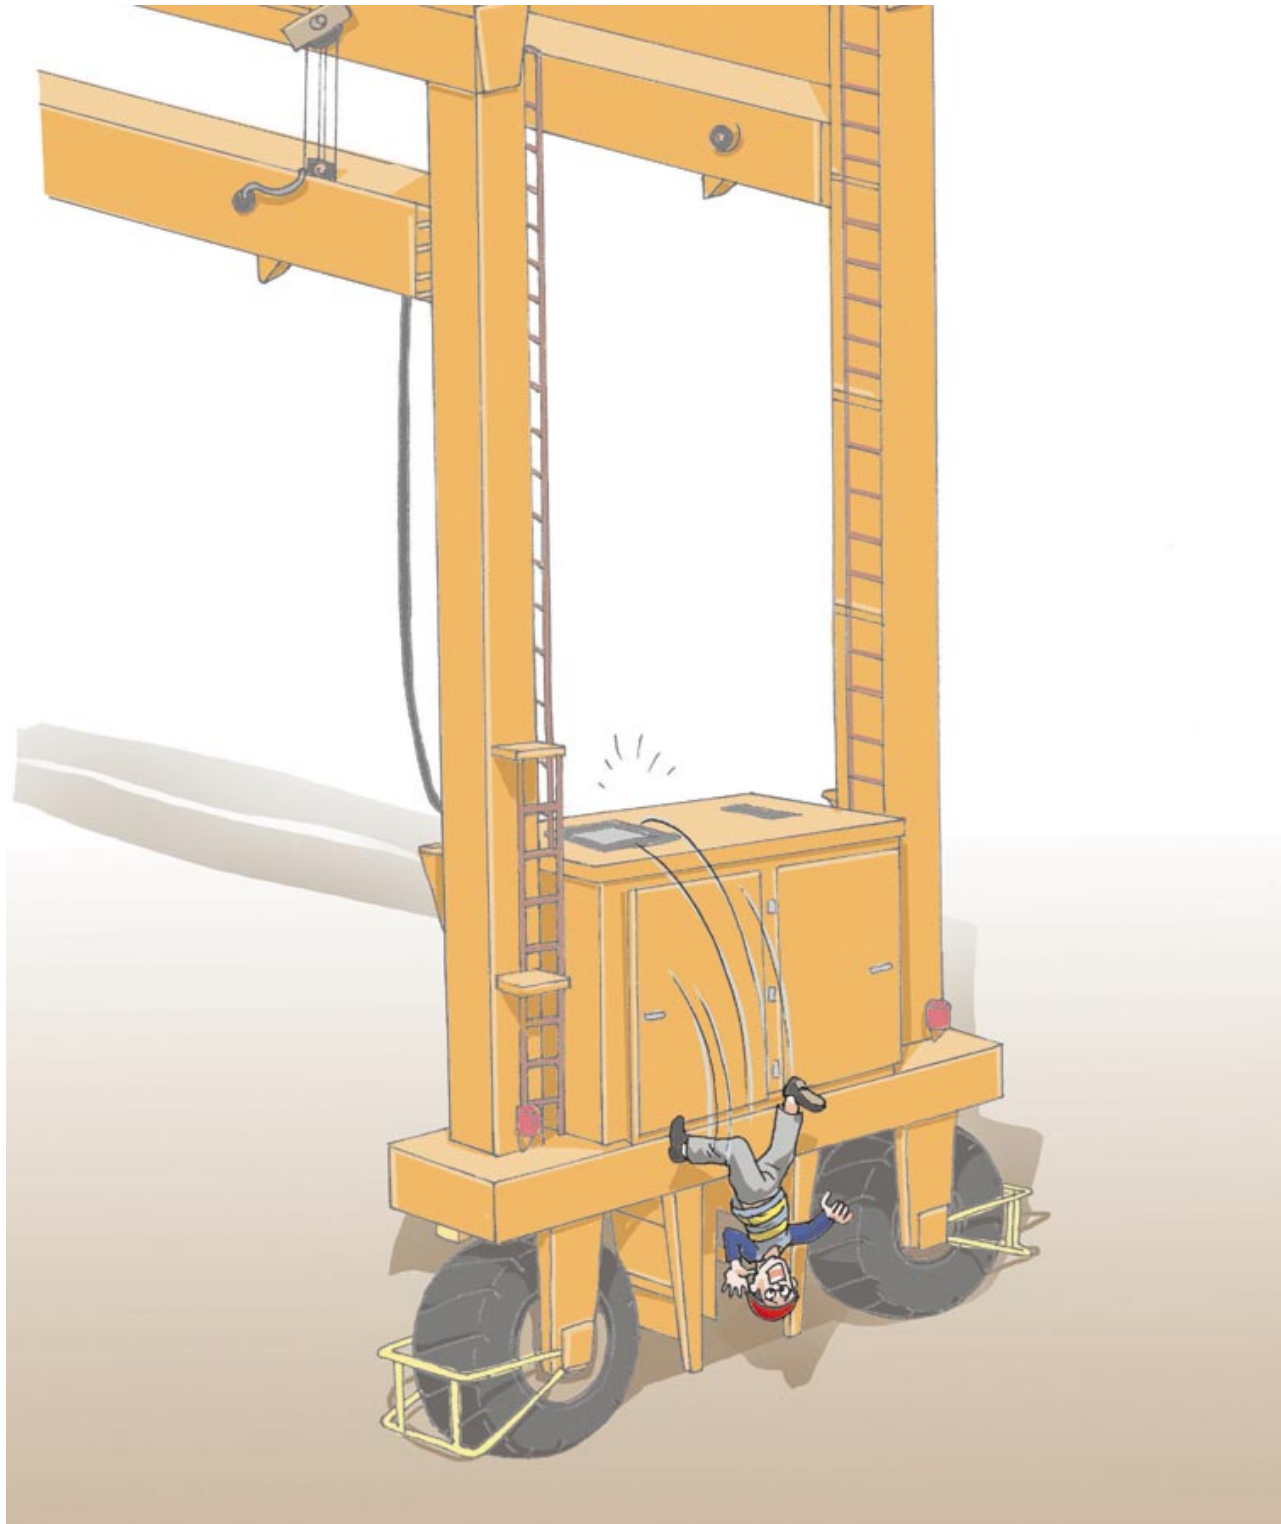
Case 2

A worker fell from a height while dismantling a canopy fitted on top of a diesel generator set of a gantry crane.

A team of eight workers, including the deceased person, was assigned to dismantle a diesel generator set from a gantry crane for maintenance in a container yard. The work sequence was to detach and remove the exhaust drum, the two canopies fitted along the top edges of the generator housing, then the generator housing, the diesel engine, the evaporator and finally the electricity generator. For the whole generator set to be lowered to the ground, preparatory work had to be done from the top surface of the generator housing. At the time of the accident, the deceased person gained access to the top of the generator housing and proceeded to unthread the bolts and nuts of one canopy. In the course of work, he might have stepped onto the loosened canopy or accidentally lost his balance and fell to the ground over the unprotected edge of the generator housing.

- The top of the generator housing was not provided with guardrails or fences.
- The deceased person had not made use of any fall protection equipment while working on the generator housing.
- No suitable anchorage for attaching the lanyard of the safety belt was available on top of the generator housing.

- (a) A safe system of work for the dismantling of diesel generator should be devised and implemented. It should include risk assessment to identify the hazards involved, formulation of precautionary measures to be taken and the means to ensure proper implementation of the plan.
- (b) Suitable working platforms should be provided and used for the dismantling work.
- (c) When the use of working platforms is impracticable, safety harness and suitable anchorages should be provided to prevent fall of person.
- (d) Adequate information, instruction, training and supervision should be provided to workers to ensure their safety while working at heights.

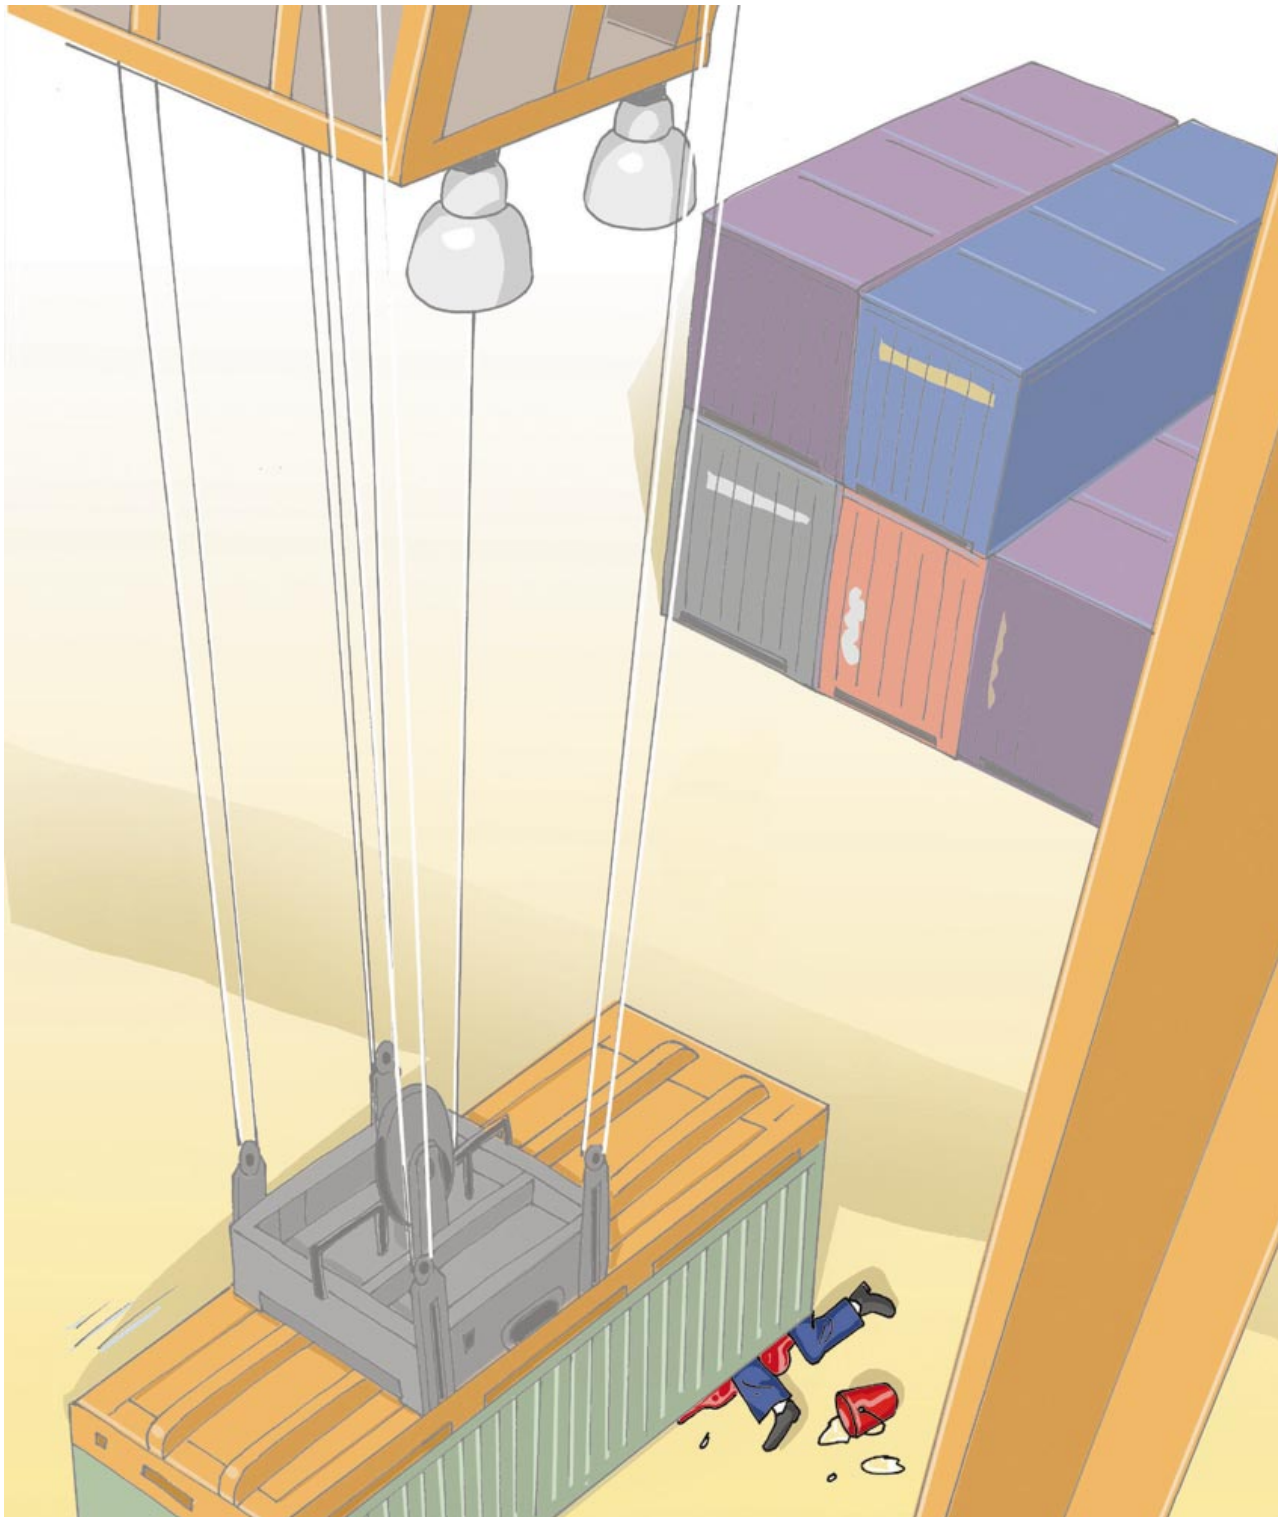
Case 3

A cleaning worker was crushed to death by a container that was being unloaded onto the ground by a gantry crane.

The deceased person was employed by a contractor responsible for cleaning work in a container yard. Before the accident happened, she was sweeping the tractor lanes of the main streets in the yard with a broom and a spade. When she passed by the junction of two main streets, she found some rubbish in an empty container stacking area. She then entered the stacking area to clean the place up. At that moment, a gantry crane approached this area to unload a container onto the ground. The deceased person was unfortunately trapped under the container being lowered.

- There was no co-ordination of work between the management of the container yard and the contractor undertaking the cleaning work.
- There was no instruction and guideline given to the cleaning workers concerning the conditions that would be safe for them to enter the container stacking area to perform cleaning work.

- The view of the crane operator in his cabin would be obstructed when a container was being lifted by the spreader of the gantry crane. The crane operator could not clearly see the area on the ground. The visible area would be further reduced when the container was gradually lowered to the ground.

- Although a closed circuit television system was installed in front of the crane operator cabin, it was only for monitoring the condition of the containers below the gantry crane and could not capture a clear view on the ground.

- There was no signaller appointed to assist in the container handling operation.

- (a) The management of the container yard should co-ordinate with the cleaning contractor to develop and implement a safe system of work so as to ensure the safety of all cleaning workers in the container yard.

- (b) The cleaning contractor should assign a supervisor to co-ordinate with the management of the container yard on the cleaning arrangements and to oversee the safety of the cleaning operations.

- (c) Appropriate measures should be taken to ensure that no cleaning work is carried out in the area where container handling activities or operation of cranes are in progress.

- (d) Adequate training and information on the hazards associated with the cleaning work in the container yard should be provided to all cleaning workers.

- (e) To ensure safety of the lifting operation, a signaller should be appointed to assist the gantry crane operator who did not have a clear and unobstructed view of the ground.

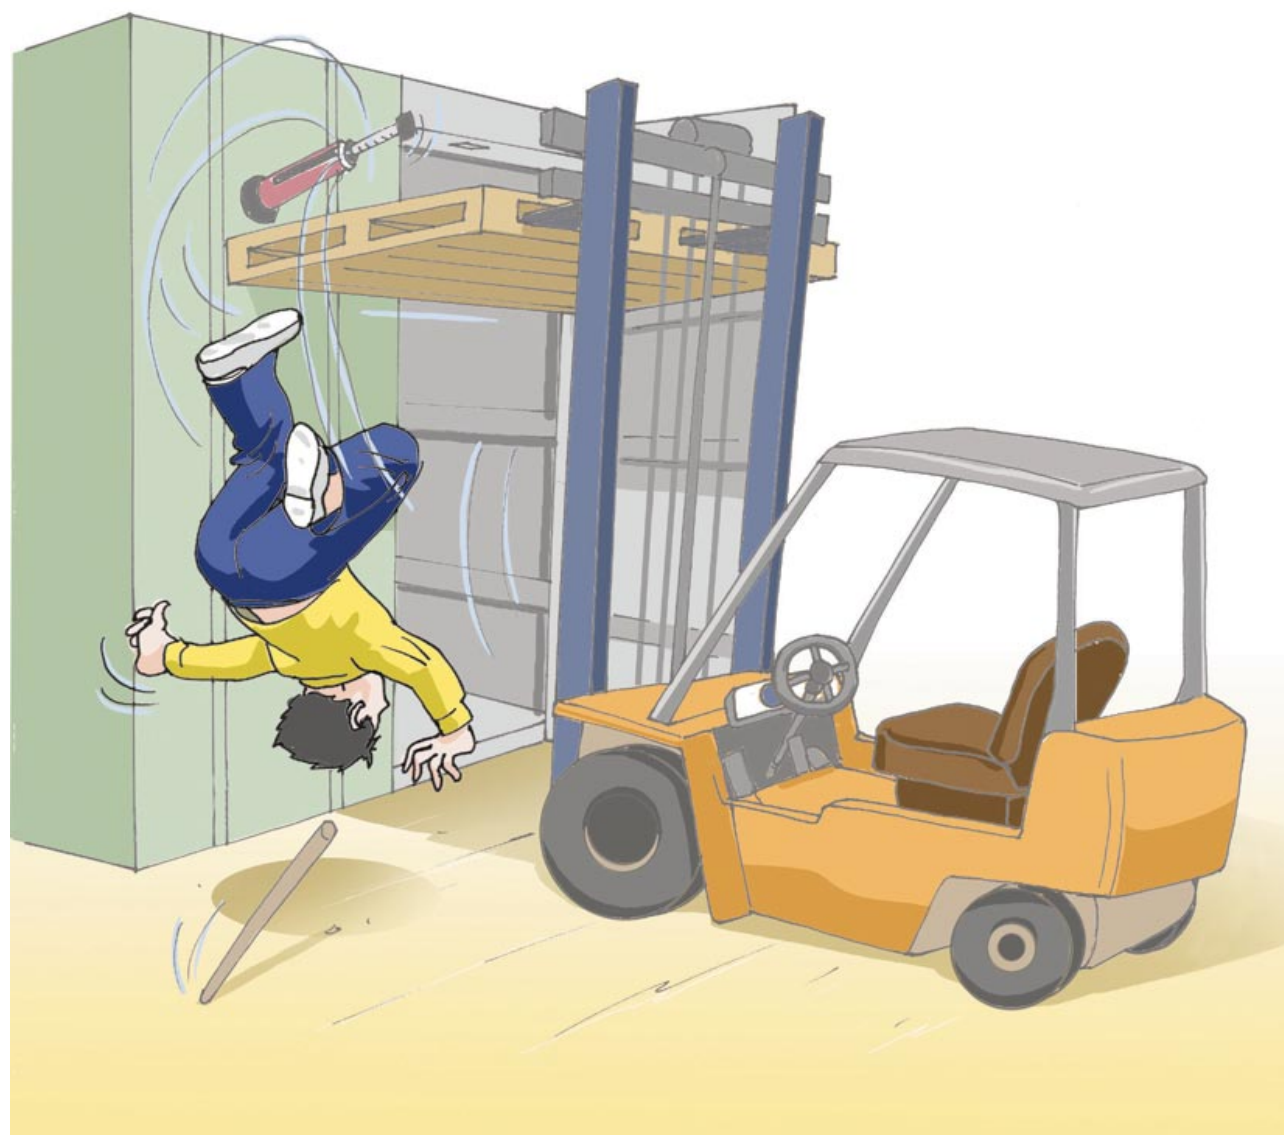
Case 4

A worker fell from a height while releasing a jammed container door.

The deceased person was engaged in unloading goods from a 20 feet container loaded on a truck parked in the loading bay of a warehouse. He found that the locking mechanism on the left container door was deformed and the door could not be opened. Intending to fix the problem, he placed a wooden pallet on the forks of a forklift truck and asked a co-worker to raise him to the top of the container. He stood on the pallet and brought with him a jack. After being raised to the top level of the container, he set up the jack on the wooden pallet and tried to restore the locking mechanism so as to release the jammed door. However, the jack accidentally displaced. The deceased person thus lost balance and fell to the ground.

- Neither the top of the container nor the wooden pallet being raised by the forklift truck was provided with suitable guardrails and toe boards.
- There was no safety measure taken to prevent the worker from falling from heights. In this incident the deceased person did not make use of any fall arresting equipment.
- No precaution was taken to prevent the accidental displacement of the jack.
- Without gaining access to the top of the container, it was practicable to pull open the jammed door by the forklift truck with the aid of a wire rope.

- (a) No person should work on the top of a container unless adequate precautions have been taken to prevent him from falling from heights.
- (b) Where practicable, working platform with suitable guardrails and toe boards should be used for work at heights.
- (c) No person should work on a wooden pallet rested on the forks of a forklift truck.
- (d) Deformed locking mechanism of the container should be repaired by a competent mechanic with suitable tools and equipment and in a manner that is safe and without risk.

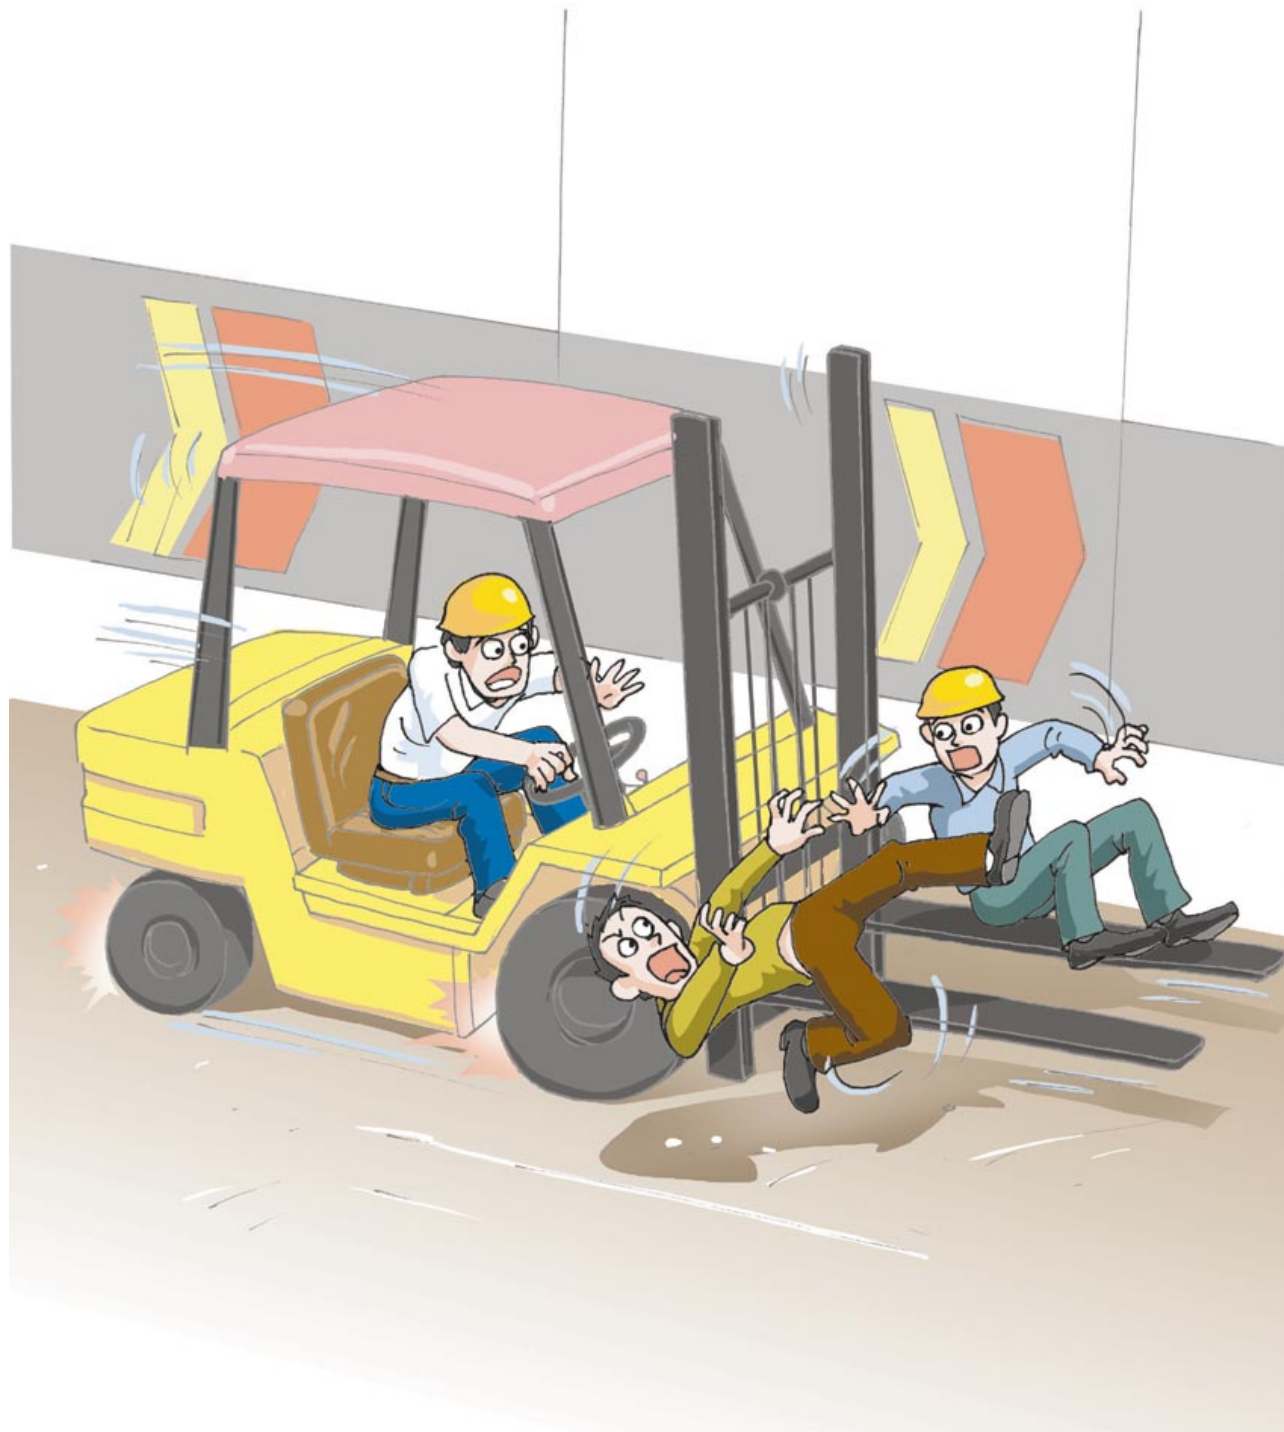
Case 5

A worker riding on the fork of a forklift truck fell and was rolled over by the forklift truck.

The deceased person was responsible for handling cargoes in an air freight forwarding centre. Before the accident happened, he was unloading cargoes together with two co-workers at Unit G9 with the aid of a forklift truck. After the work was completed, they proceeded to Unit G53 to perform other loading operation. The deceased person and one of the co-workers rode respectively on the two forks of a forklift truck, which was operated by another co-worker. When on their way to Unit G53, the deceased person accidentally lost balance and fell from the fork to the ground. The co-worker driving the forklift truck immediately applied the brake to stop the truck but it could not come to a dead stop at once. The forklift truck thus rolled over the lower part of the deceased person's body.

- There was a notice on the body of the forklift truck warning workers not to ride on the forks.
- Safety training on cargo handling operations, including the prohibition of riding on the forks of a forklift truck, had been provided to every employee employed as manual labourer. The workers were also issued with a safety manual and other related pamphlets during the training sessions.
- The workers were aware that forklift truck should not be used for transportation of people and they were not allowed to ride or stand on the forks of a forklift truck.
- The operator had about eight years' experience in operating forklift truck.
- The driveway from Unit G9 to G53 was paved with concrete, level and wide enough for the forklift truck to operate safely.

- (a) A safe system of work on the use of forklift truck should be developed and implemented.
- (b) In addition to the provision of information, instruction and training to the workers, an effective system of supervision should also be implemented to ensure that safe working practices and procedures are fully adopted.
- (c) Every worker should co-operate with the proprietor of the workplace and take reasonable care for the safety and health of himself and others who might be affected by his acts or omissions at work.

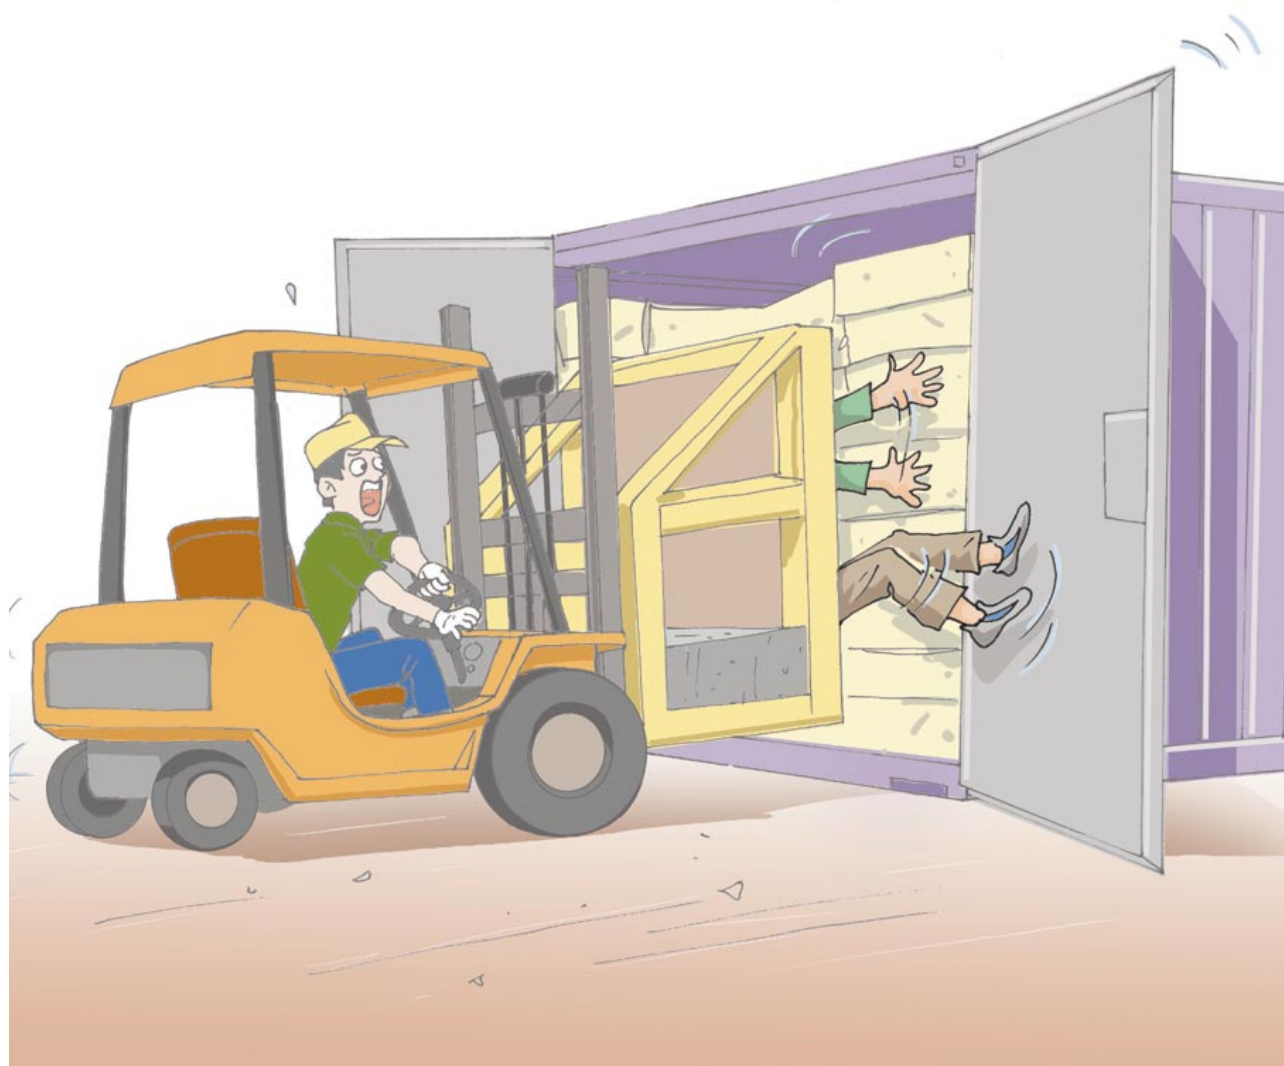
Case 6

A warehouse keeper was trapped between a forklift truck and the goods stacked in a container.

Loading of goods into containers was being carried out in a container depot. The deceased person was responsible for assuring goods were correctly loaded into the respective container. Before the accident occurred, the deceased person had finished checking a container but found the doors could not be closed because the loaded goods were not properly stacked into the container. He then arranged a forklift truck installed with a pushing block at the front to compact the goods by pushing them further into the container. In the course of pushing the goods into the container, the deceased person was trapped between the pushing block of the truck and the goods in the container.

- The pushing block on the forklift truck consisted of a metal frame with a concrete base and a vertical metal plate at the front. There was no opening or perforation on the metal plate.
- The operator did not have a clear and unobstructed view in front of the pushing block installed on the forklift truck. He had only a limited view of the upper part of the container.
- To push goods at an elevated level, the pushing block had to be raised. In so doing, the view of the driver would be seriously obstructed.
- There was no signaller appointed to assist the forklift truck operator in this goods compacting operation.

- (a) Goods in the container should be properly stacked to avoid obstructing the closing of the container doors.
- (b) To ensure the safety of workers engaged in the goods compacting work, risk assessment to identify the hazards involved should be conducted and appropriate safe working procedures should be devised.
- (c) The pushing block used for compacting goods into the container should be suitably designed and constructed with perforation or opening on it so that the view of the forklift truck operator would not be obstructed.
- (d) Signaller should be appointed to assist in the compacting operation if the forklift truck operator could not have a clear and unobstructed front view.

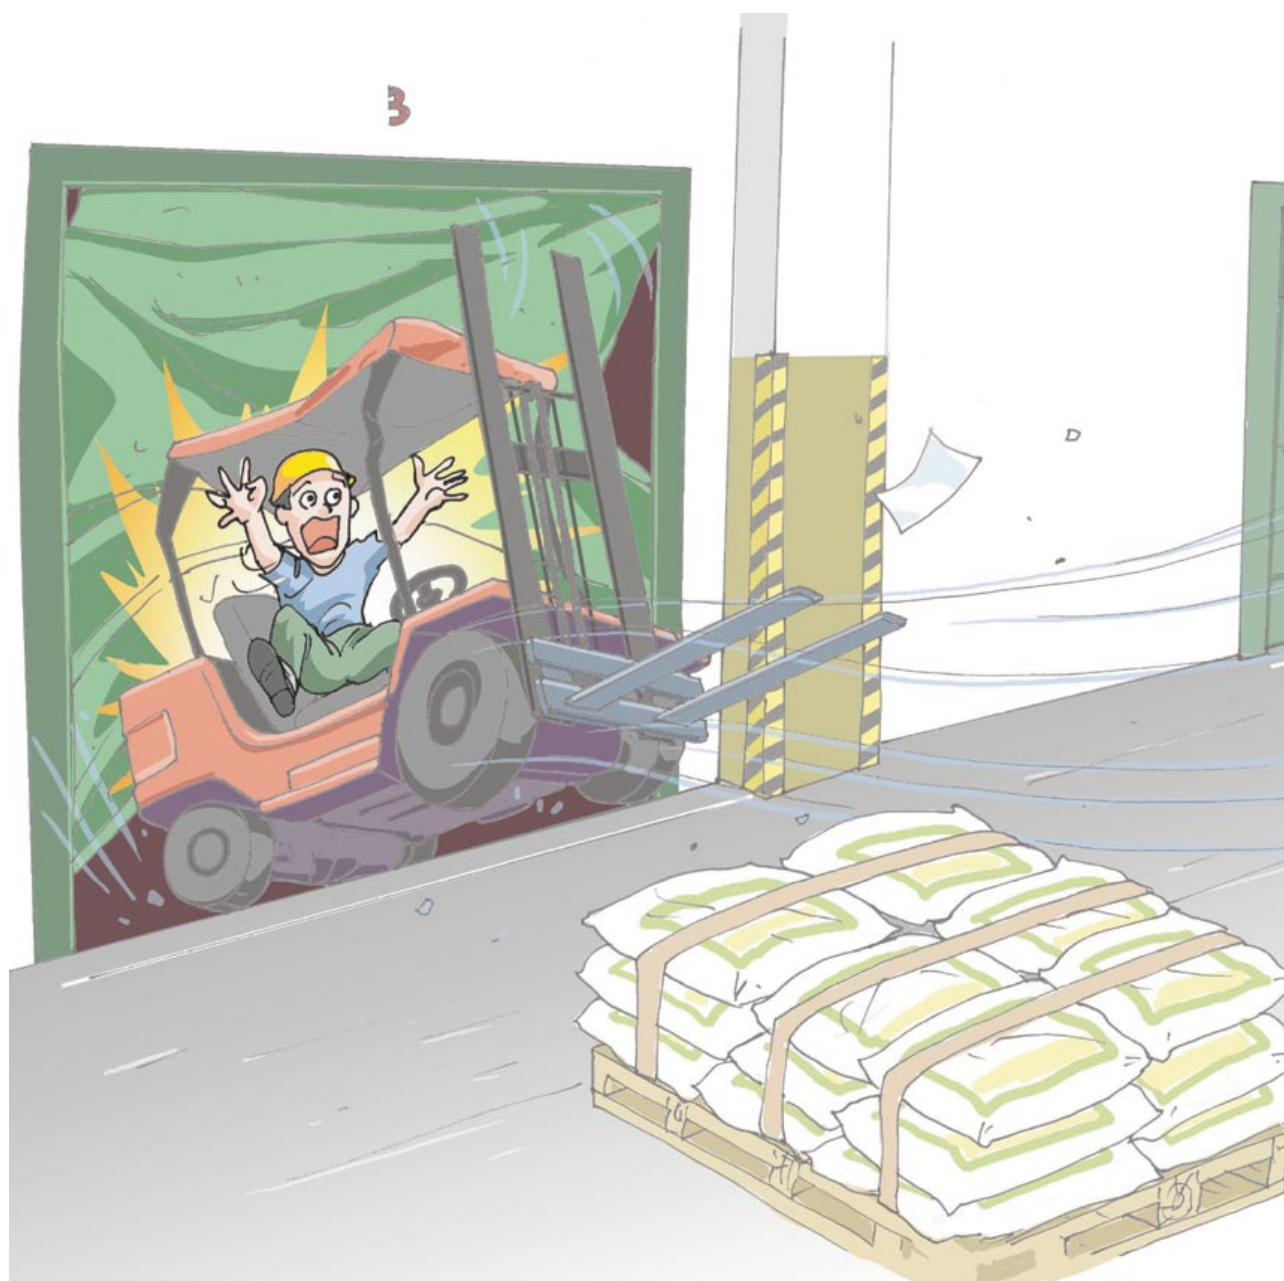
Case 7

A forklift truck crashed into the gate of a cargo lift and fell into the lift shaft.

The deceased person, a co-worker and a forklift truck operator were responsible for loading lorries parked at the 1/F loading bay with rice stored on the 2/F and 3/F of the warehouse. Three forklift trucks were available for use. One was located on the 3/F and the other two on the 1/F. The deceased person and his co-worker had to stack packs of rice onto wooden pallets on the upper floors. The pallets would be transported by the forklift truck into the cargo lifts for transferring to the 1/F, where they would be picked up by another forklift truck for loading onto the lorries. Prior to the accident, the forklift truck operator parked the forklift truck in the lift hall on the 3/F and went down to the 1/F to continue with the loading work. By that time, the deceased person was alone on the 3/F. He got into an unattended forklift truck and attempted to operate it. In doing so, the forklift truck hit the lift gate, damaged and derailed it. The deceased person thus fell with the forklift truck into the lift shaft down to the 1/F below.

- The deceased person was a trainee in the warehouse. The day of the accident was his second working day.
- The deceased person was left to work alone on the 3/F without any supervision.
- No formal training was provided to the deceased person. He was put under the guidance of a foreman and trained on the job.
- The forklift truck operator had to operate three trucks at three different locations in the warehouse.
- The operator did not apply the parking brake and remove the ignition key from the forklift truck when he parked and left the truck in the lift hall at the 3/F.
- No warning notice to prohibit unauthorised use of the forklift truck was displayed on the forklift truck or at prominent places in the warehouse.

- (a) A safe system of work should be devised and implemented to ensure the safety of all workers working in the warehouse.
- (b) Adequate information, instruction and training as were necessary to ensure safety should be provided to the workers. As far as practicable, trainees should work under the direct supervision of competent persons.
- (c) A forklift truck left unattended should have the parking brake applied and the ignition key removed.
- (d) Unauthorised use of forklift truck should be prohibited. Warning notice should be displayed on the forklift truck or at prominent positions in the warehouse.

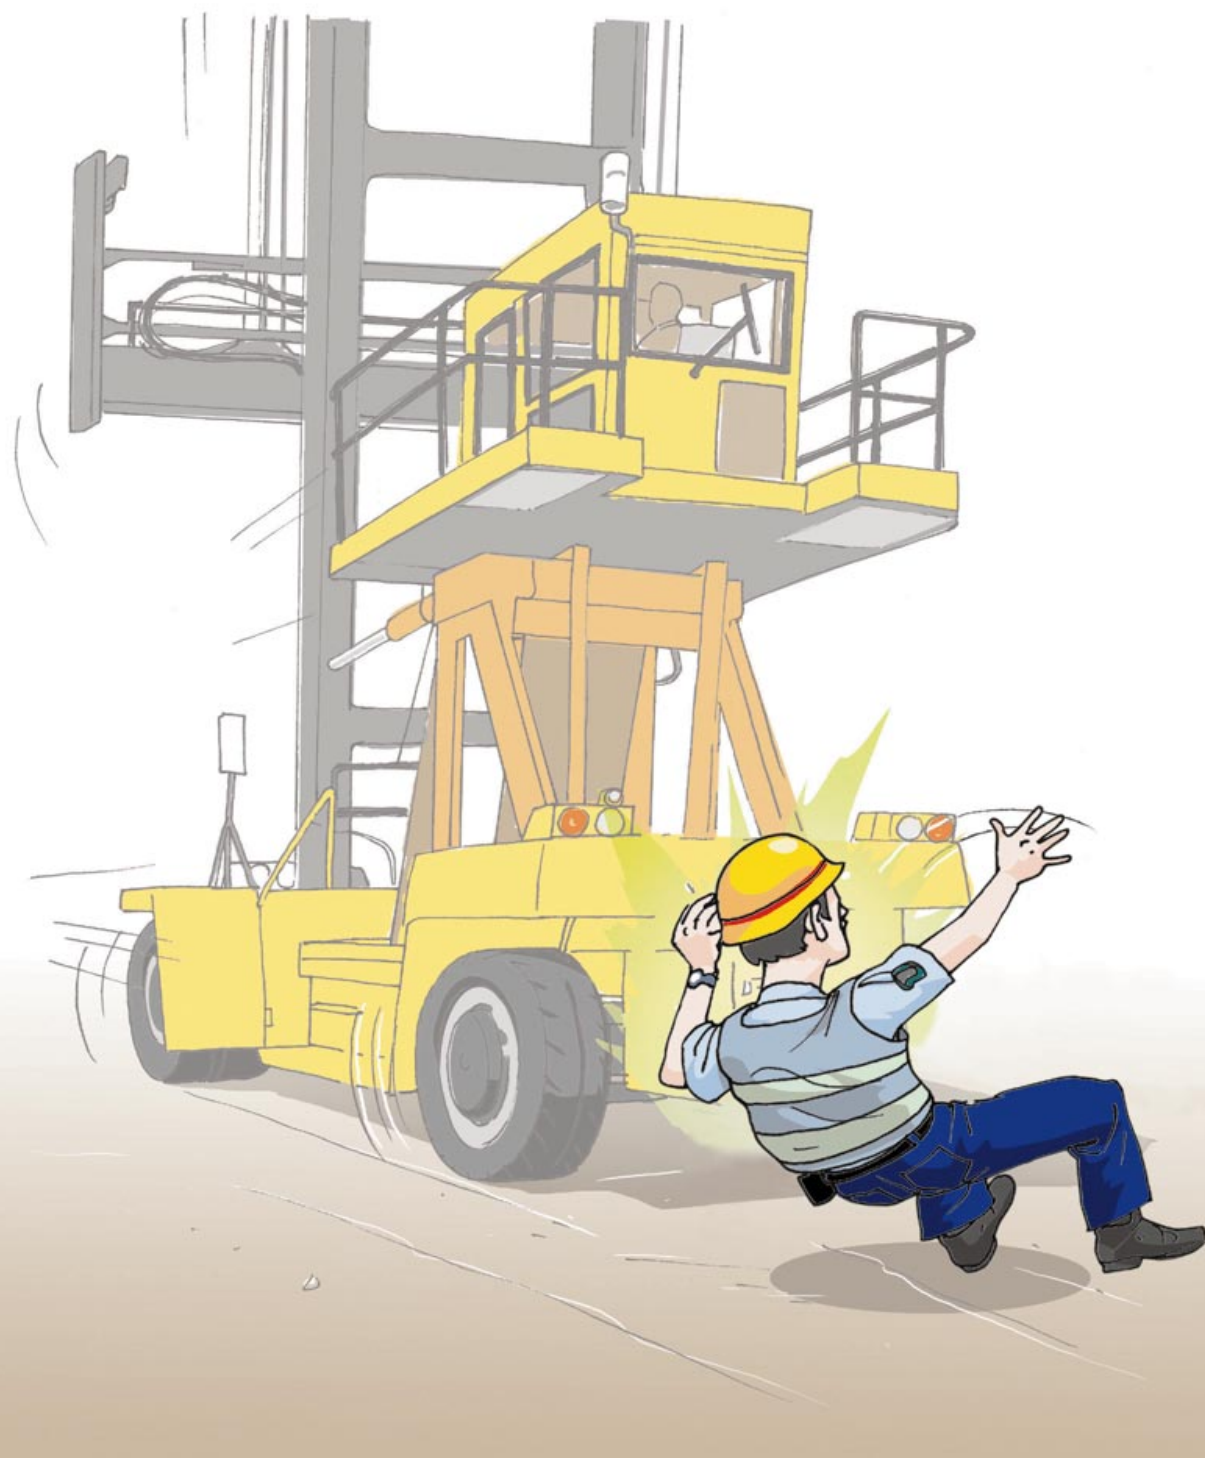
Case 8

A security guard was knocked down and rolled over by a front loader in a container yard.

The deceased person was employed as a security guard. He was responsible for directing traffic and recording information of container trucks entering into the container yard. There was an open ground adjacent to the security post, where containers were relocated by front loaders. Everyday, the deceased person had to walk across this open ground to go to toilet. At the time of the accident, a front loader was in operation on the open ground. Having relocated a container, the operator reversed the front loader intending to pick up another container. The deceased person was at the moment walking across the open ground. He was knocked down and his body rolled over by the front loader.

- There was no physical segregation to prevent the entry of persons into the open ground. No warning notice prohibiting the entry of persons into the open ground was displayed.

- The deceased person was not warned of the hazards associated with the operation of the front loader. He was not provided with such information and instruction as were necessary to ensure his safety.

- The management of the container yard had not taken any action about the deceased person going to the toilet everyday by crossing the open ground.
- The view of the front loader operator was partially obstructed by the left and right columns of the vertical mast. There were blind spots in front of the loader.

- Two convex mirrors were mounted on both sides of the front loader for the operator to view the condition at the rear of the machine. The rear view in the side mirrors was also partially obstructed by the driving cabin. There were also blind spots at the rear.

- (a) The operating area of the front loader should be physically segregated to prevent the entry of persons on foot.
- (b) Persons working in a container yard should be adequately trained, and provided with suitable information and instruction as were necessary to ensure their safety and health at work.
- (c) A monitoring system should be implemented to ensure that no person travelling on foot would enter into an area where container-handling activities were in progress.
- (d) Suitable devices should be installed on the front loader to enable the operator to have a clear front and rear view of the loader.

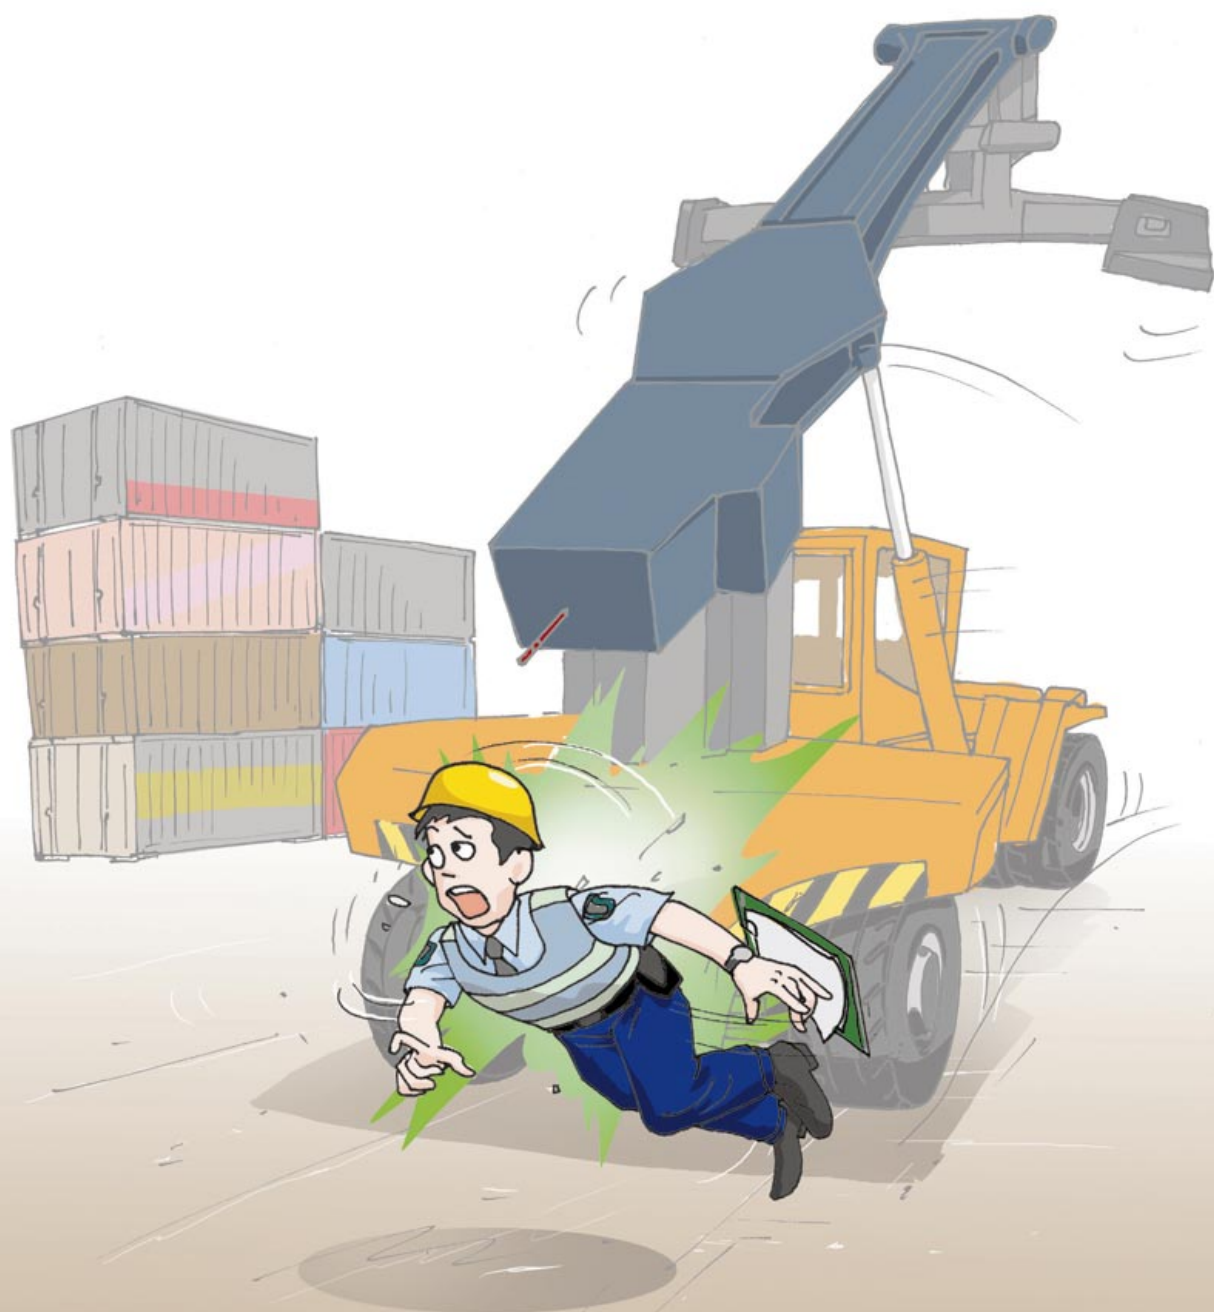
Case 9

A container checker was knocked down by a reach stacker in a container yard.

The deceased person was directed to record identifications of containers on a barge berthed at the container yard. To go to the barge, he walked on foot from the checker's room right across the container-handling yard. A reach stacker was at that time stacking containers at Section 3 in the yard. After stacking, the operator intended to drive the stacker to Section 2 for further operation. While the stacker was reversing into an open access of Section 3, the deceased person happened to walk by. The stacker operator failed to notice that the deceased person was walking close to the reversing stacker. The deceased person was also unaware of a reach stacker reversing at him from his back. As a result, the stacker knocked down the deceased person and rolled over his body.

- In this container yard, container stacking machines and container trucks moved in all directions inside the stacking area. Checkers would walk across sections to perform their duties. They usually walked on the streets with moving traffic.
- There was no demarcation on the streets and sections in the container yard to separate persons from vehicles. There was also no sign to control the direction of traffic in the container yard.
- The reach stacker operator could not have a clear and unobstructed rear view when he was sitting inside the driver's cabin. Blind spots were created by the lifting mast of the stacker. No additional safety device was installed to eliminate the blind spots at the back of the stacker.

- (a) A safe system of work should be devised and maintained for checkers to gain access to various sections in container yard to perform their duties.
- (b) The container handling areas should be demarcated as "Restricted Zone". Unless authorised, personnel accessing on foot into these areas should be prohibited.
- (c) Safe working procedures should be developed, such as adopting a "Permit-to-Work" system, to cater for the situation where checkers are required to enter the "Restricted Zone" on foot.
- (d) Pedestrian pavements, vehicles routes and directions of traffic should be well defined and demarcated in the container yard.
- (e) Suitable safety devices should be installed on the reach stacker to eliminate the blind spots at its rear. The devices should also be properly maintained in good working order at all time.
