A Casebook of Occupational Fatalities in the Container Handling and Storage Sector

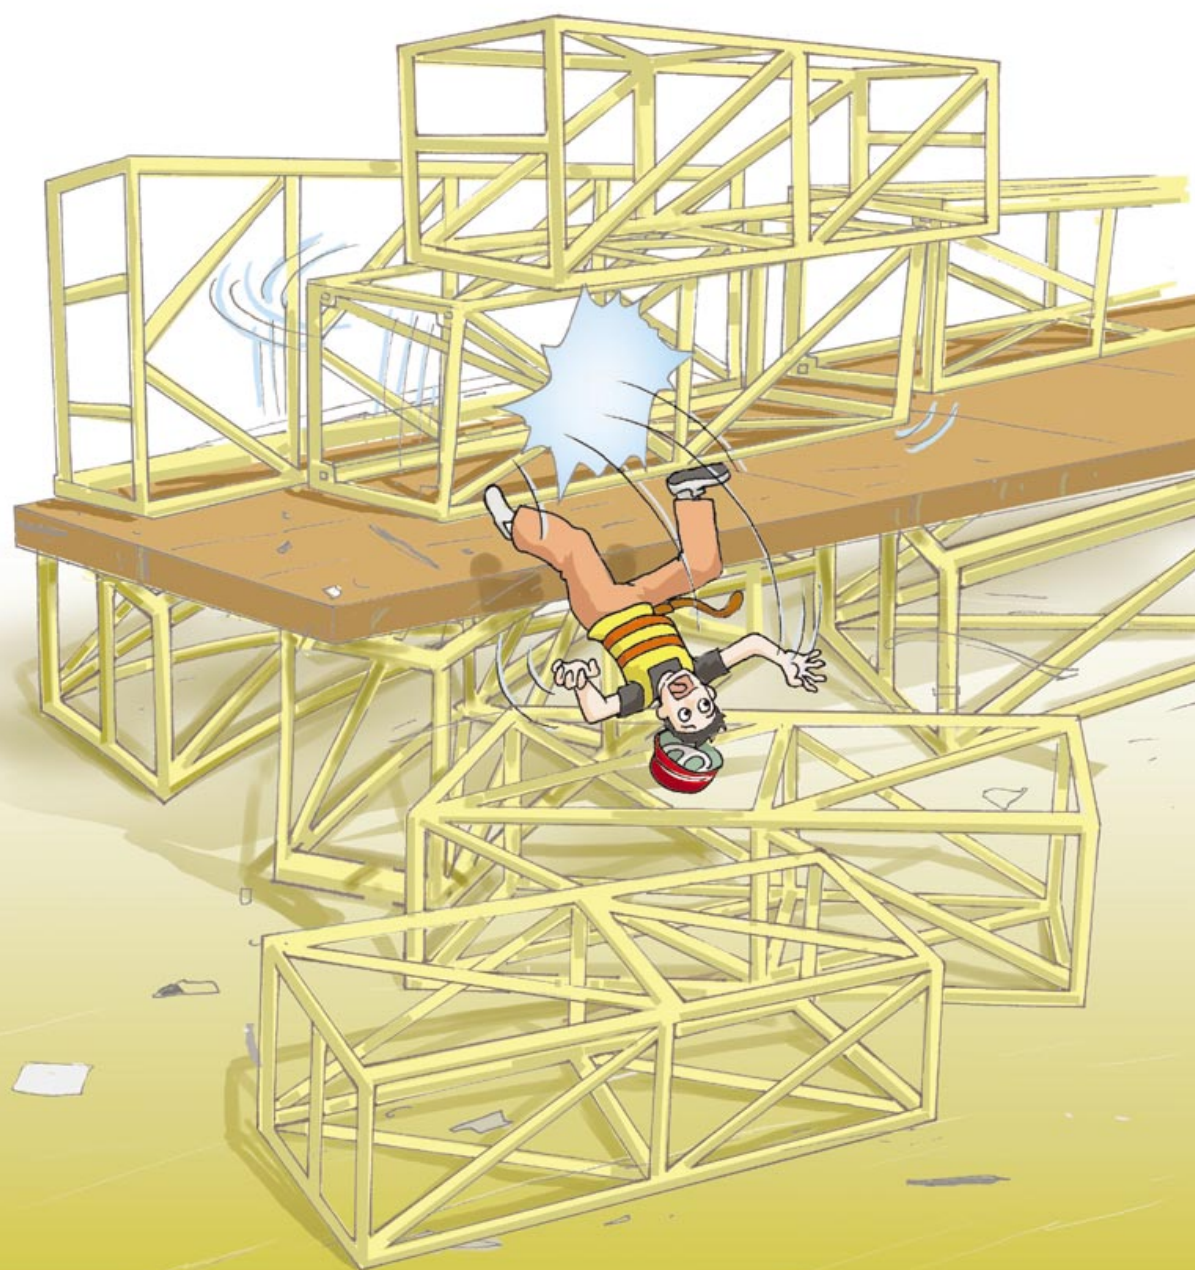
A worker was struck by a displaced tower crane jib member while performing rigging work in a storage yard.

Parts of a dismantled tower crane were to be transported by truck cranes from the storage yard to a construction site for installation. The deceased person was the rigger employed by a transportation company. He was responsible for hooking and unhooking wire ropes to and from the dismantled tower cranes parts and giving signals to the truck crane operator during the lifting operations. At the time of the accident, the deceased person was working alone. He was going to attach a wire rope to a tip section of the crane jib. This tip section was rested on a stage platform on another end section of the crane jib. The stage platform was 2.15 m above the ground whereas the top of the tip section was 3.48 m above the ground. To reach the point of hooking on the tip section, the deceased person had to climb up the dismantled jib sections stacked there. In so doing, the stability of the jib sections was disturbed and the tip section toppled. The tip section displaced and struck onto the deceased person.

- Risk assessment was not conducted before the lifting operation.
- Suitable scaffold, ladder or other means of support was not provided for the use of the rigger to perform rigging work at an elevated position.
- Adequate training as was necessary to ensure the safety at work of the rigger was not provided.
- The rigger engaged in such high-risk work activity was not supervised. He was left alone to perform the task.

- (a) A safe system of work for the transportation of tower crane parts should be devised and implemented. The system should include the followings:
 - (i) Risk assessment should be conducted to identify the hazards of hooking, lifting and unhooking of stacked loads.

- (ii) Safe working procedures for the lifting operation should be devised and implemented.
 - (iii) The workers should be provided with adequate information, instruction and training in relation to the transportation of dismantled tower crane parts.

- (iv) Qualified safety personnel should be appointed to ensure that the lifting operation is carried out in accordance with the safe working procedure.

- (v) The workers engaged in high-risk work activities should be suitably supervised.
- (b) No person should climb on stacked loads to avoid disturbing stability of the loads.

- (c) Suitable scaffolds, ladders or other means of support should be used to provide access for the rigger. Steps should also be taken to ensure that the rigger make full and proper use of the scaffolds, ladders or means of support provided.
