An Analysis on

Occupational Fatalities - Casebook Volume No. 2

OCCUPATIONAL SAFETY AND HEALTH BRANCH
LABOUR DEPARTMENT

This edition December 2003

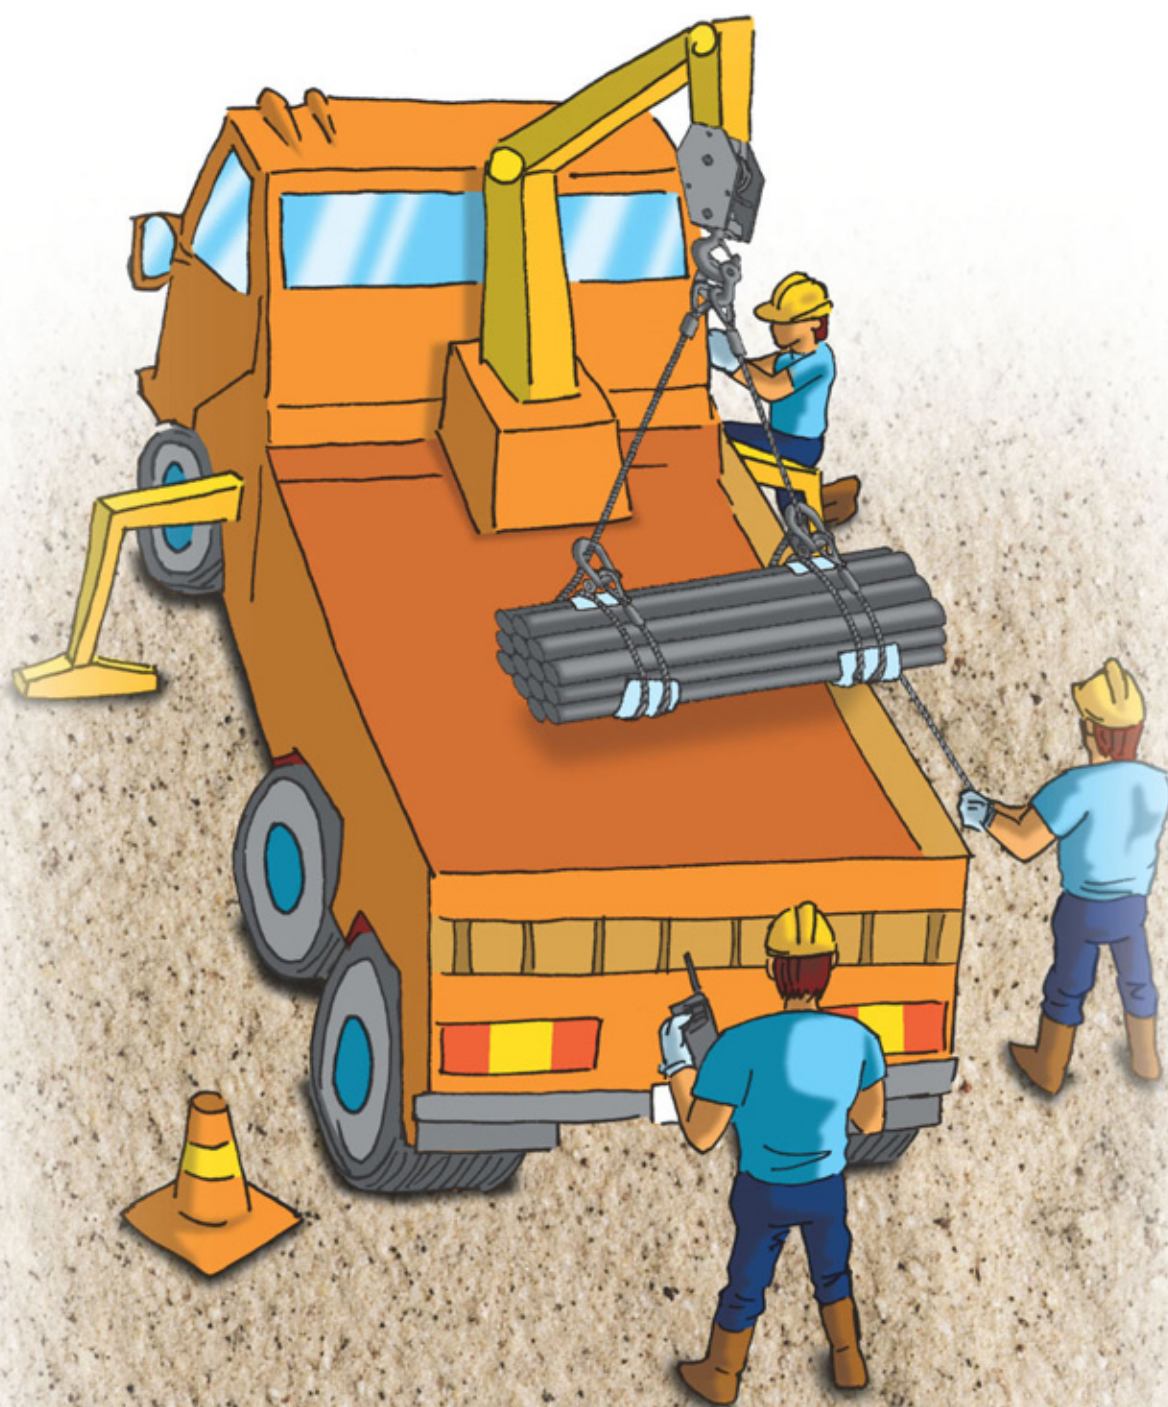
When the lifting operation was ready, D/P gave hand signal to the crane operator who then operated the crane to lift the bundle of U-channels away from the loading platform to the ground. The D/P was staying on the loading platform near the end of the lorry. Shortly afterwards, the co-worker on the loading platform and the crane operator heard somebody's shouts and the D/P was found lying on the ground near the end of the lorry. The D/P was rushed to hospital for treatment but he was certified dead on the same day.

- (a) Before any lifting operation begins, workers should leave the loading platform and stay away from the lifting path of the load;
- (b) Guide rope should be attached to the load being lifted and controlled by a worker at a suitable distance so as to prevent any undue movement of the load.

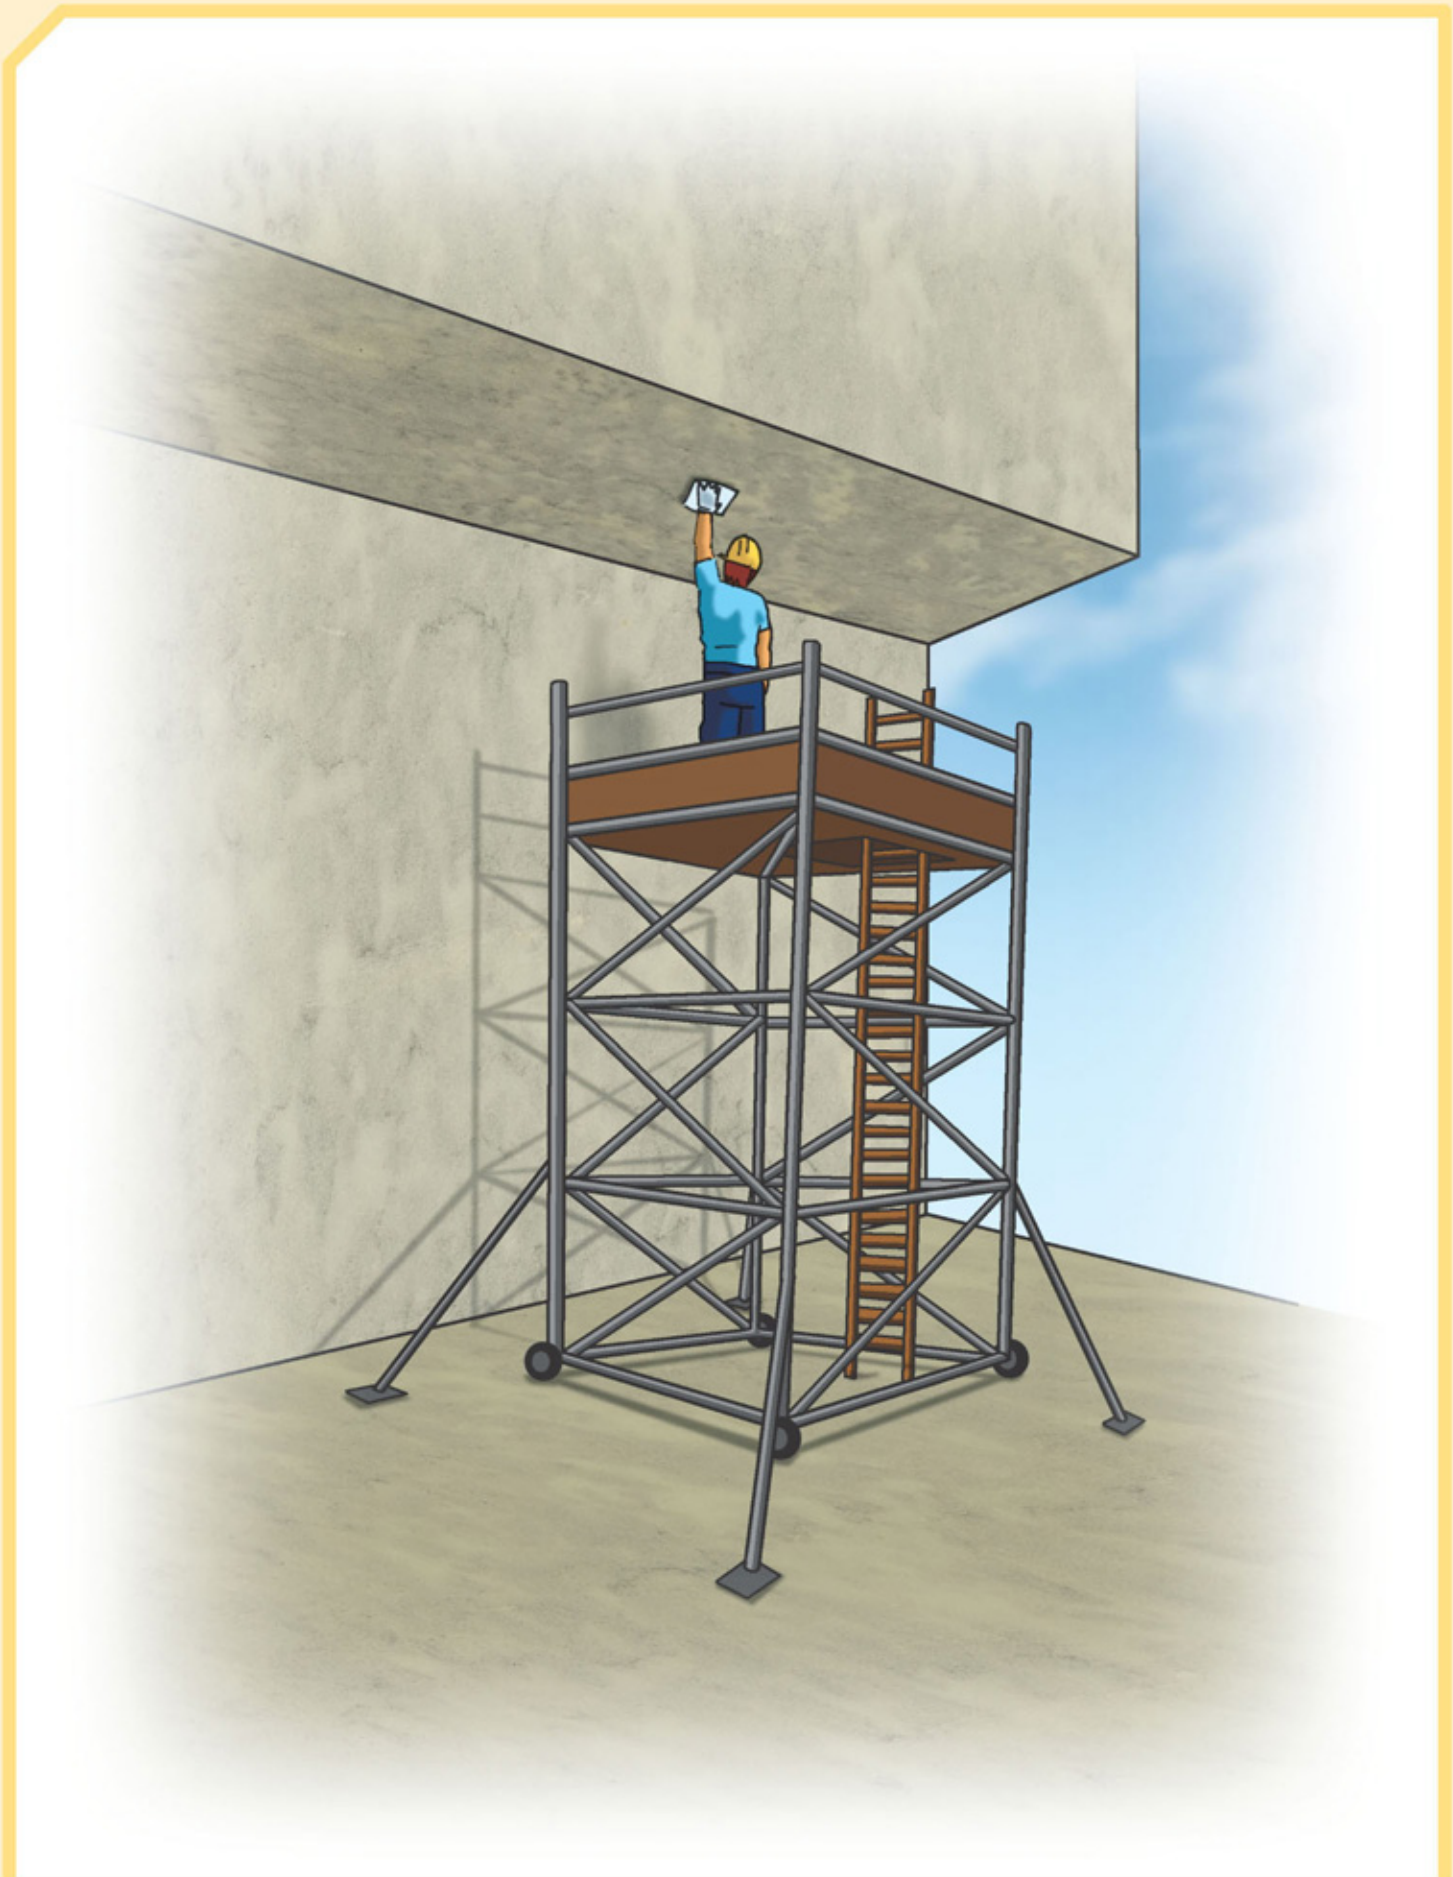
At the material time of the accident, while the D/P was cleaning the ceiling on a working platform at the top of the scaffold, fitful gust of wind suddenly caused the scaffold to topple. The lower part of the scaffold struck against a parapet wall of the podium. The top layer of the scaffold dislodged from the lower part and fell to the promenade below the podium. The D/P fell out from the working platform and his head struck against the floor of the promenade. He sustained fatal injury in the fall.

- Every side of the working platform should be provided with toe-board of a minimum height of 200mm.
 - The scaffold together with the working platform should be inspected and certified safe by a competent person before use.

- (b) Provision of appropriate and sufficient safety training, information, supervision and instruction to the workers working on the scaffold.
- (c) A monitoring system should be developed, implemented and maintained to supervise and ensure the safety performance of the workers.

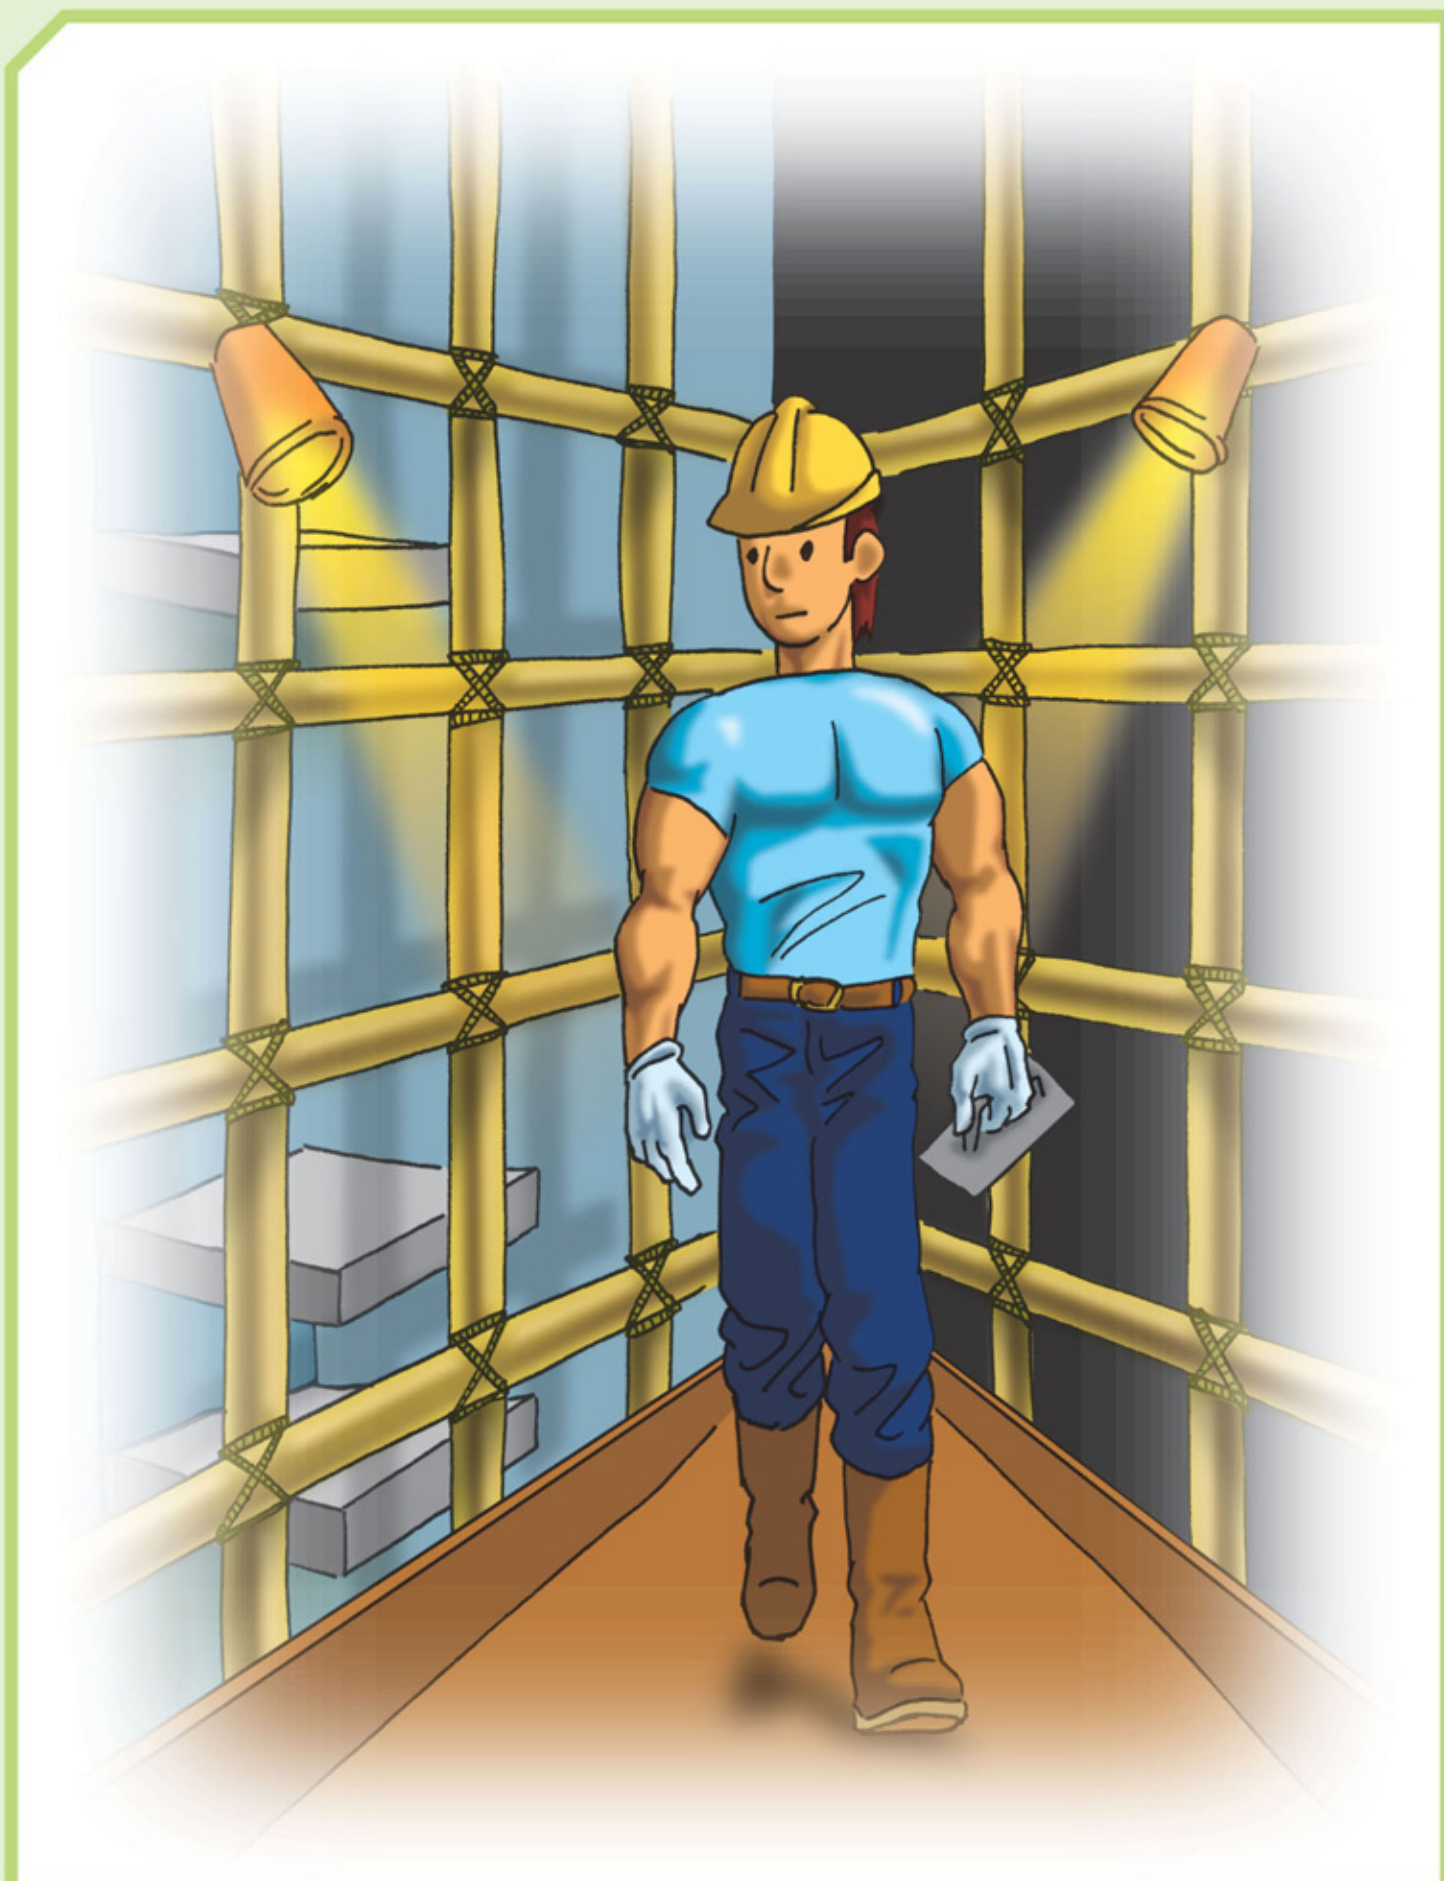
The lighting condition at the external wall where the accident happened was very poor. The only lighting provided was ten spotlights installed on the jib of a tower crane above the building. Sometimes, the tower crane slewed around over floor slab for other operations.

The D/P was wearing a waist type safety belt but there was no independent lifeline or other anchorage for attachment of the safety belt.

As the external wall of the 13/F was inadequately lit and there was no working platform provided on the single row bamboo scaffold, the D/P had to work in the dark and at the same time, keep balance of the body on the scaffold. It was likely that the D/P might have lost balance in the course of work and fell.

- (a) Suitable working platform for worker performing concrete smoothing work at the external wall of the building should be provided and properly maintained.
- (b) Suitable and adequate safe access to and egress from the working place at the external wall should be provided and properly maintained.
- (c) Every working place and the approach to such place should be adequately and suitably lit.

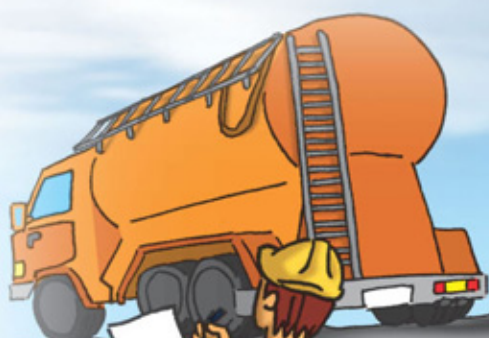
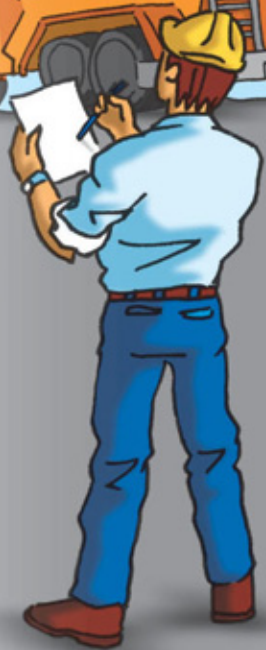
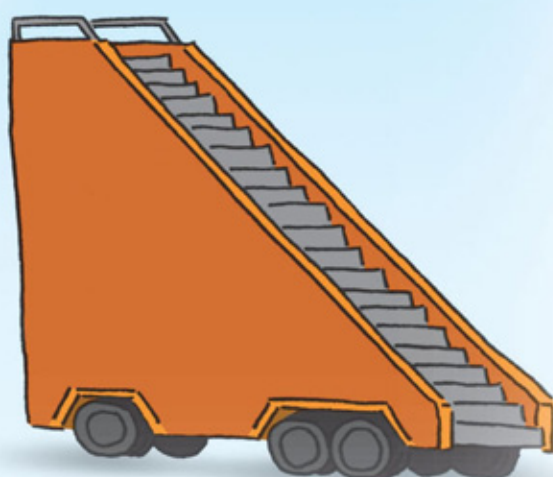
tanker, he should have been protected from falling from the sides by the foldable guardrails had they been properly erected. However, falling hazard still existed at the front and rear ends at the top of the cement tanker where no guardrail was available. Furthermore, falling hazard also existed when a cement tanker driver was climbing on the rear ladder in particular with one hand carrying a water hose, since no fall arresting equipment was provided.

Worker must be prohibited from working on the top of a cement tanker unless a safe system of work has been established and adopted. The safe system of work should include:

- (a) The carrying out of a risk assessment for working on the top of the tanker;
- (b) The development and implementation of safe procedures for relevant work;
- (c) The provision and maintenance of suitable guardrails on the top of the cement tanker to prevent persons working thereon from falling;
- (d) The provision and maintenance of suitable means of access to and egress from the top of the cement tanker;
- (e) The provision, maintenance and use of suitable fall arresting equipment and anchorage where necessary;
- (f) The provision of training, information, instruction and supervision to the worker in relation to safety at work on the top of the cement tanker.

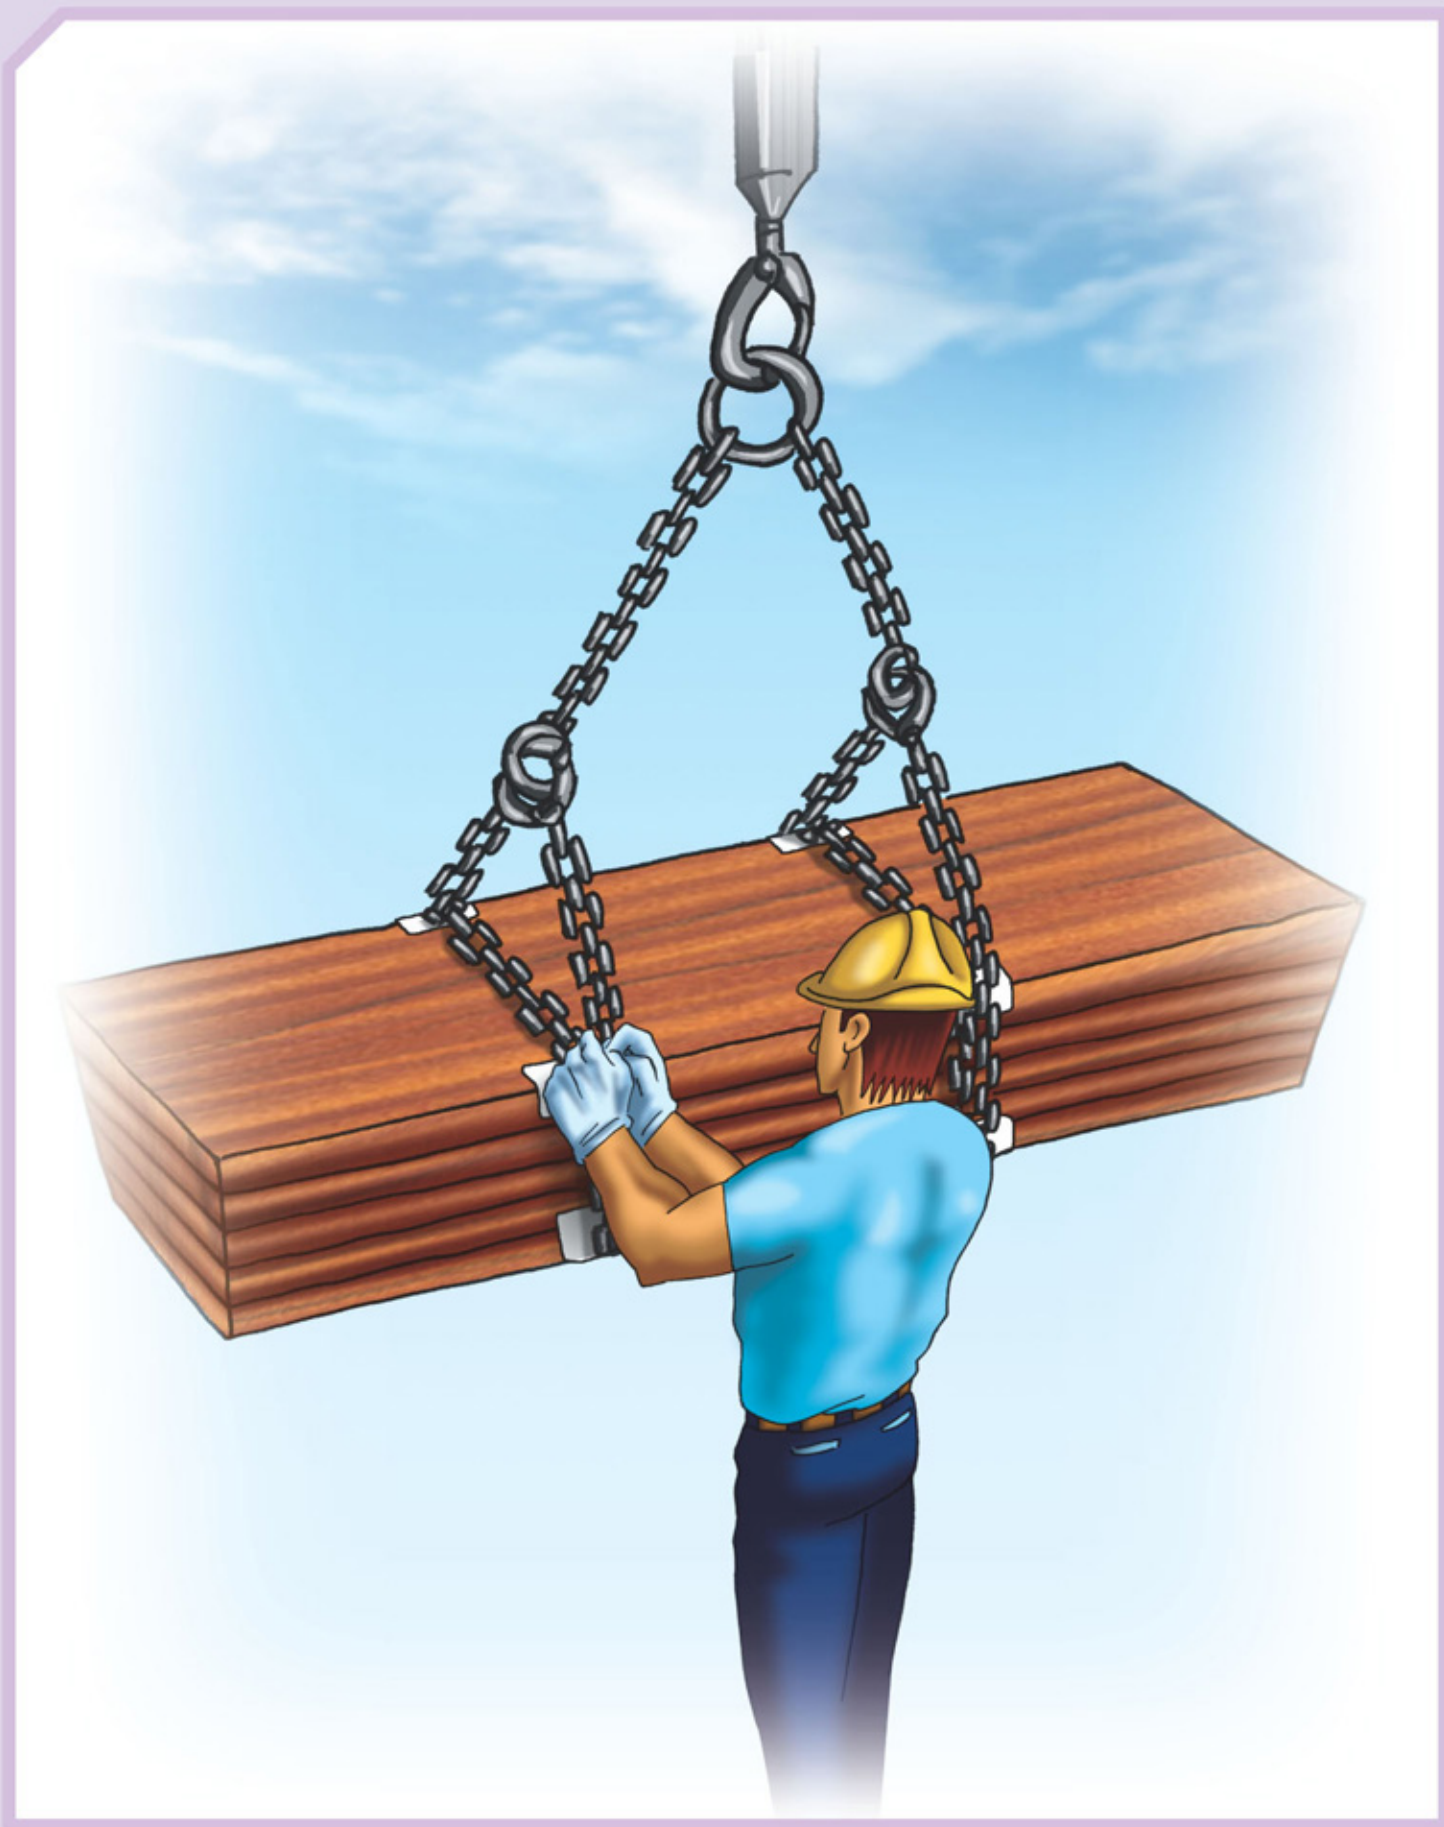
No damage or defect was found on the metal chain slings. The latch hooks of the sling were in normal condition and their locking mechanisms could work properly. Workers had to close the latch hooks properly in order to actuate the locking mechanisms. Since the latch hooks could appear to have been locked, they should check them with hands on each occasion. However, the rigging worker only conducted a visual check.

The choker hitch formed by each metal chain sling could not completely grip the wooden boards which were loosely gathered. Besides, the wooden boards had been used before and some of them had even deformed with nails and debris on the surfaces. They might slip or displace during lifting when there were no other means to tighten them up.

- Suitable arrangement should be made to prevent the load being lifted from passing over persons.
 - Safe work procedures for the lifting operation should be established and adequate steps should be taken to ensure the compliance by workers.

- Suitable information, instruction and training on the lifting operation should be provided to the workers.

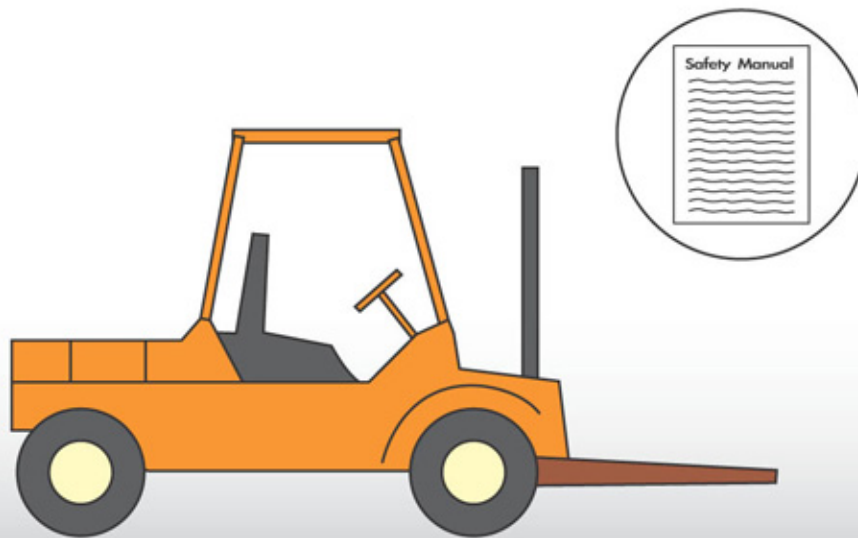
A homemade metal counterweight of semi-circular shape (110 mm diameter, 140 mm thick and 760kg in weight) was affixed to another counterweight at the tail part of the truck so as to increase the lifting capacity. It had two projecting rods (30mm in diameter and 180 mm in length) on its underside for inserting into the holes of the counterweight of the truck.

It was possible that the D/P, while operating the forklift truck at quite a speed and coming close to the railway track, might have applied brake upon entering the undulated surface there. The metal sheet roll shifted forward, and so did its centre of gravity. That caused the forklift truck to tilt forward. Since the extra counterweight had not been secured in position, it dislodged and hit the D/P from the back.
